INTERSTATE AVIATION COMMITTEE

FINAL REPORT

ON THE RESULTS OF THE AIR ACCIDENT INVESTIGATION

Type of occurrence	Fatal accident
Type of aircraft	RRJ-95 (RRJ-95B model) airplane
Nationality and registration marks	RA-89098
Owner	VEB Leasing, JSC
Operator	Aeroflot, PJSC
Aviation authority	FATA
Place of occurrence	Sheremetyevo aerodrome, Moscow region, Russian Federation; reference position: 55°58'06.20" N, 37°24'07.20" E
Date and time	May 05, 2019, 18:30 local time (15:30 UTC), daytime

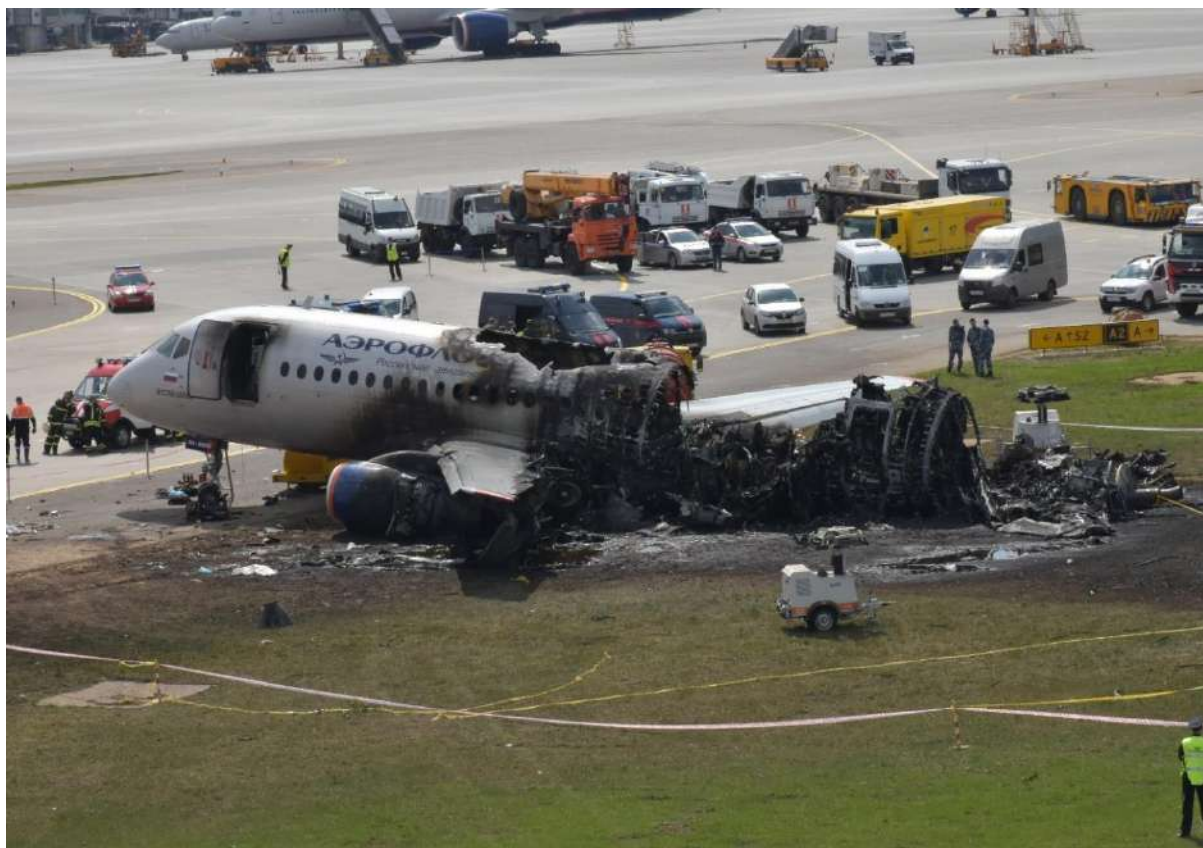
Fig. 1. The RRJ-95B RA-89098 airplane after the air accident

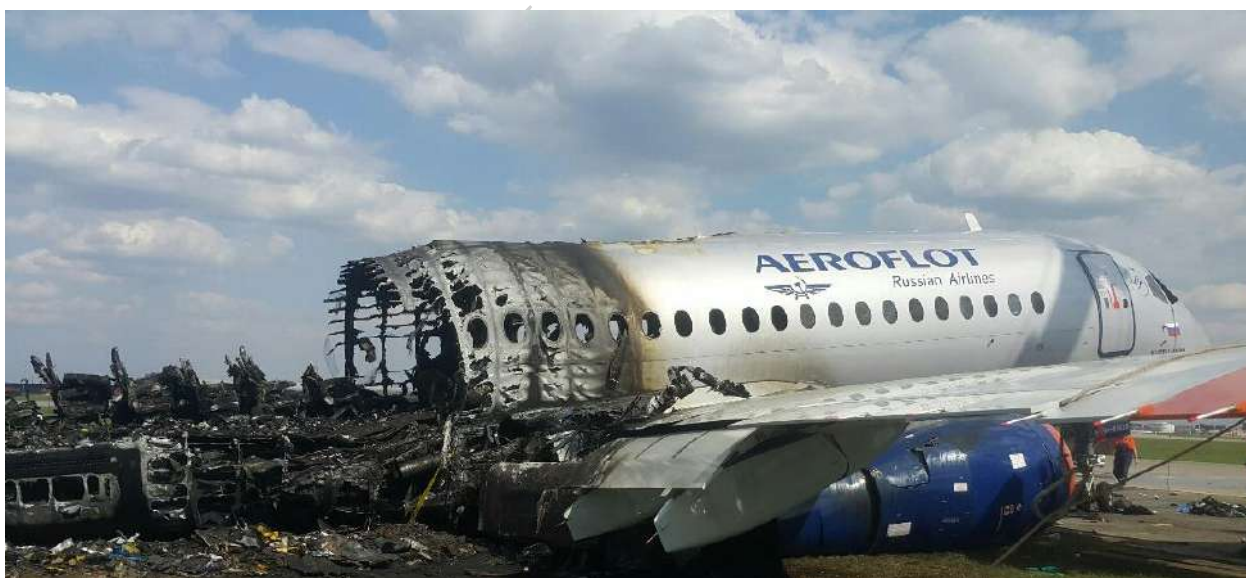
No visible significant structural damage is identified of the F1, F2 fuselage compartments/FR1 – 24 (Fig. 2)¹⁰.

Fig. 2. The post-accident forward fuselage exterior

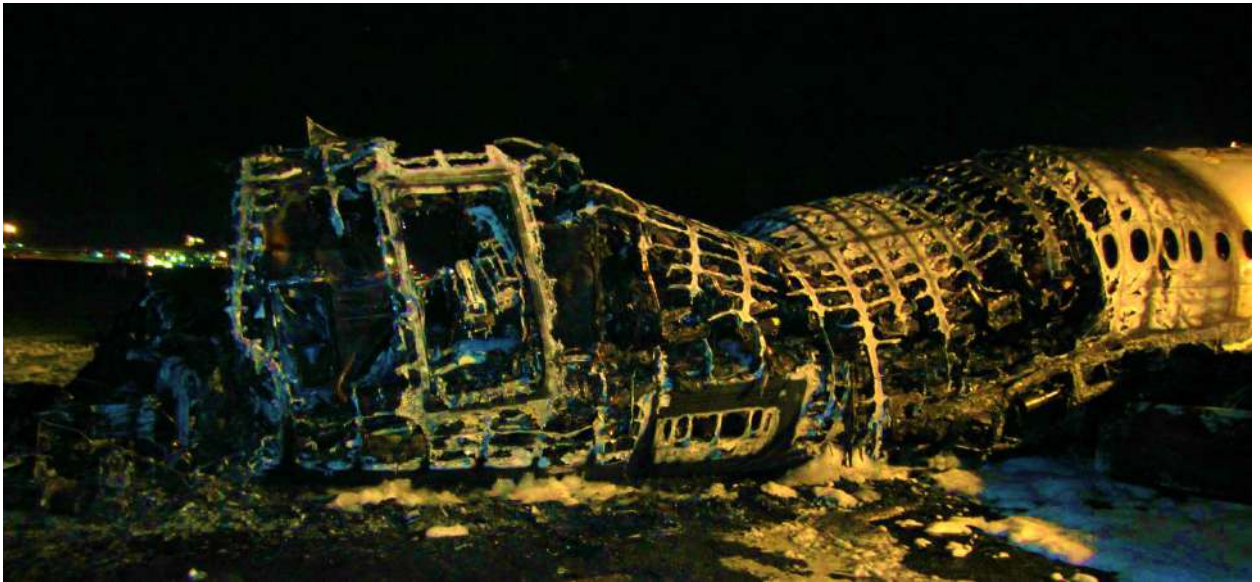
The F3 and F4 fuselage compartments/FR24 – 51 burnt out completely upwards from the floor level beyond the FR29 and sustained the considerable skin burnout below the floor level (Fig. 3).

Fig. 3. The post-accident center and rear fuselage exterior

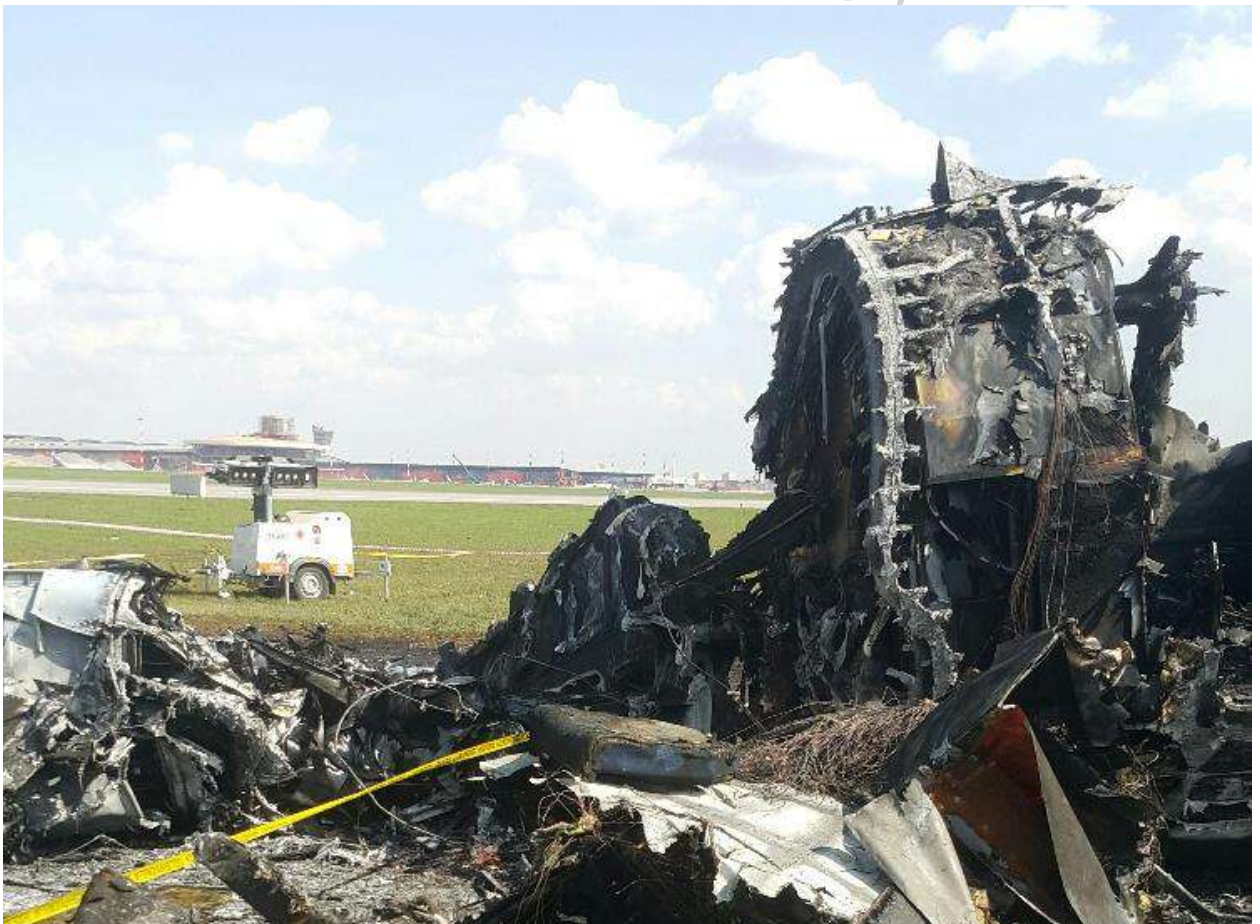
The F5 fuselage compartment is completely burnt out, the elements of the fuselage framework and the assemblies are allocated on the ground surface (Fig. 4).

Fig. 4. The F5 compartment exterior

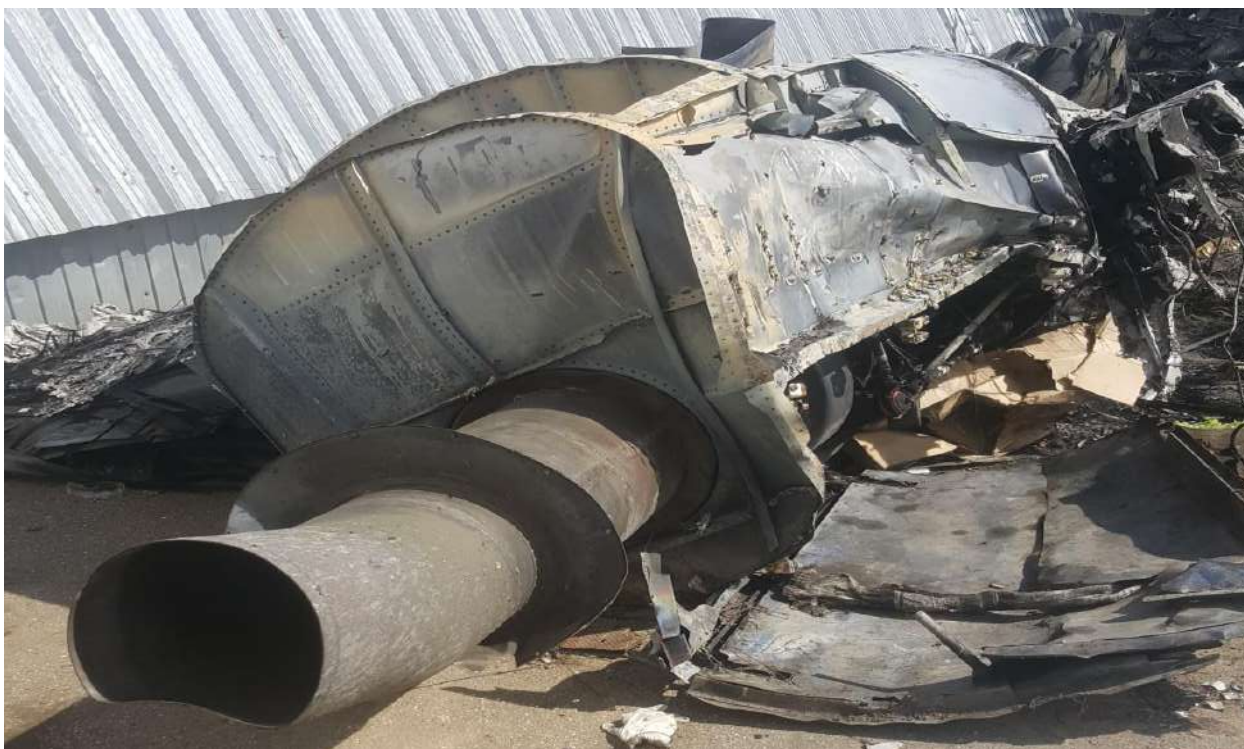
The F6 compartment is burnt out except for the steel and titanium alloy parts, the survived elements of the fuselage framework and assemblies (Fig. 5) were allocated on the ground surface.

Fig. 5. The F6 compartment elements exterior (the picture was taken at the storage site)

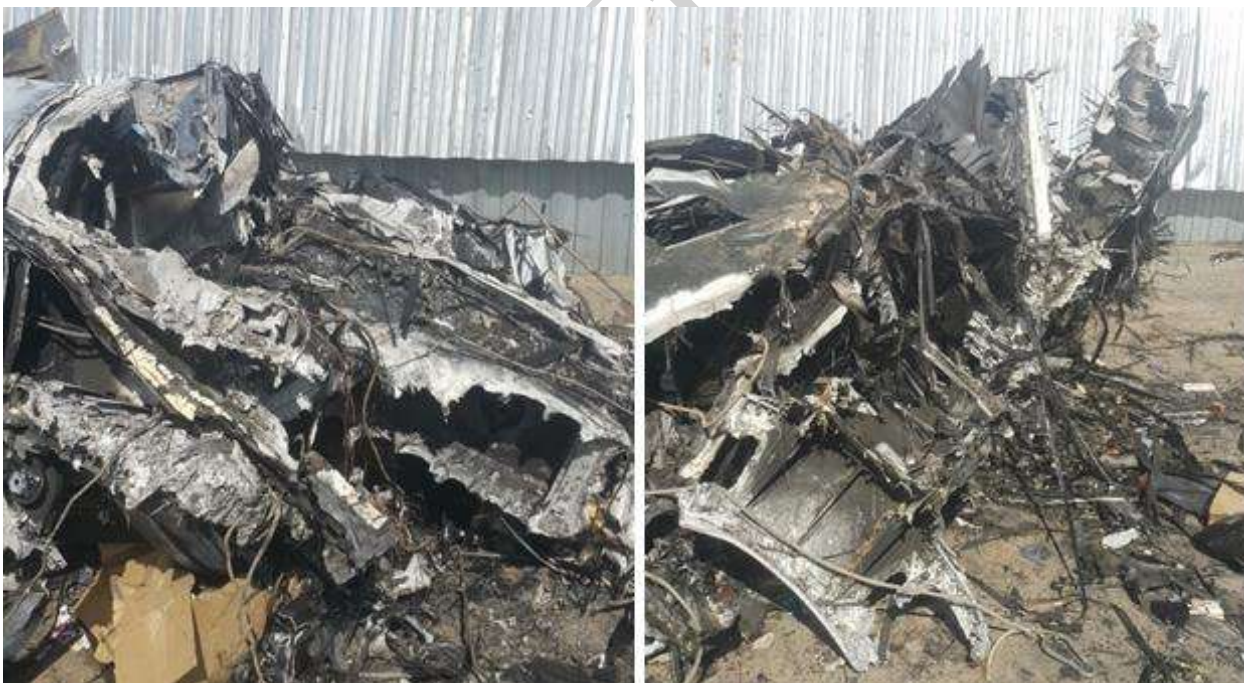
The vertical and horizontal parts of the empennage are burnt out, their survived elements (Fig. 6) were resting on the ground surface.

Fig. 6. The post-accident exterior of the vertical and horizontal parts of the empennage (the picture was taken at the storage site)

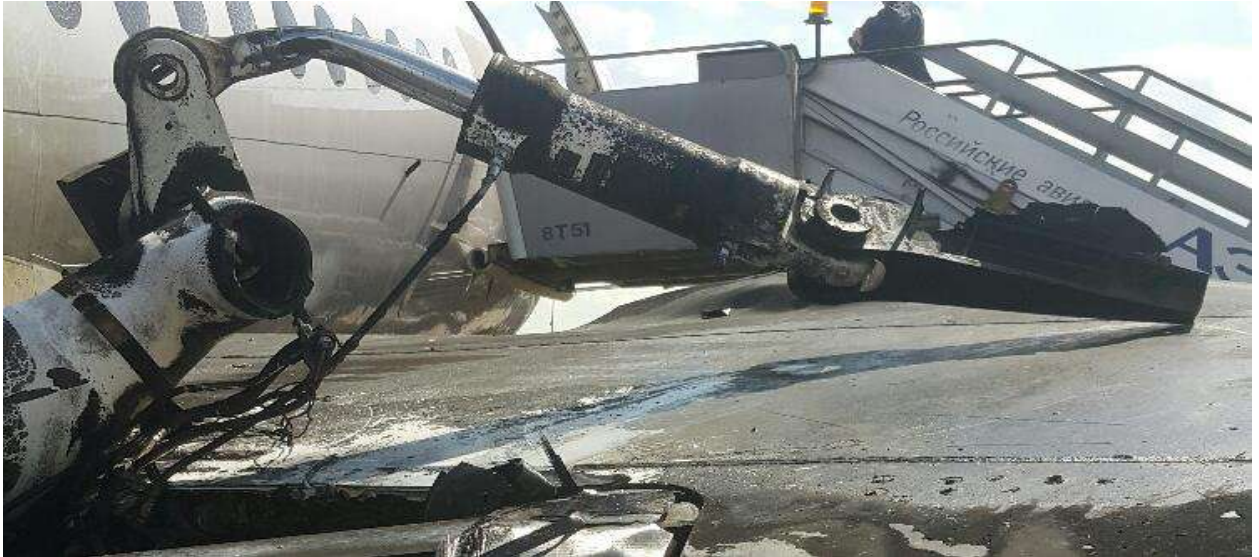
– the right MLG actuating cylinder mounting bracket is separated off the rear spar and rests hanging above the panel box (Fig. 7). After the separation of the right MLG actuating cylinder mounting bracket the hole was formed in the spar web, through which the fuel had been leaked out of the right wing fuel tank (Fig. 8);

Fig. 7. The right MLG actuating cylinder exterior

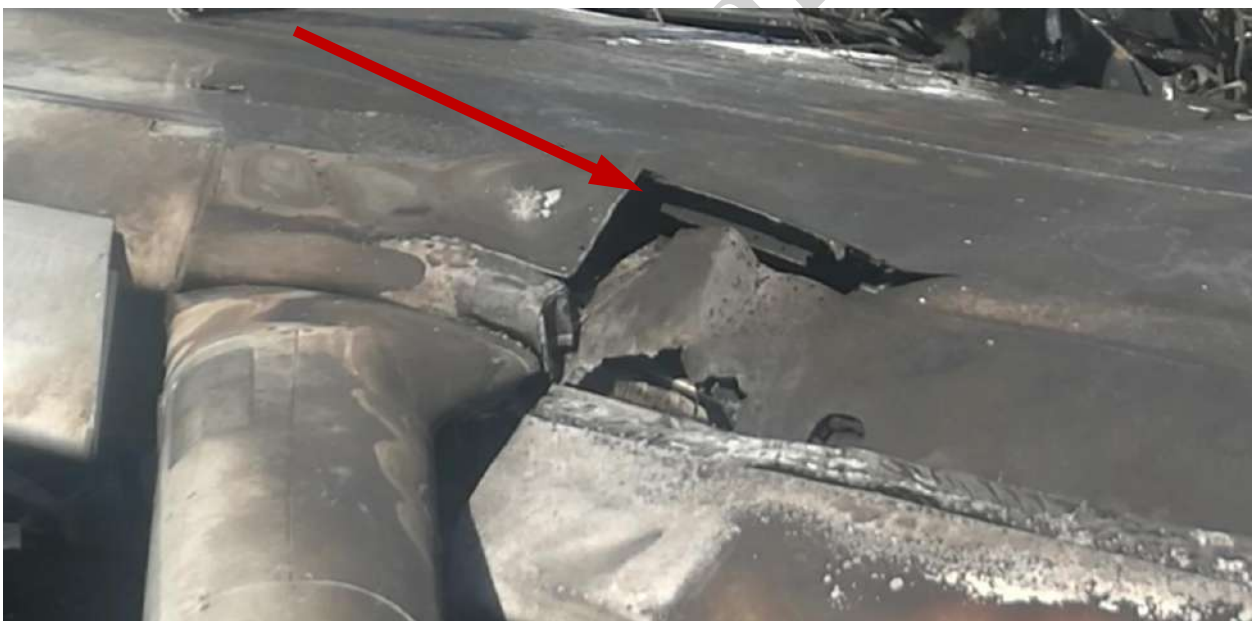
Fig. 10. The destruction of the upper panel and the fore spar of the right wing adjacent to ribs 3-4 in between the fuselage and engine pylon

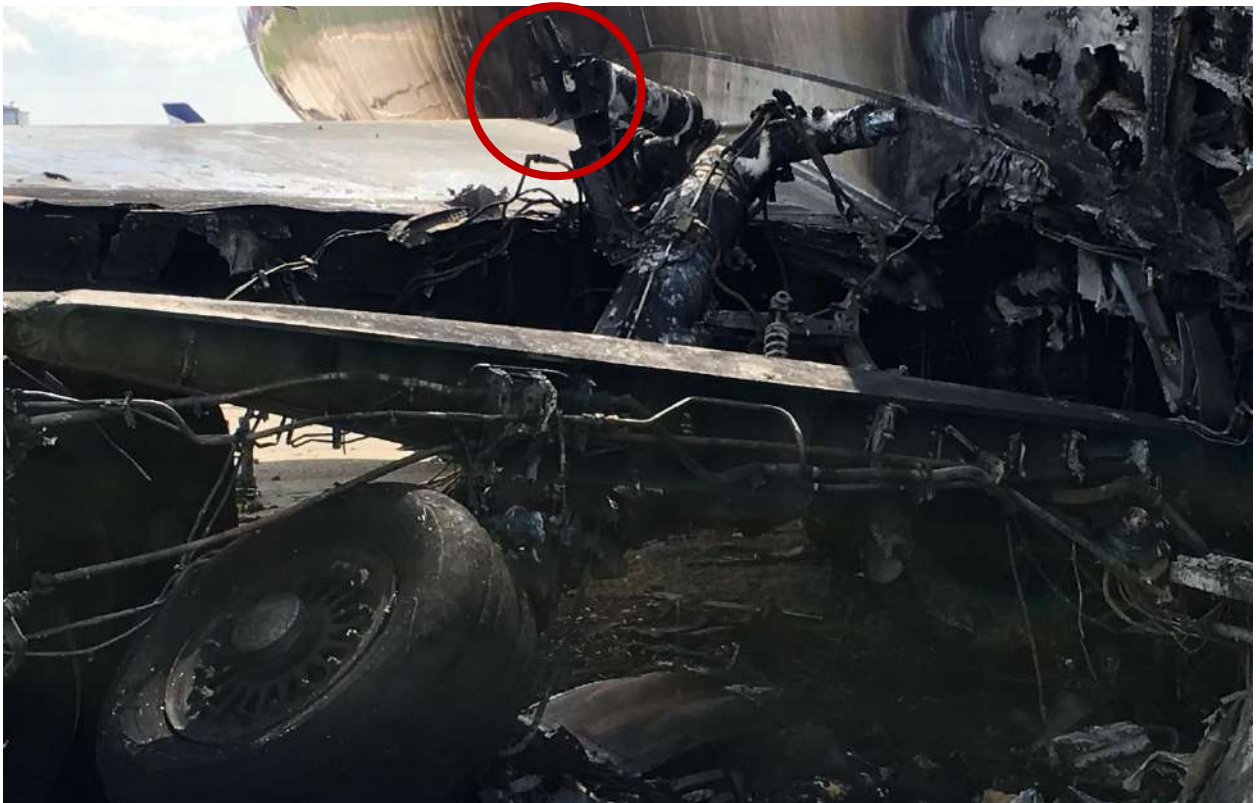
- the left wing nose lower skin is burnt and deformed;
- the left MLG actuating cylinder mounting bracket is separated off the rear spar and rests hanging above the panel box. The nature of the separation and damage (Fig. 11 and Fig. 12) is similar to the right MLG. The rear spar upper panel, caps and web of the left wing box adjacent to ribs 5-6 sustained damage as well (Fig. 13 and Fig. 14), these elements are the fuel tanks walls;

Fig. 11. The left MLG actuating cylinder exterior

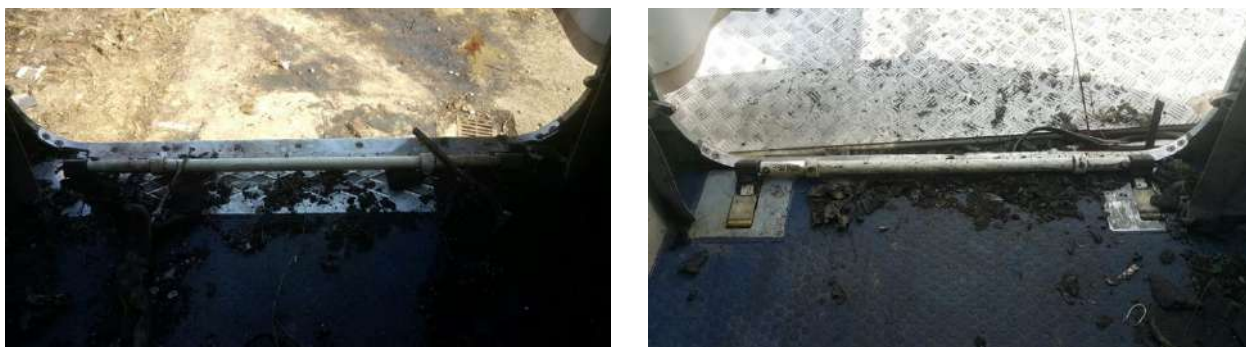
The right and left FWD doors of the passenger cabin are opened, the escape slides bars are engaged to the mounting brackets of the step bars (Fig. 15).

Fig. 15. The post-accident FWD doors - the left and right ones - exterior

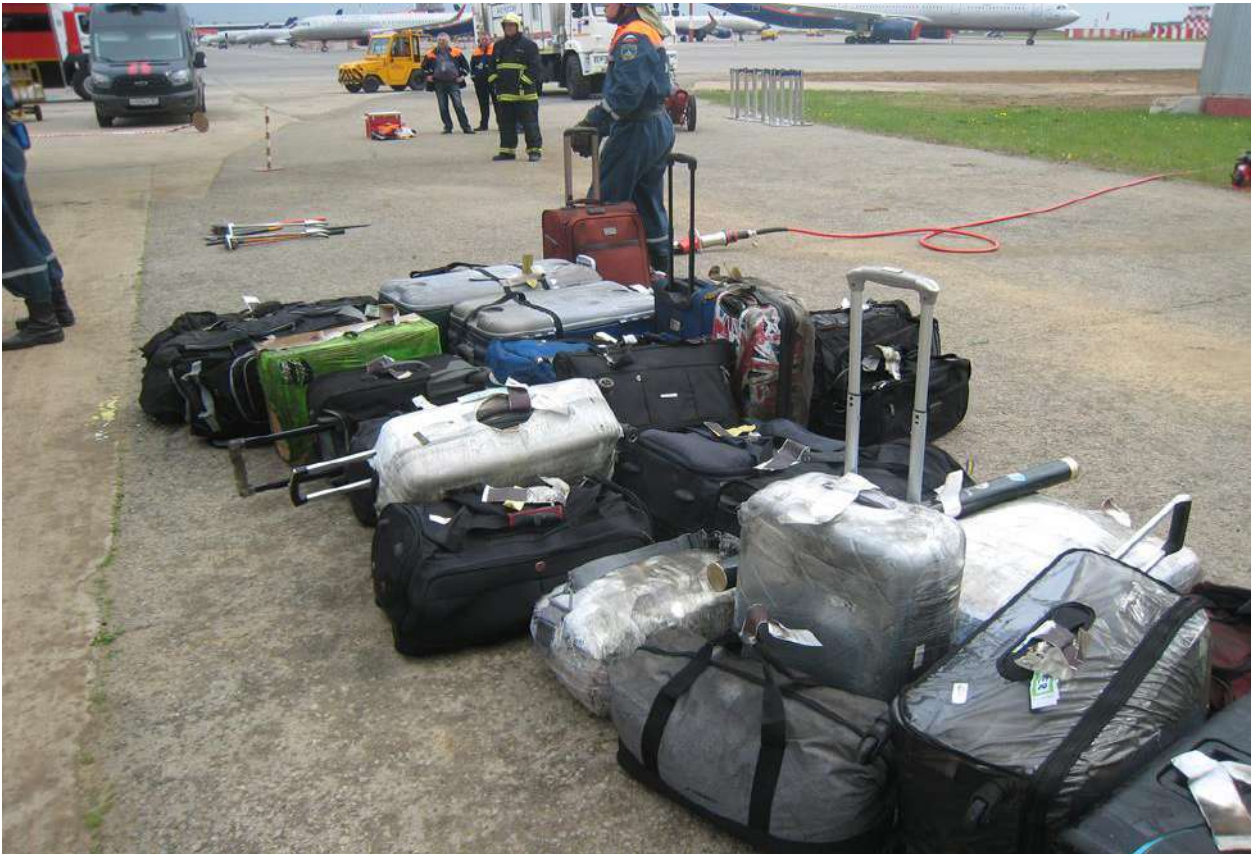
The rear baggage compartment is partially damaged, but there are no burning or open fire signs observed in the compartment. Traces of soot were revealed on the front wall of the compartment and on the passengers' baggage (Fig. 16). The rear baggage compartment after the accident was accessible through the upper access door that did not sustain any mechanical damage (Fig. 17).

Fig. 16. The passengers' baggage, having been allocated in the rear baggage compartment subsequent to the accident

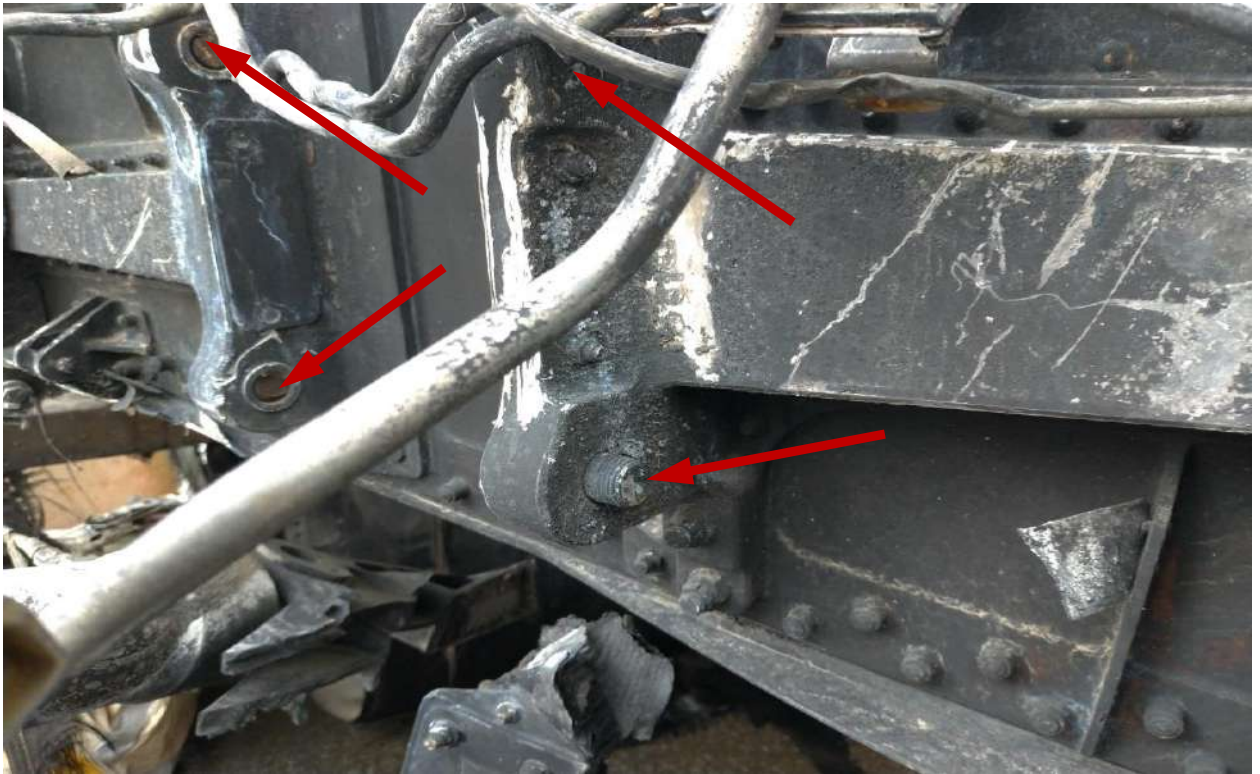
- the NLG is in an extended position with no visible damage and no traces of the hydraulic fluid leakage observed;
- the left and right MLG legs are in an extended position and are substantially damaged;
- the MLG harnesses (the electric ones, the hydraulic hoses) are stated to be disintegrated;
- the mechanical damage was stated to the MLG braces and the elements that ensure their fold;
- the right MLG side brace fuse spring is destroyed, its fragment was discovered on the RWY along with the other destructed MLG components apart;
- the fuse pins («weak links») of the FWD attachment A of both MLG legs are destructed (Fig. 18 and Fig. 19), with the fuse pins bodies remaining into the bearings housings, and the fuse pins heads remaining into the bearings mounting brackets.

Fig. 18. The left MLG attachment A fitting on the rear spar adjacent to rib 3, the attachment A fuse pins («weak links») are sheared

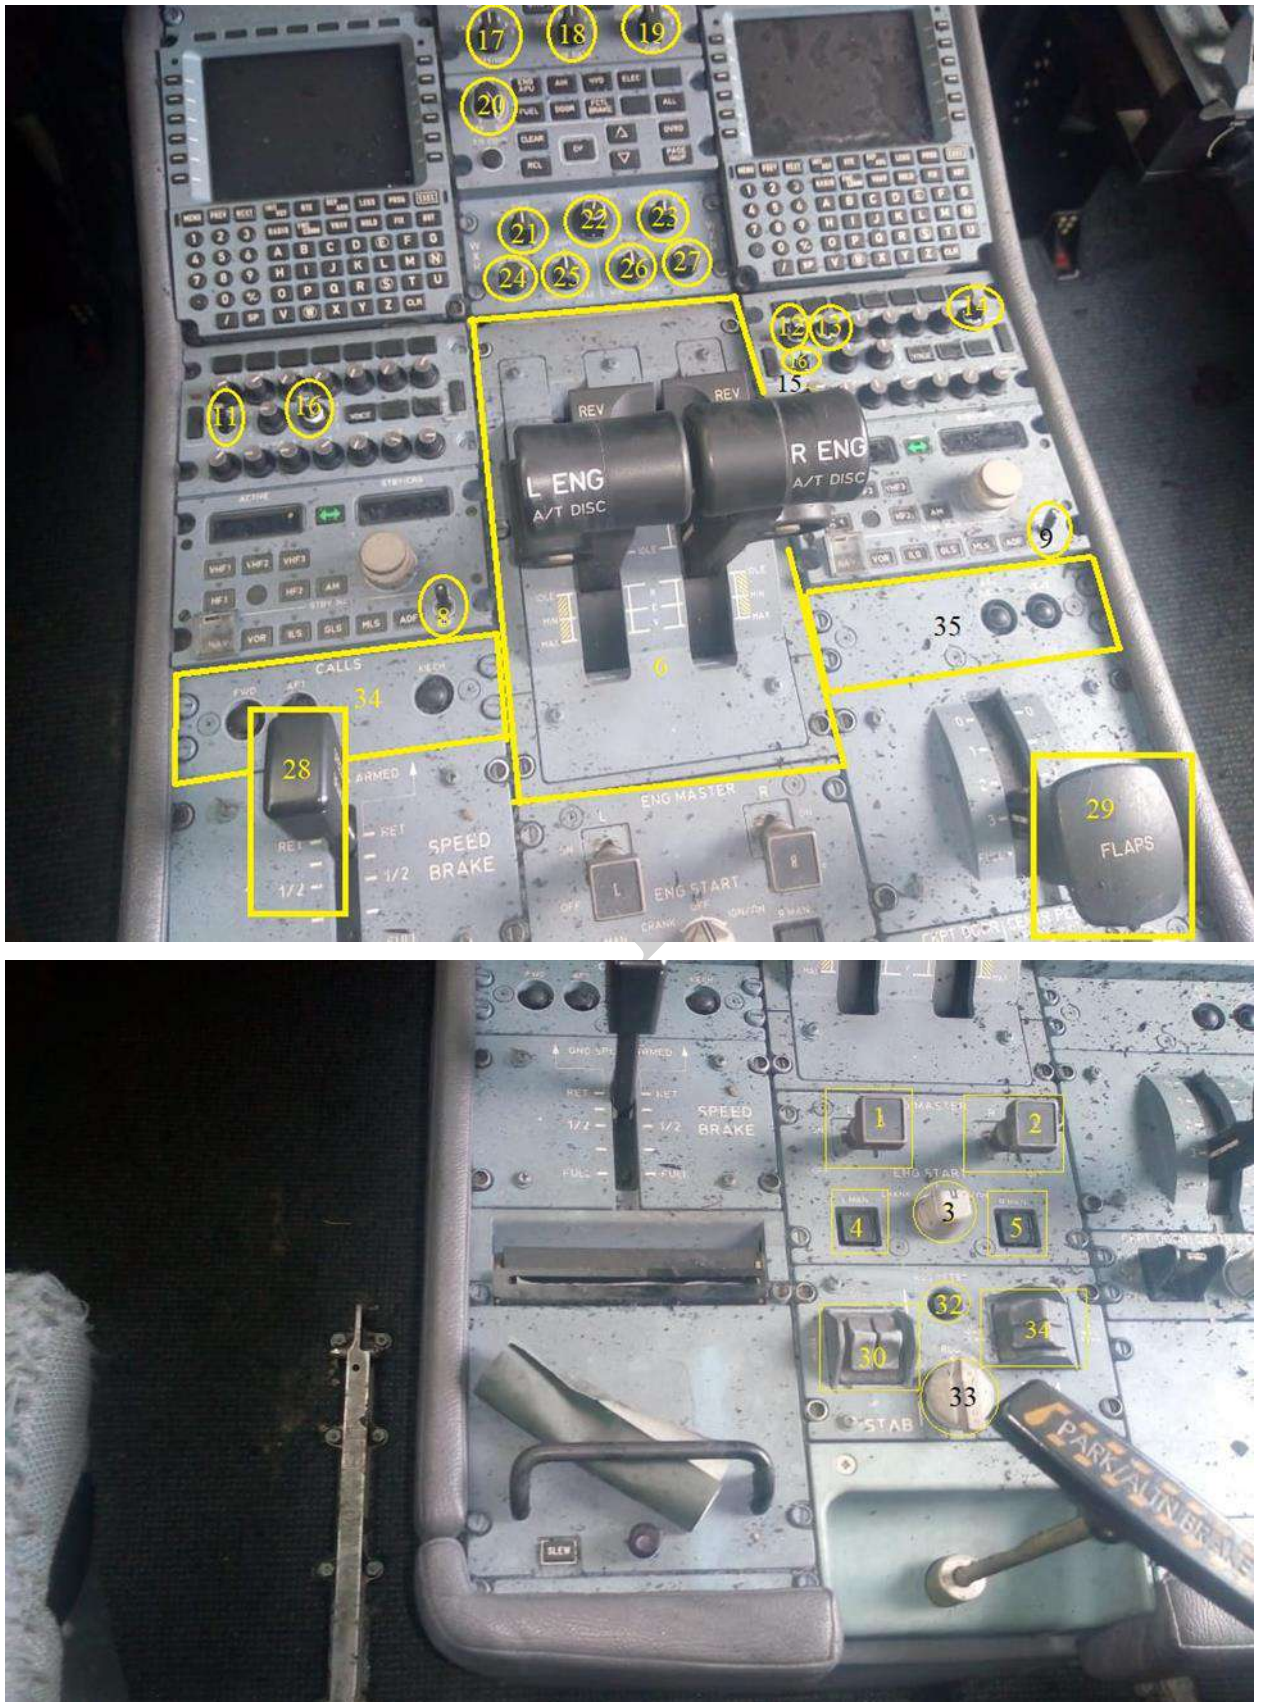
The following position of the engine start (Fig. 20), fire extinguishing systems (Fig. 21) and batteries (Fig. 22) control panels switches is observed.

Fig. 20. The post-incident position of the engine control panel switches

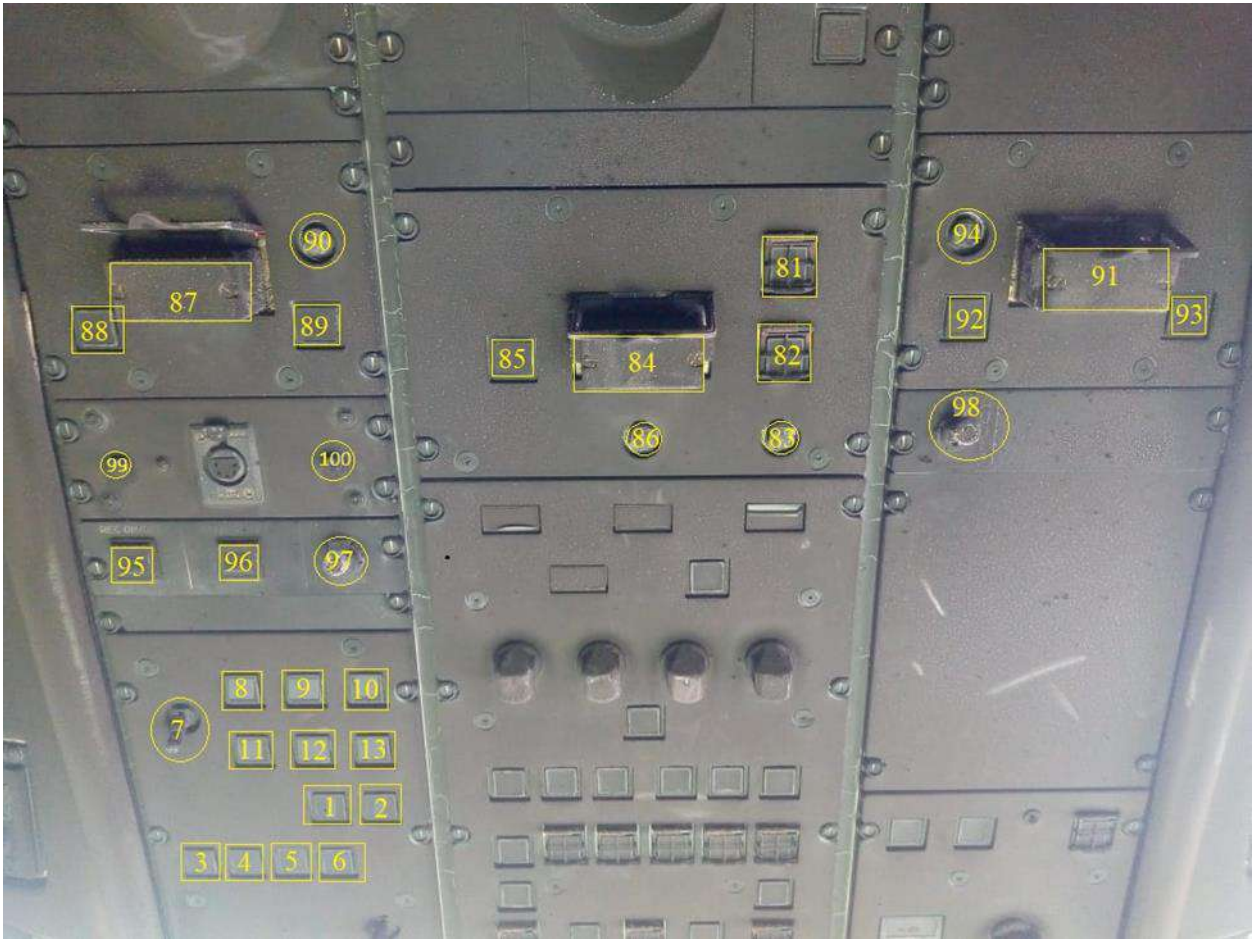
As a result of the performed post-accident inspection of the cockpit it is stated that the APU FIRE (the APU fire protection system (Fig. 21, position # 84)), L ENG FIRE (the left engine fire protection system (Fig. 21, position # 87) and the R ENG FIRE (the right engine fire protection system (Fig. 21, position # 91) switchlights were in an Activated position.

Fig. 21. The post-accident position of the ENG FIRE and APU FIRE switchlights

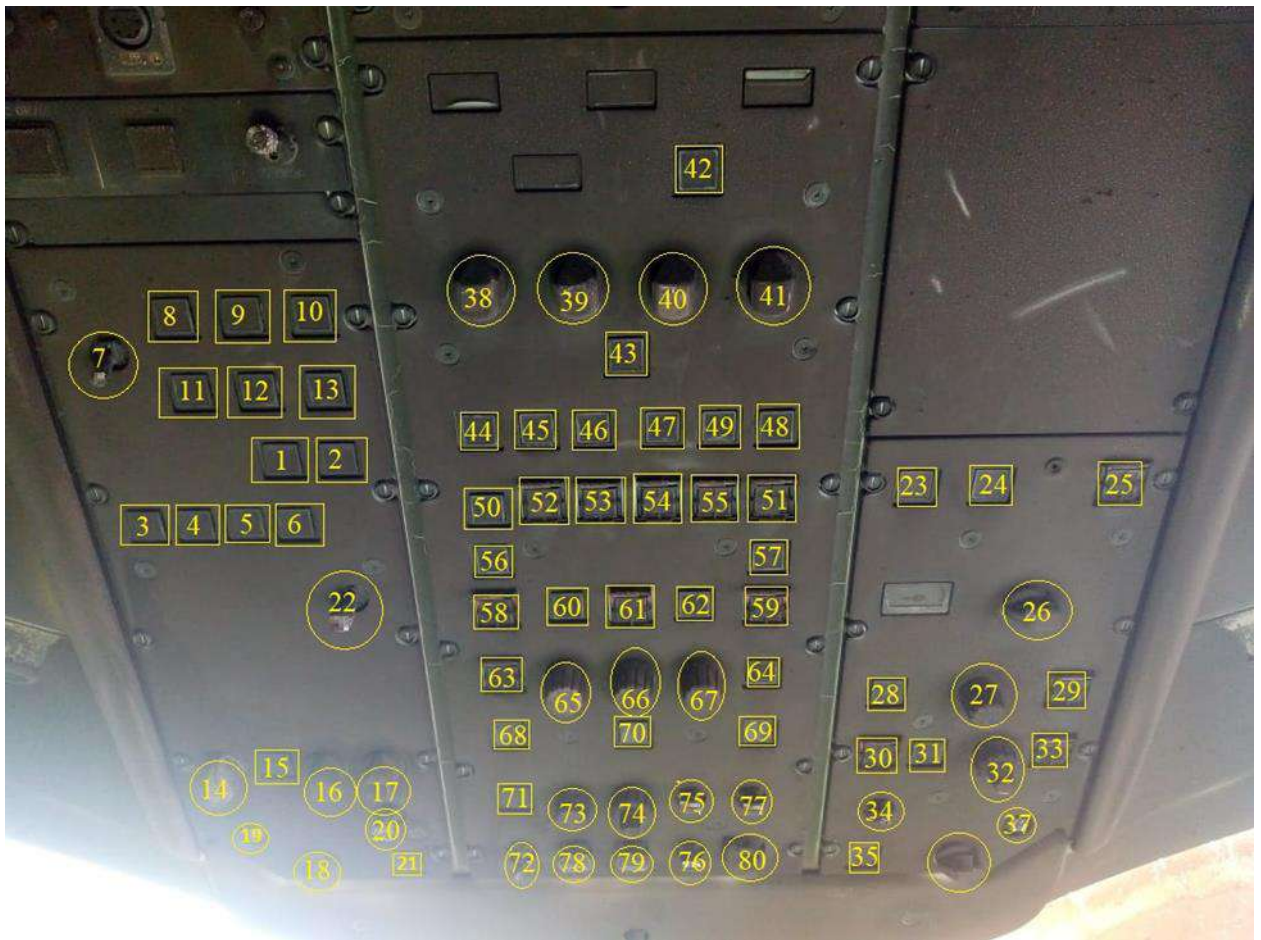
The switches of all the four batteries are observed in a released (turned off) position (Fig. 22, positions # 52, 53, 54 and 55).

Fig. 22. The post-accident position of the batteries switches

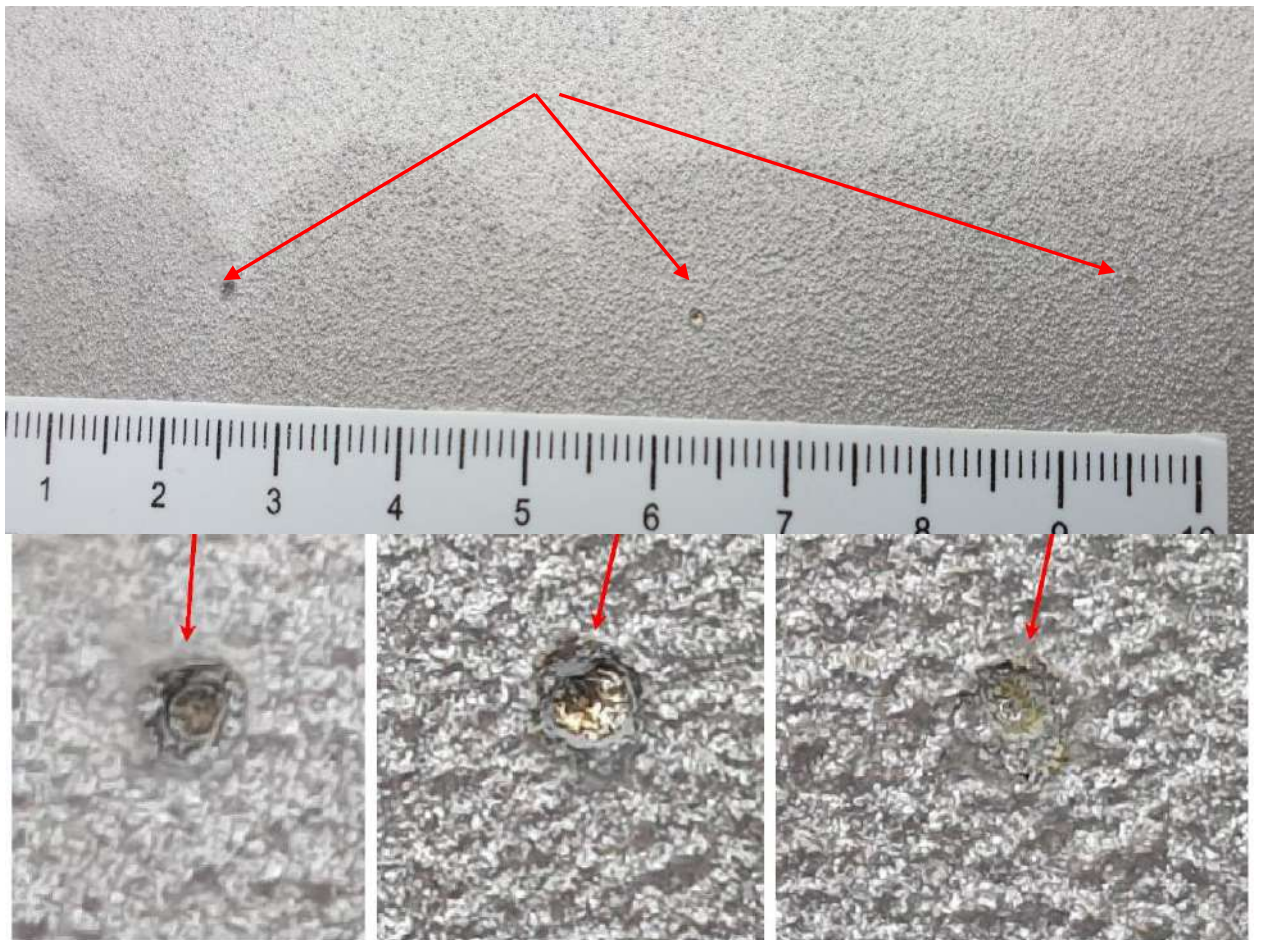
At the fuselage inspection and the evaluation of the condition of the antennas, sensors (ice detector, temperature and AOA sensors), the doors and the cockpit windshield floodlights elements the traces were observed, specific to the lightning exposure (Fig. 23, Fig. 24 and Fig. 25).

Fig. 23. The lightning exposure traces (pointed with red arrows), adjacent to the TCAS and VHF1 antennas at the upper fore fuselage segment in between FR12-15

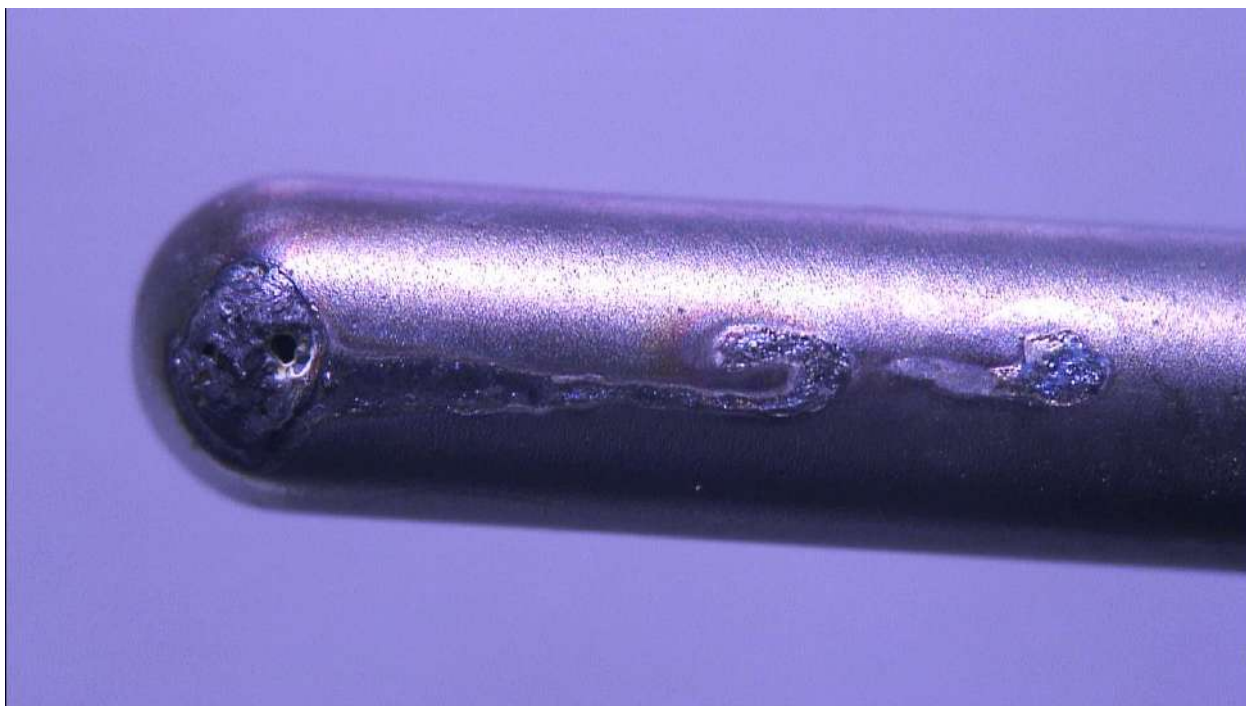
Fig. 25. The lightning exposure traces on the right ice detector

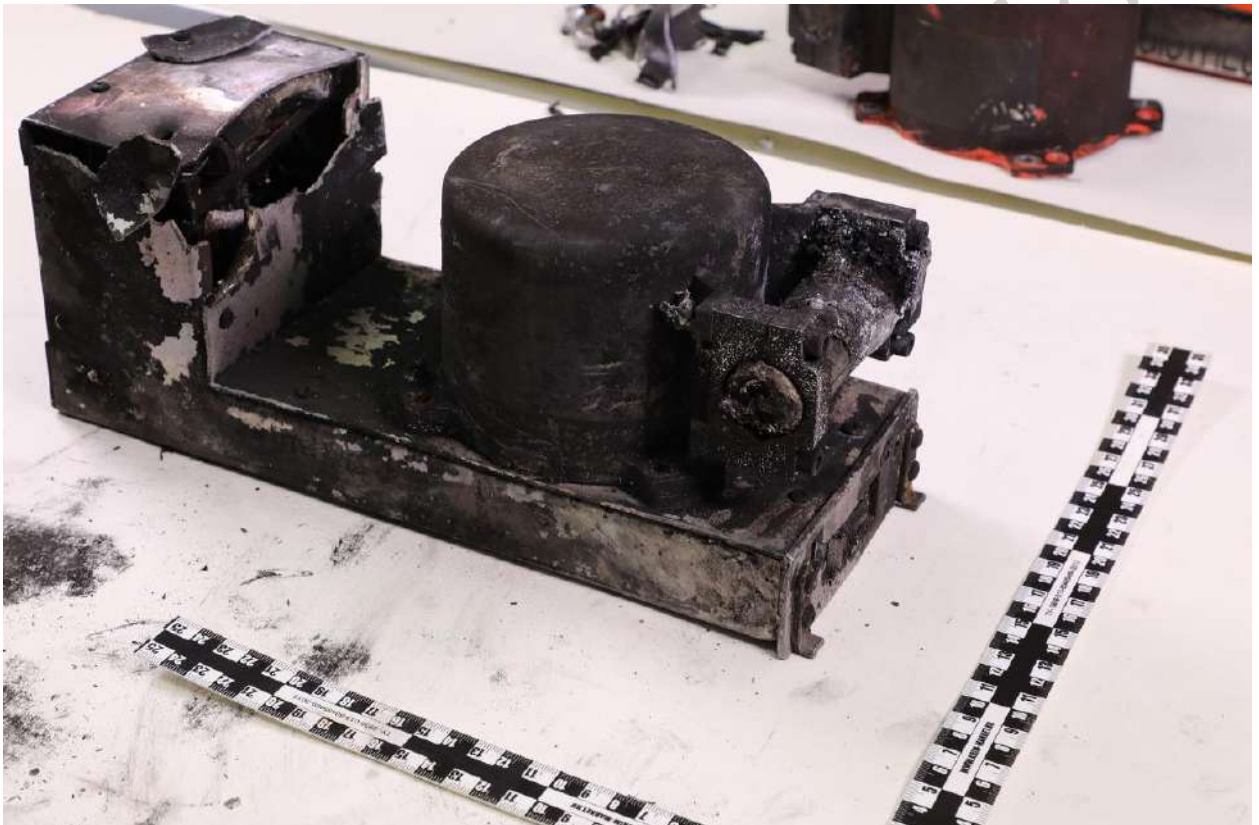
- the L3 FA2100 (PNR 2100-2043-12) FDR had sustained damage. Under the thermal effect the recorder unit case had been partially destroyed (Fig. 30);

Fig. 30. The L3 FA2100 FDR general view

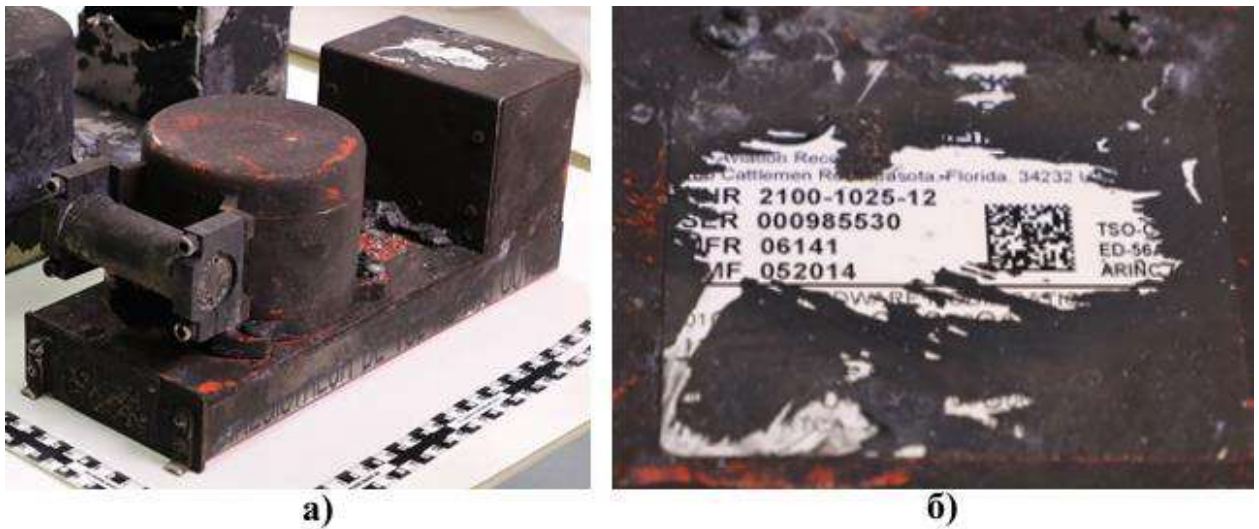
→ the L3 FA2100 (PNR 2100-1025-12) CVR had been subject to damage. The cases of the recorder and the crash-resistant memory module are covered with soot, had not been deformed (Fig. 31);

Fig. 31. The L3 FA2100 CVR: a) the general view; b) the unit data plate

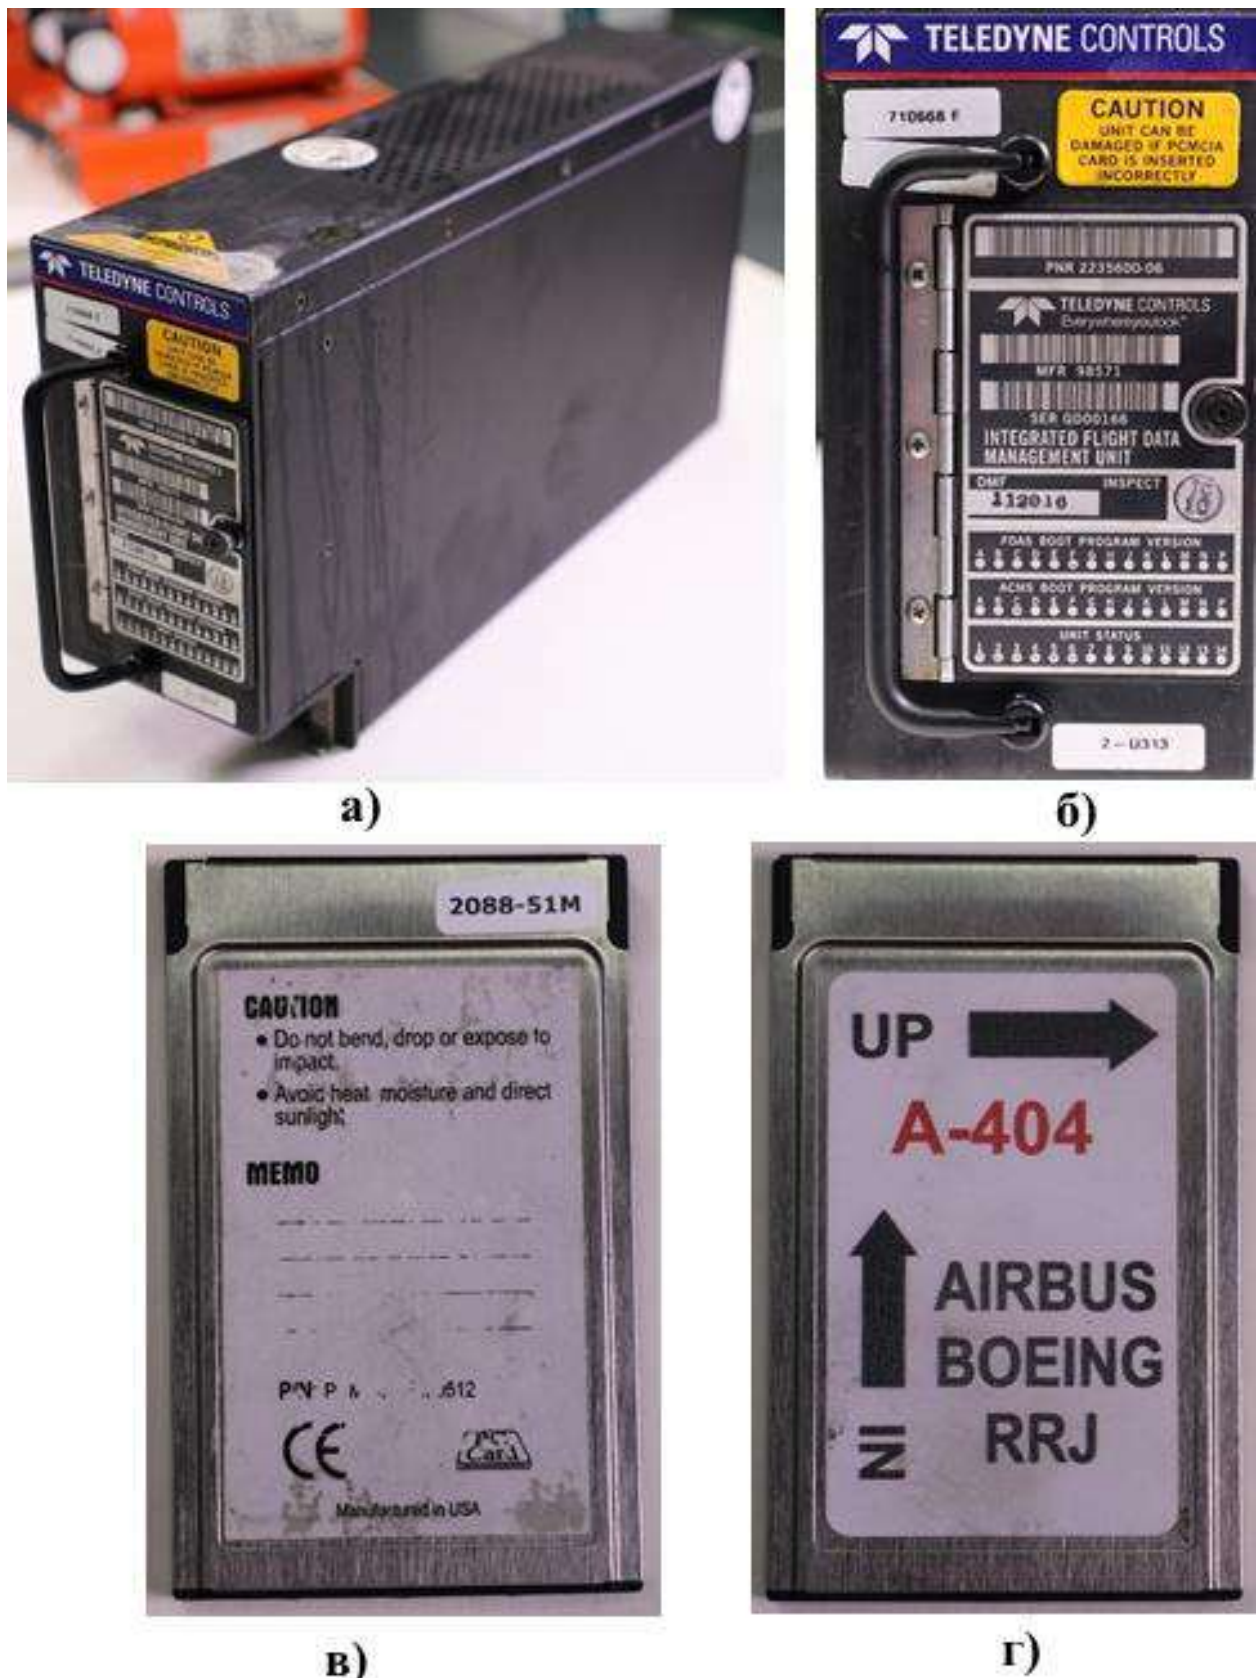
– the Integrated Flight Data Management Unit (PNR 2235600-06) with the PCMCIA flash card (s/n 2088-51M). The IFDMU case had no visible damage, having been out of the fire seat, had been stated in a satisfactory condition (Fig. 32).

Fig. 32. The IFDMU operational data collecting device with the PCMCIA flash card (# 2088-51M): a) the general view of the unit; б) the unit data plate; б) and r) the PCMCIA flash card (# 2088-51M) on both sides
