INTERSTATE AVIATION COMMITTEE

FINAL REPORT

ON THE RESULTS OF THE AIR ACCIDENT INVESTIGATION

Type of occurrence	Fatal accident
Type of aircraft	RRJ-95 (RRJ-95B model) airplane
Nationality and registration marks	RA-89098
Owner	VEB Leasing, JSC
Operator	Aeroflot, PJSC
Aviation authority	FATA
Place of occurrence	Sheremetyevo aerodrome, Moscow region, Russian Federation; reference position: 55°58'06.20" N, 37°24'07.20" E
Date and time	May 05, 2019, 18:30 local time (15:30 UTC), daytime

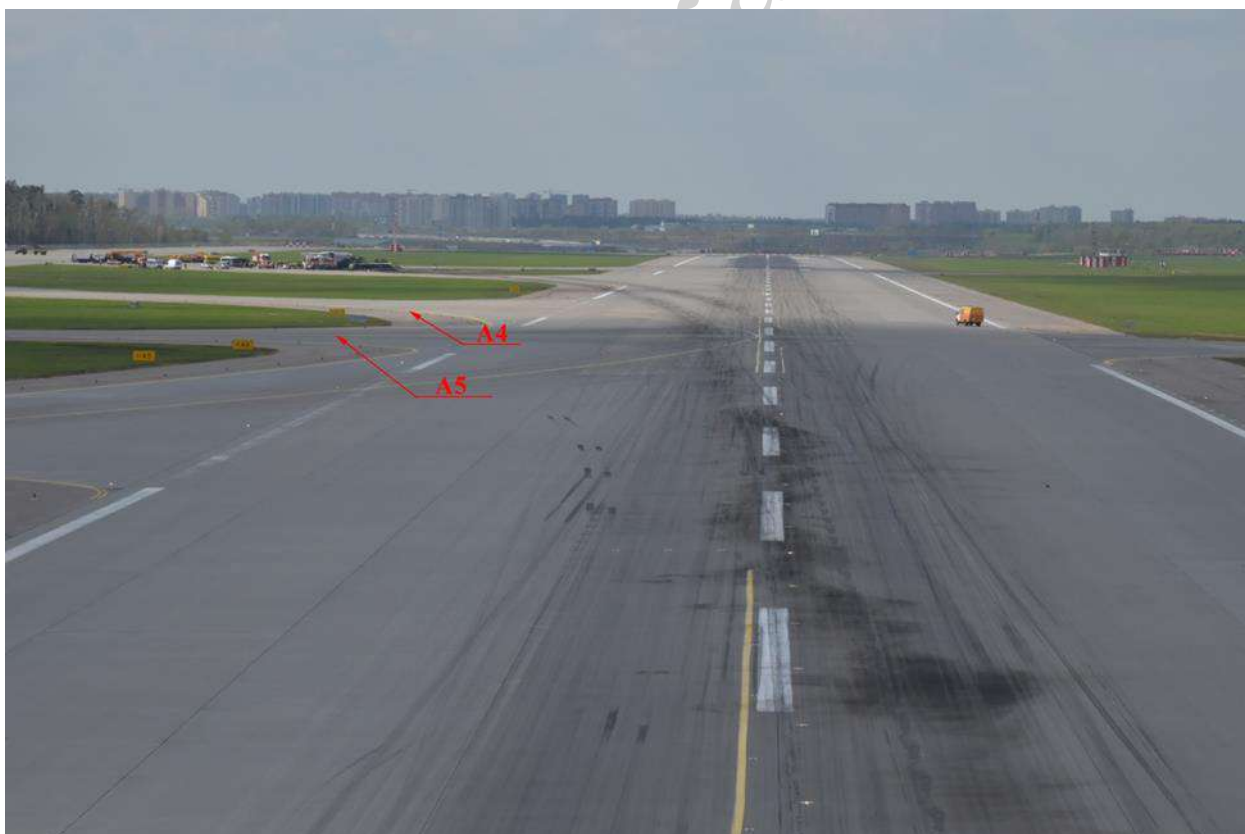
Initially after the lowering on the engines nacelles the aircraft movement had been a straight line by nature along the RWY axis to the right off it. At the area of the A5 TWY the shift of the aircraft to the left had started with its deviation off the RWY centerline (Fig. 38).

Fig. 38. The starting point of the traces shift to the left off the RWY centerline at the area of the A5 TWY

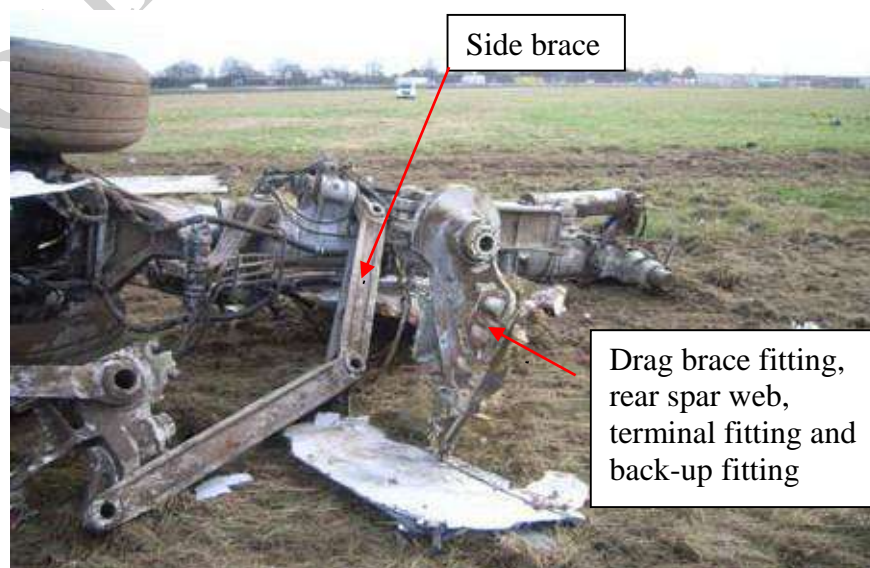
Fig. 132. The post-accident condition of the elements to the right MLG leg and the right wing panel rear spar

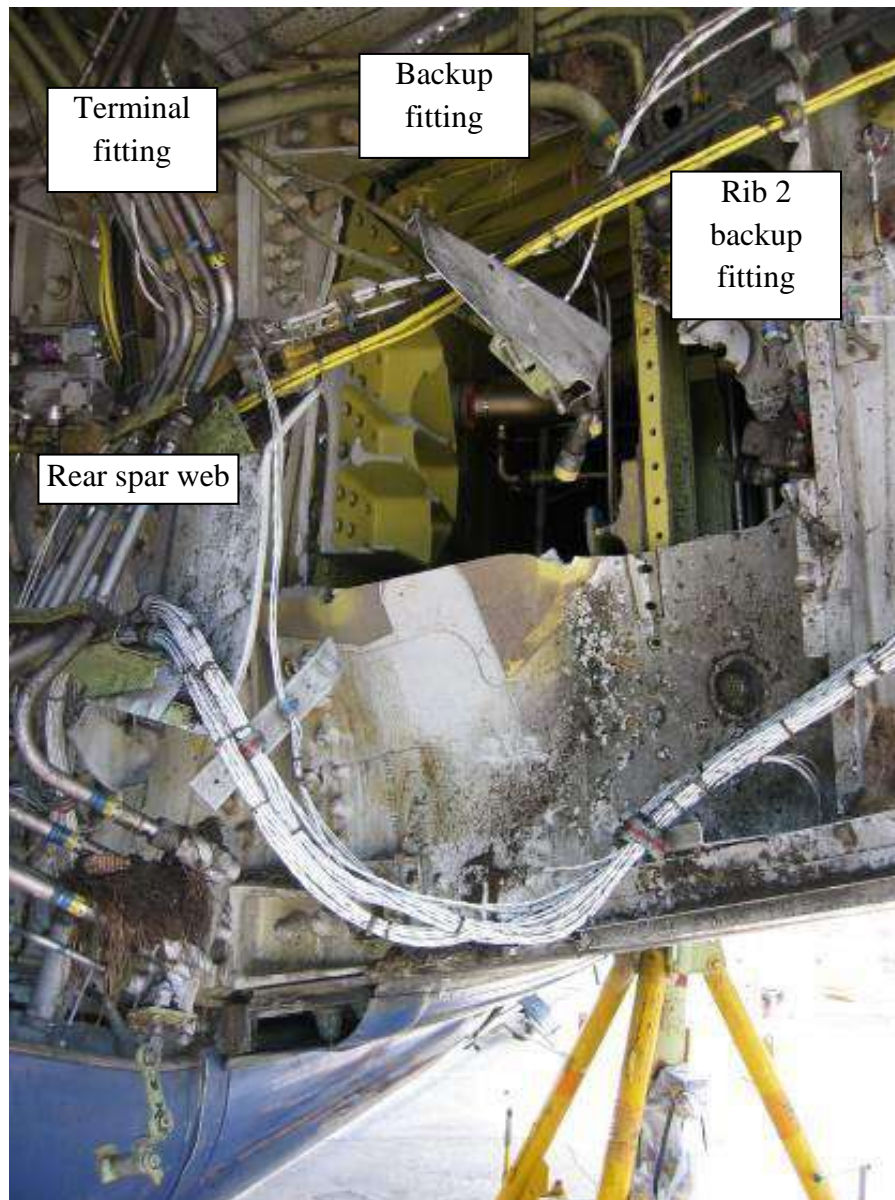
Fig. 133. The exterior of the destruction of the right wing panel rear spar and fuel tank at the MLG leg drag brace attachment
