INTERSTATE AVIATION COMMITTEE

FINAL REPORT

ON THE RESULTS OF THE AIR ACCIDENT INVESTIGATION

Type of occurrence	Fatal accident
Type of aircraft	RRJ-95 (RRJ-95B model) airplane
Nationality and registration marks	RA-89098
Owner	VEB Leasing, JSC
Operator	Aeroflot, PJSC
Aviation authority	FATA
Place of occurrence	Sheremetyevo aerodrome, Moscow region, Russian Federation; reference position: 55°58'06.20" N, 37°24'07.20" E
Date and time	May 05, 2019, 18:30 local time (15:30 UTC), daytime

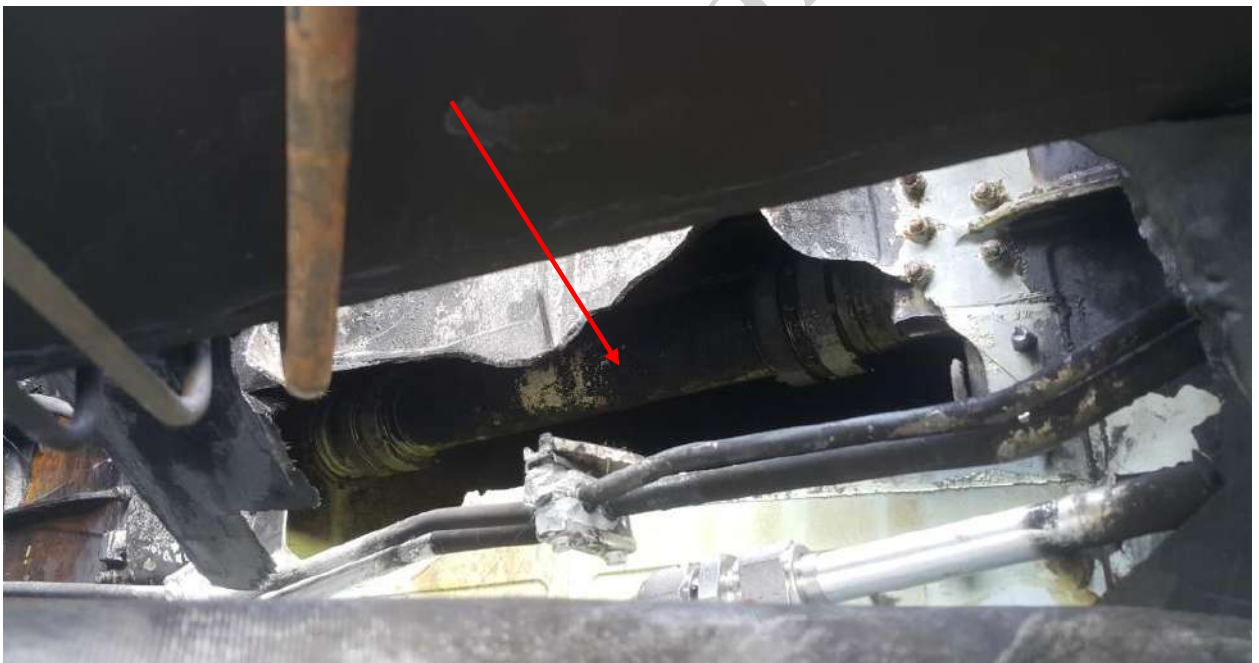
– the right MLG actuating cylinder mounting bracket is separated off the rear spar and rests hanging above the panel box (Fig. 7). After the separation of the right MLG actuating cylinder mounting bracket the hole was formed in the spar web, through which the fuel had been leaked out of the right wing fuel tank (Fig. 8);

Fig. 8. The hole in the right wing spar web at the cylinder mounting location (pointed with arrow)

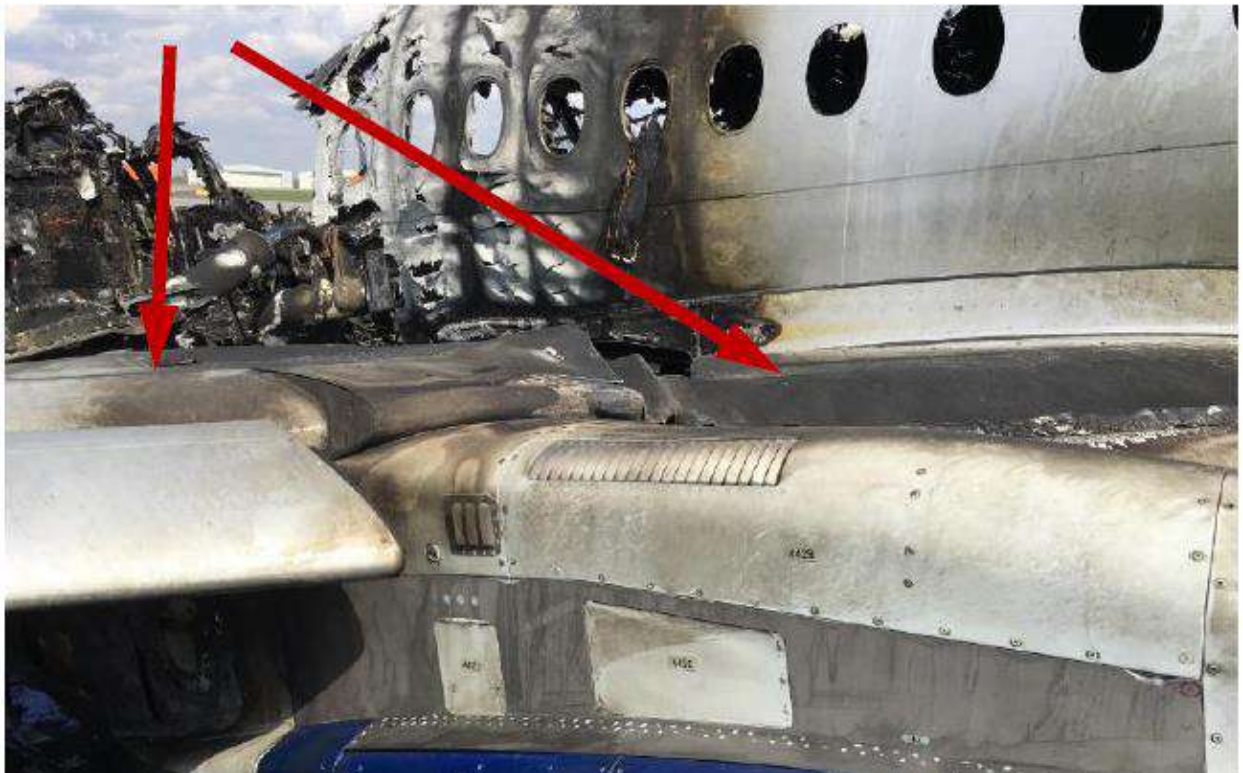
– the destruction of the upper panel, booms and web of the fore spar of the right wing box, adjacent to the pylon hinge fitting exposed to the vertical load by the pylon attachment fittings at the fore spar (Fig. 9 and Fig. 10). These elements are the fuel tanks walls;

Fig. 9. The destruction of the right wing adjacent to ribs 3-4 in between the fuselage and engine pylon

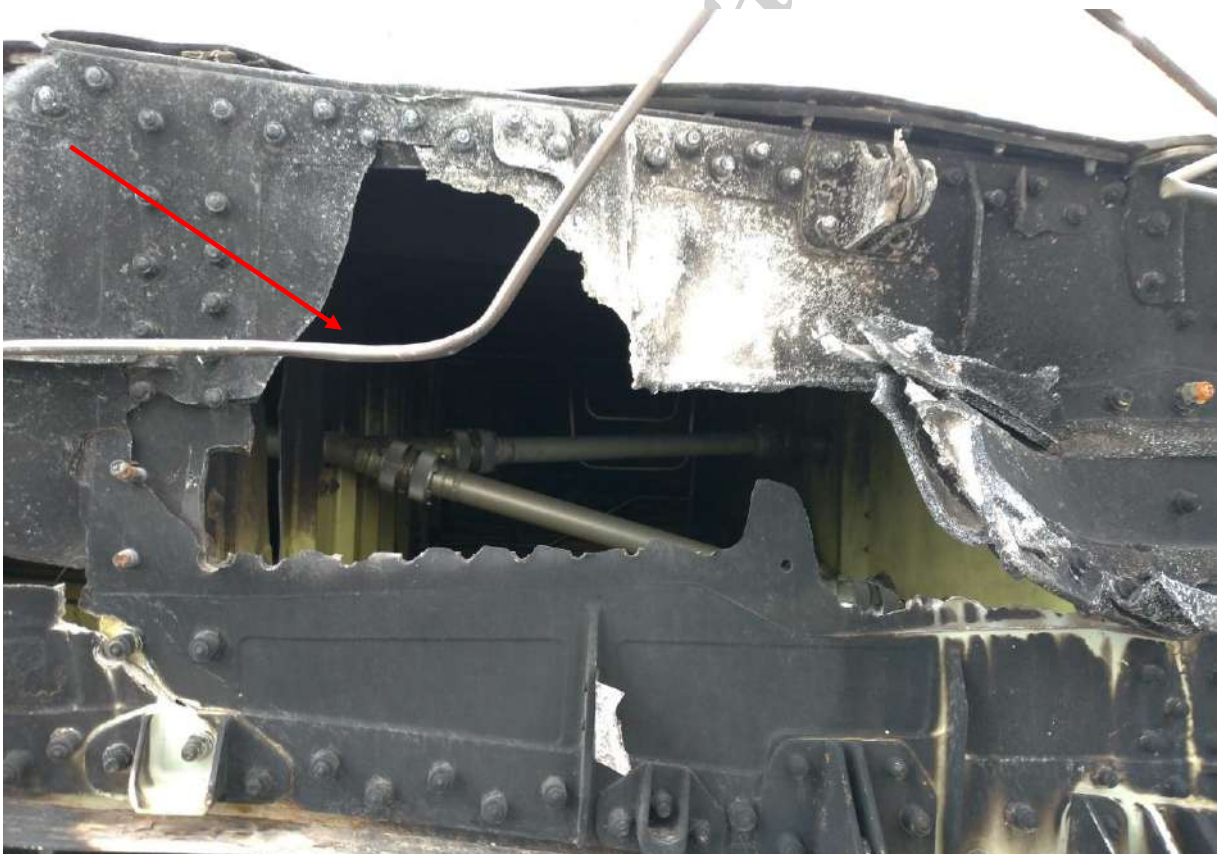
- the left wing nose lower skin is burnt and deformed;
- the left MLG actuating cylinder mounting bracket is separated off the rear spar and rests hanging above the panel box. The nature of the separation and damage (Fig. 11 and Fig. 12) is similar to the right MLG. The rear spar upper panel, caps and web of the left wing box adjacent to ribs 5-6 sustained damage as well (Fig. 13 and Fig. 14), these elements are the fuel tanks walls;

Fig. 12. The hole in the left wing spar web at the actuating cylinder mounting location (pointed with arrow)

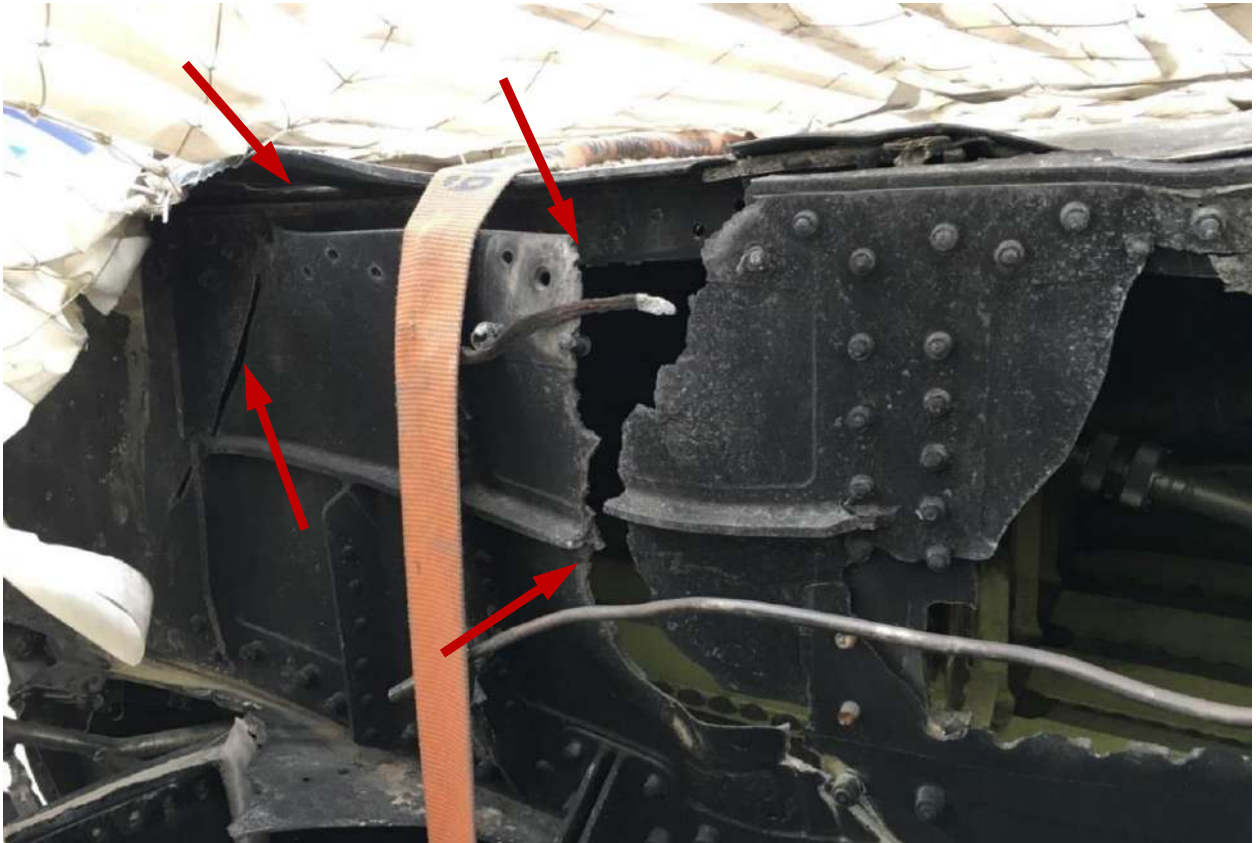
Fig. 13. The destruction of the rear spar of the left wing adjacent to ribs 5-6

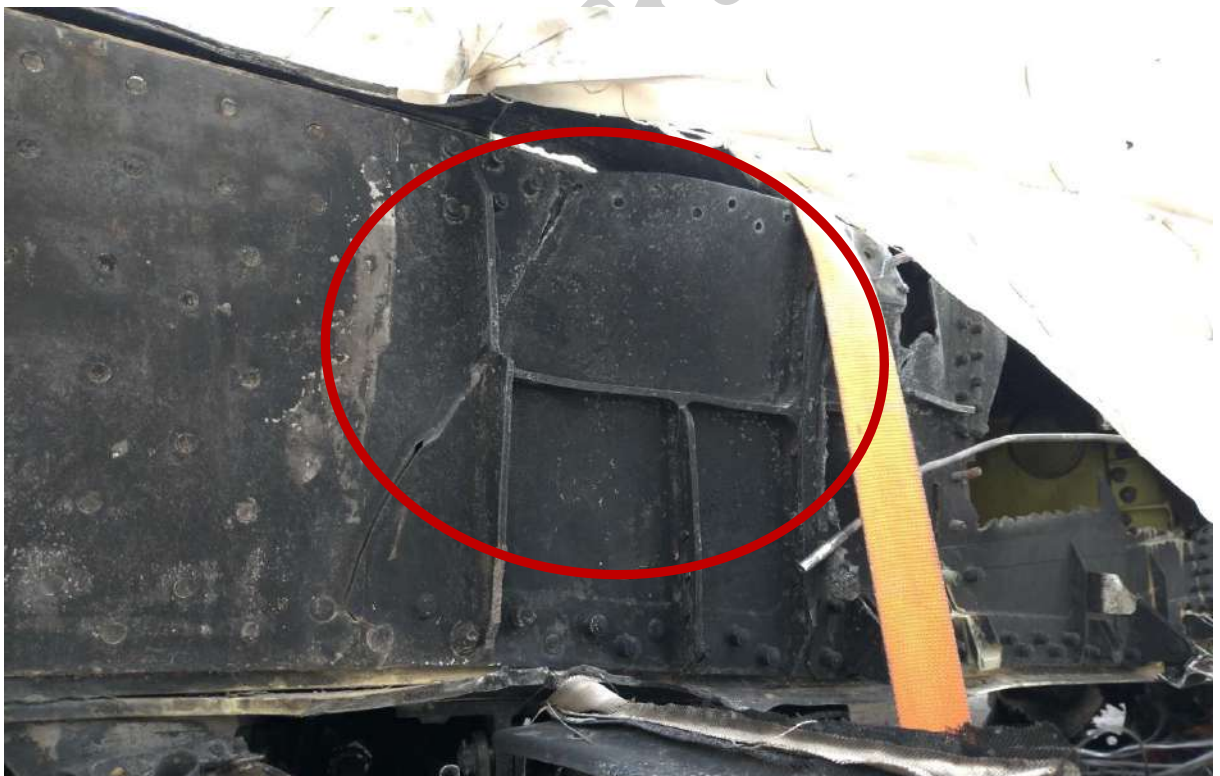
Fig. 14. The destruction of the rear spar of the left wing adjacent to ribs 5-6 and the landing gear beam hinge bracket

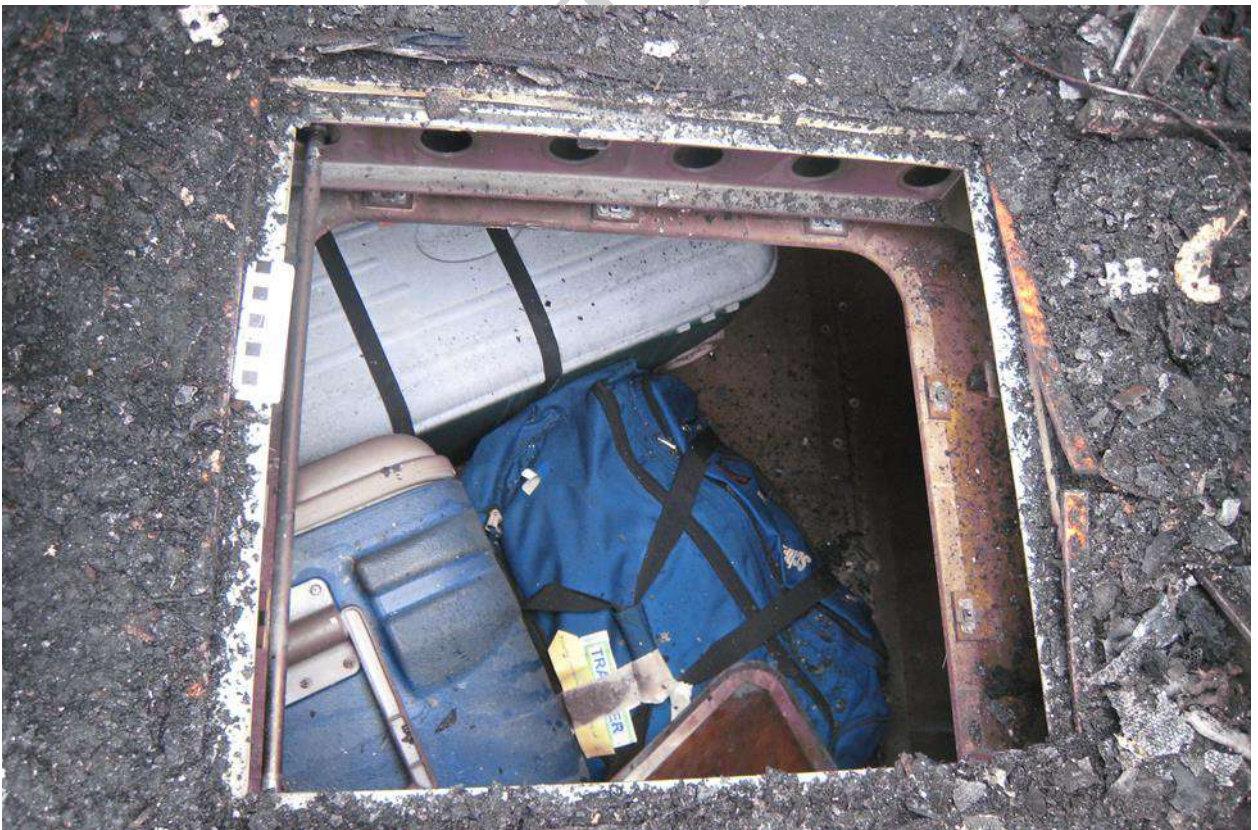
The rear baggage compartment is partially damaged, but there are no burning or open fire signs observed in the compartment. Traces of soot were revealed on the front wall of the compartment and on the passengers' baggage (Fig. 16). The rear baggage compartment after the accident was accessible through the upper access door that did not sustain any mechanical damage (Fig. 17).

Fig. 17. The rear baggage compartment exterior subsequent to the accident

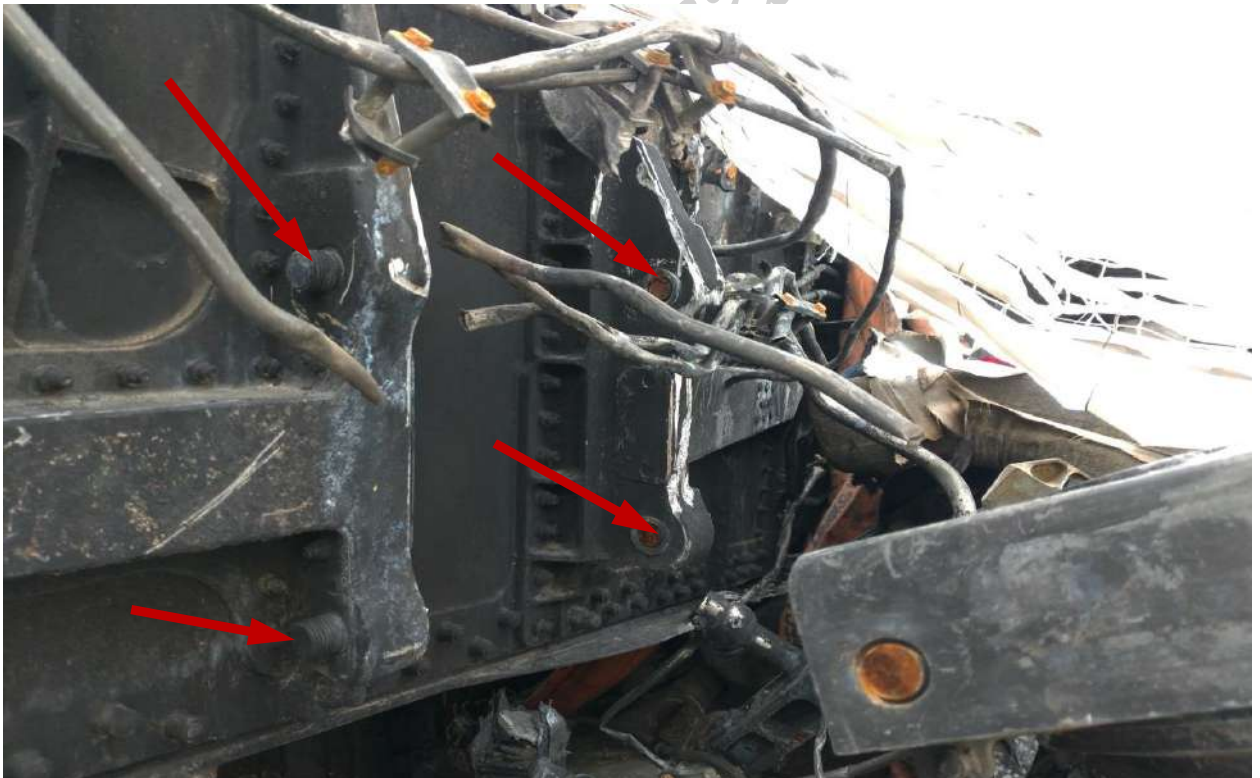
- the NLG is in an extended position with no visible damage and no traces of the hydraulic fluid leakage observed;
- the left and right MLG legs are in an extended position and are substantially damaged;
- the MLG harnesses (the electric ones, the hydraulic hoses) are stated to be disintegrated;
- the mechanical damage was stated to the MLG braces and the elements that ensure their fold;
- the right MLG side brace fuse spring is destroyed, its fragment was discovered on the RWY along with the other destructed MLG components apart;
- the fuse pins («weak links») of the FWD attachment A of both MLG legs are destructed (Fig. 18 and Fig. 19), with the fuse pins bodies remaining into the bearings housings, and the fuse pins heads remaining into the bearings mounting brackets.

Fig. 19. The right MLG attachment A fitting on the rear spar adjacent to rib 3, the attachment A fuse pins («weak links») are sheared

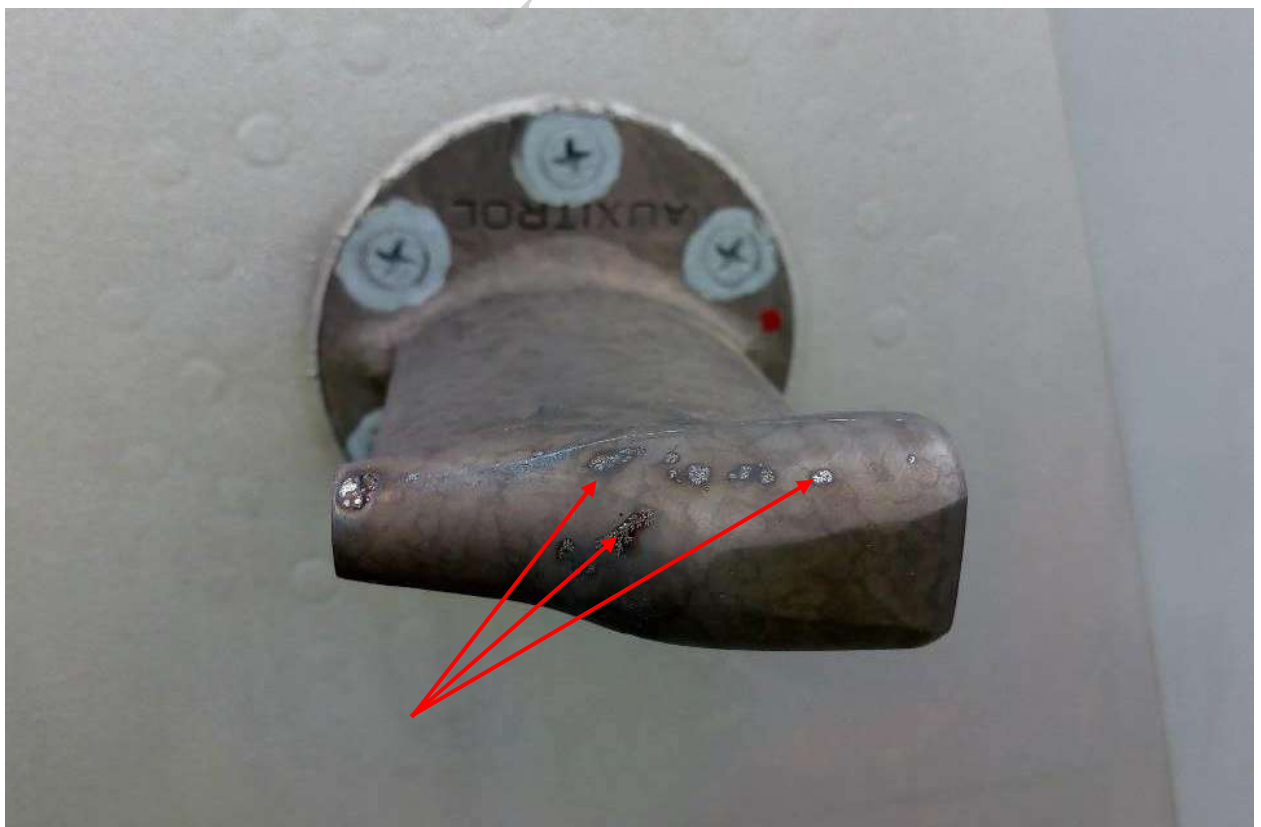
At the fuselage inspection and the evaluation of the condition of the antennas, sensors (ice detector, temperature and AOA sensors), the doors and the cockpit windshield floodlights elements the traces were observed, specific to the lightning exposure (Fig. 23, Fig. 24 and Fig. 25).

Fig. 24. The lightning exposure traces on the right temperature sensor

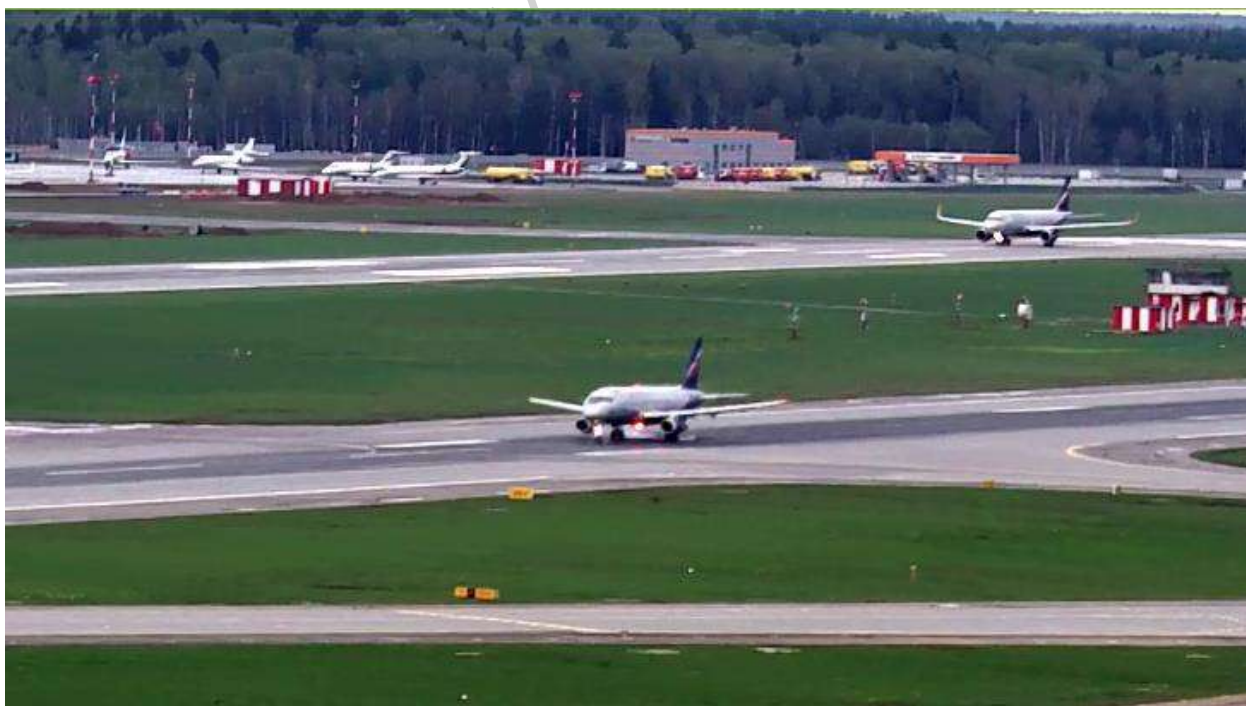
As per the footage by the Sheremetyevo airport CCTV cameras the first aircraft touchdown of the RWY 24L occurred at the area of the A8 TWY, at the distance of ≈ 890 m off its entry threshold, having been on the three landing gear legs at once (Fig. 33), followed by the aircraft separation off the RWY (the bounce) (Fig. 34).

Fig. 33. The spot of the aircraft first touchdown on the RWY

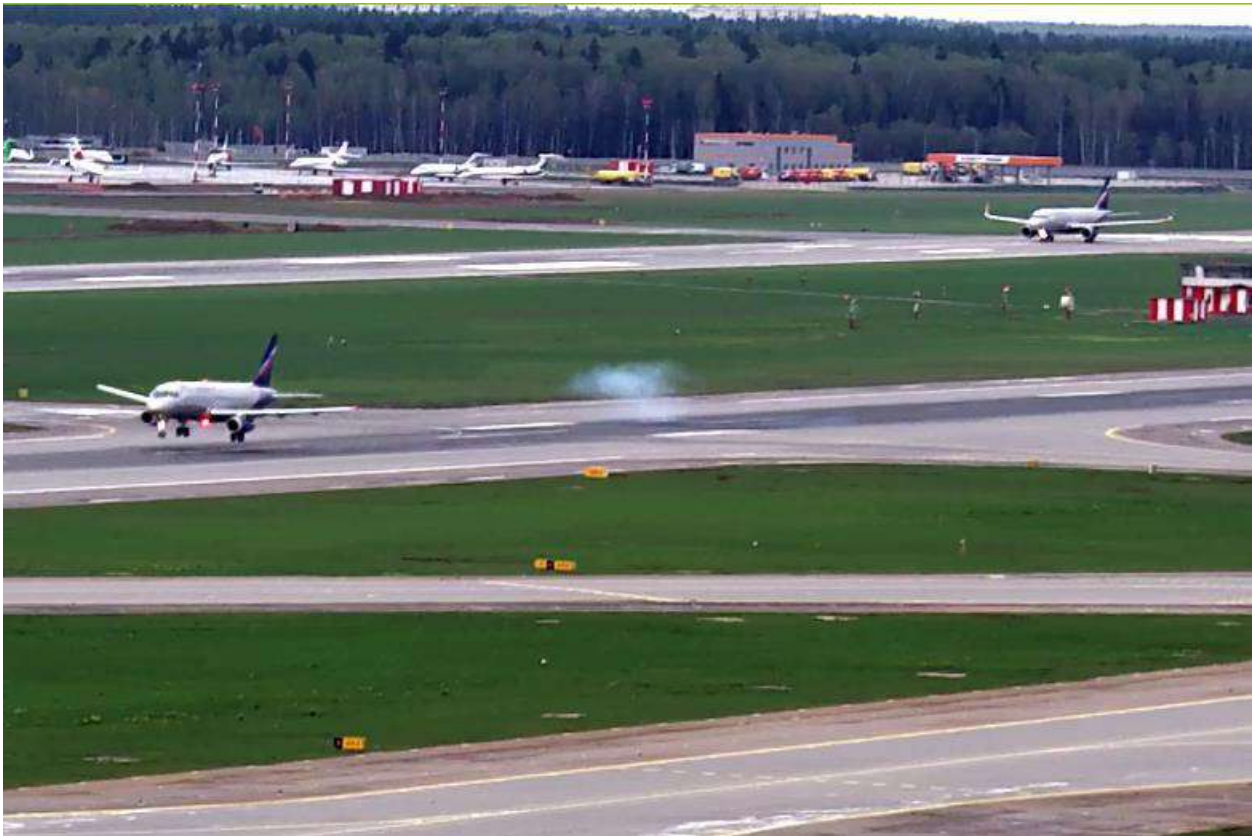
Fig. 34. The aircraft separation (the bounce) off the RWY

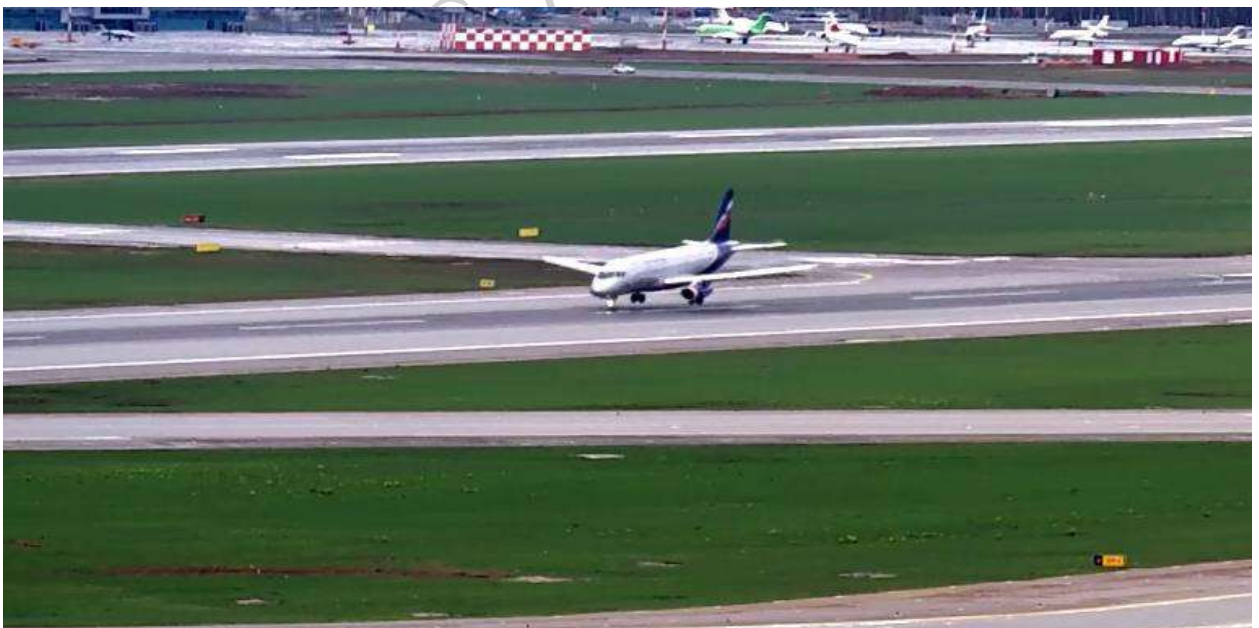
The second touchdown occurred at the distance of ≈ 1070 m off the RWY 24L entry threshold with the NLG coming first (Fig. 35) with the subsequent touchdown by the MLG legs, which had been followed by another bouncing of the aircraft (Fig. 36). There had been no fuel traces and the aircraft fragments revealed adjacent to the second touchdown spot.

Fig. 35. The spot of the aircraft second touchdown on the RWY

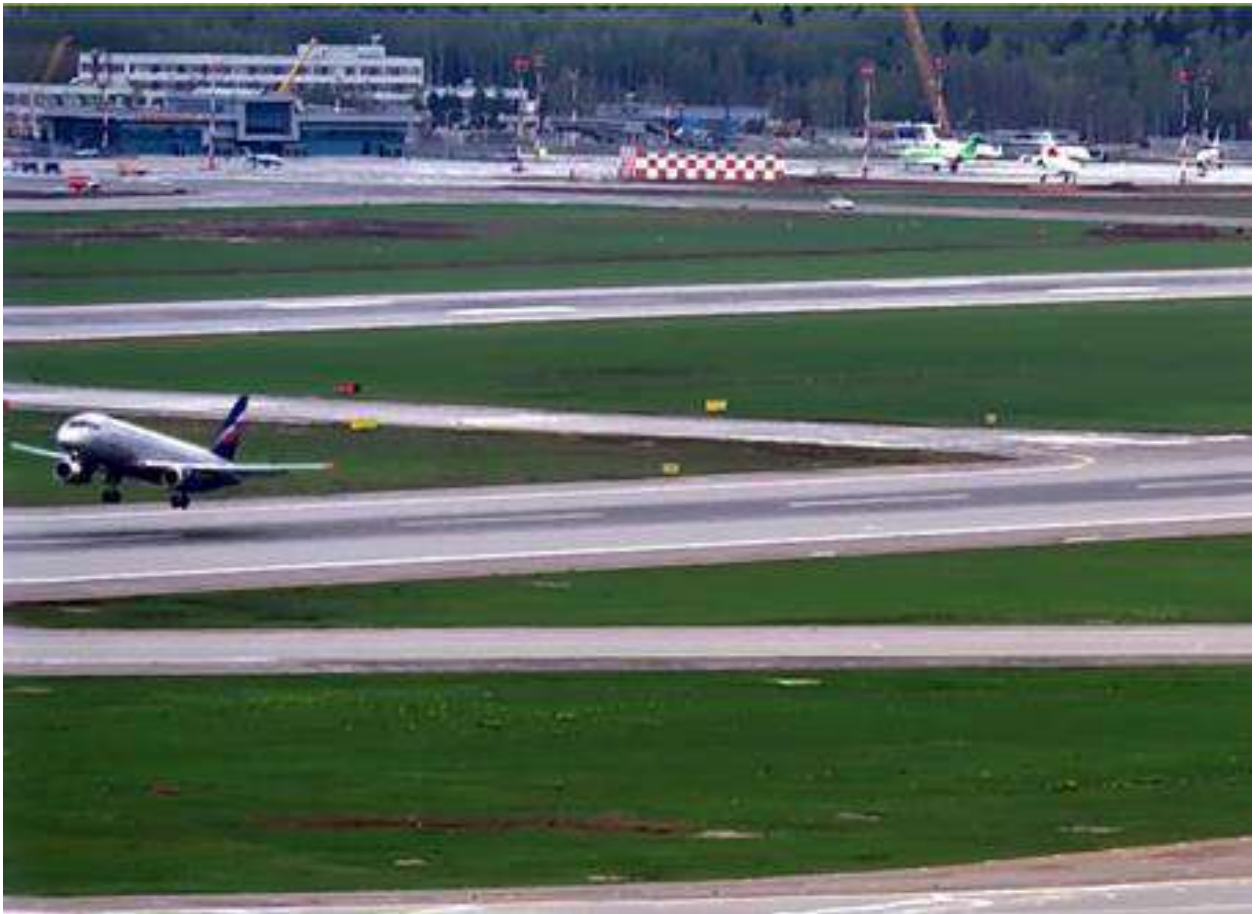
Fig. 36. The aircraft bouncing off the RWY after the second touchdown

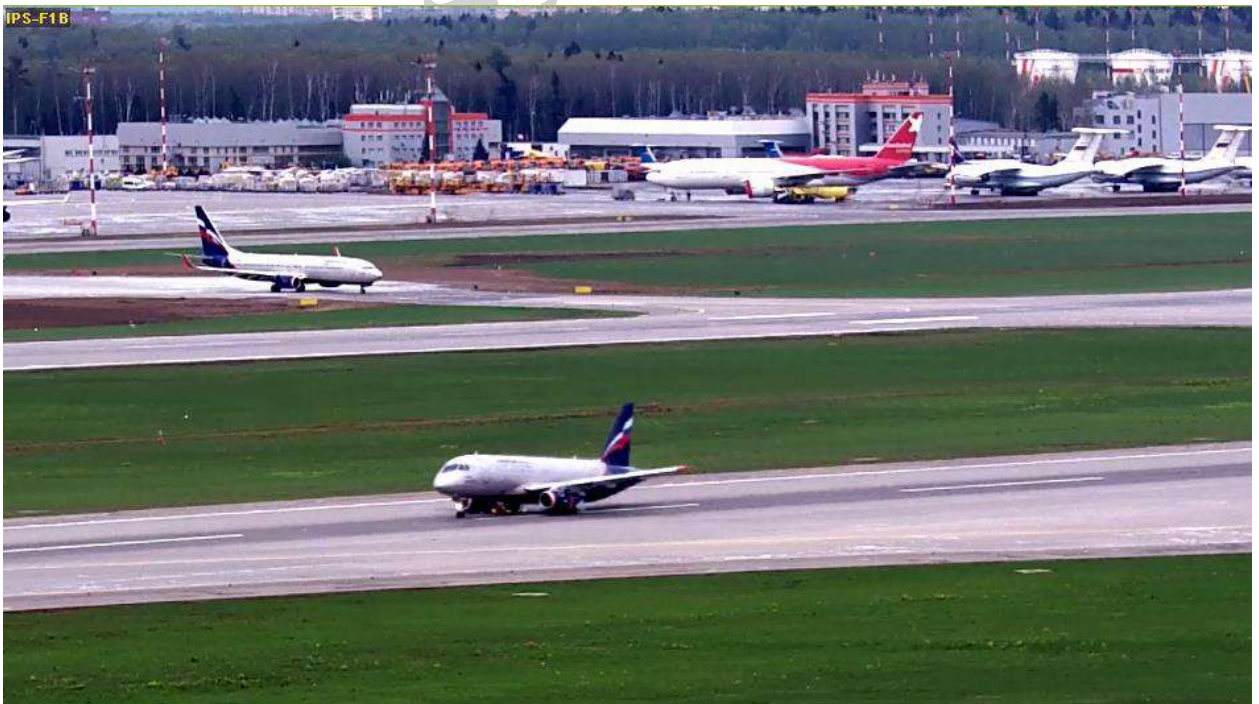
The third touchdown occurred at the area of the A7 TWY, at the distance of about 1360 m off the RWY 24L entry threshold, with the right MLG coming first, then the left one with their breaking under (collapse) (Fig. 37).

Fig. 37. The spot of the aircraft third touchdown on the RWY

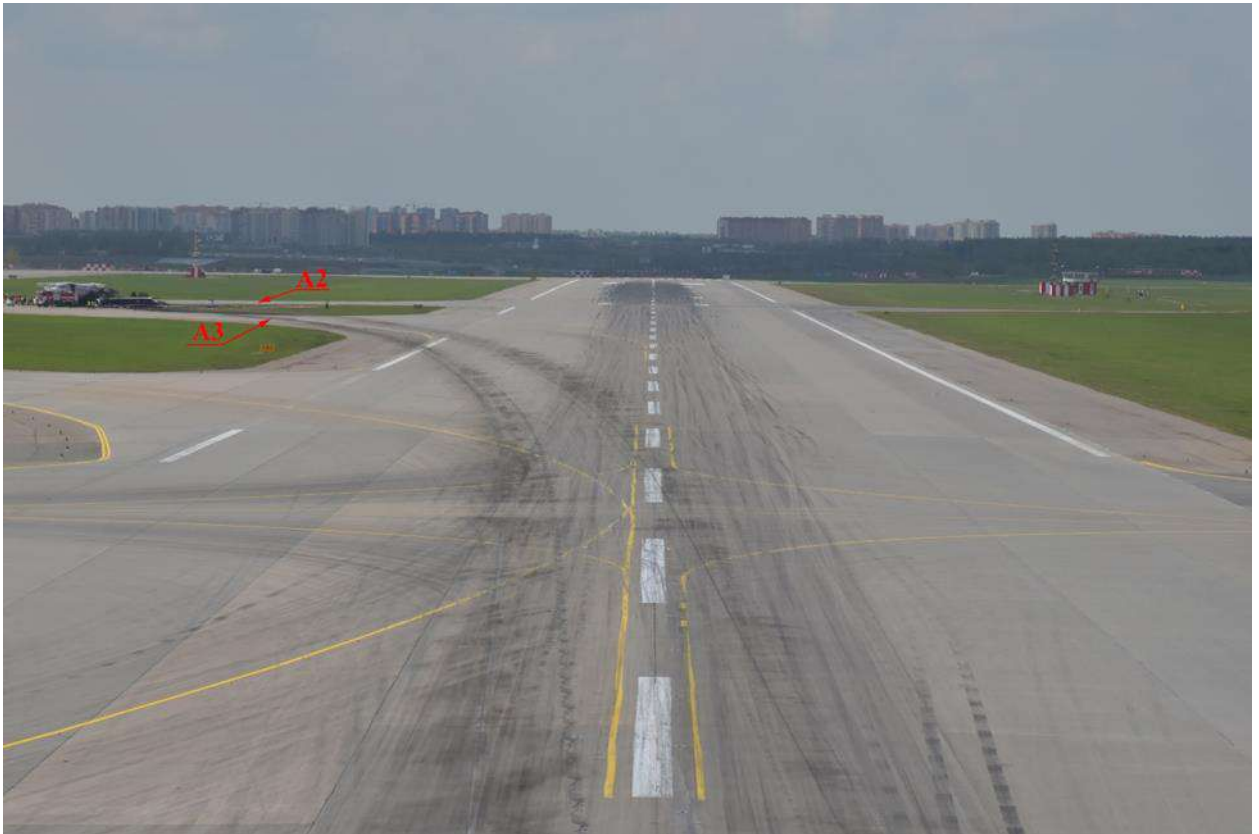
The aircraft veering off the RWY had occurred at the area of the A3 TWY (at 2460 m off the RWY 24L entry threshold) (Fig. 39).

Fig. 39. The traces of the aircraft movement, the spot of the veering off the RWY at the area of the A3 TWY

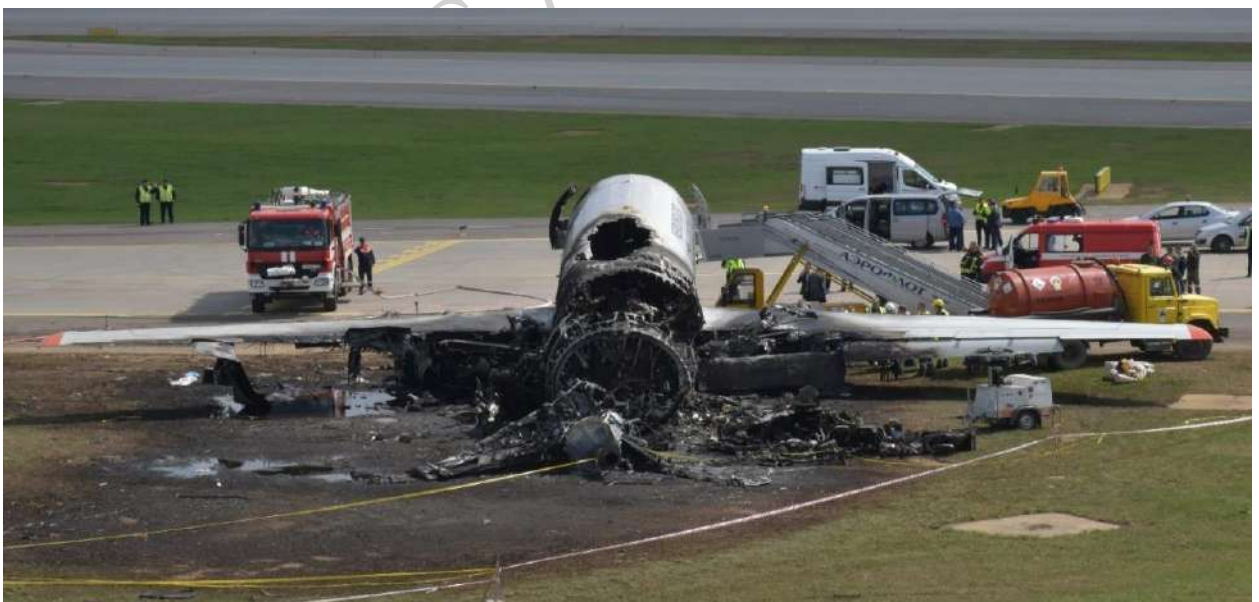
The aircraft stop had occurred between TWY 2 and TWY 3 at the point with the reference position: $55^{\circ}58'06.20''$ N, $37^{\circ}24'07.20''$ E, $\Delta h = 185$ m, with the true heading $\approx 128^{\circ}$ (Fig. 40). The distance off the RWY 24L entry threshold amounted to ≈ 2720 m, the lateral deviation had been equal to about 110 m to the left off the RWY centerline.

Fig. 40. The RRJ-95B RA-89098 airplane at the accident site

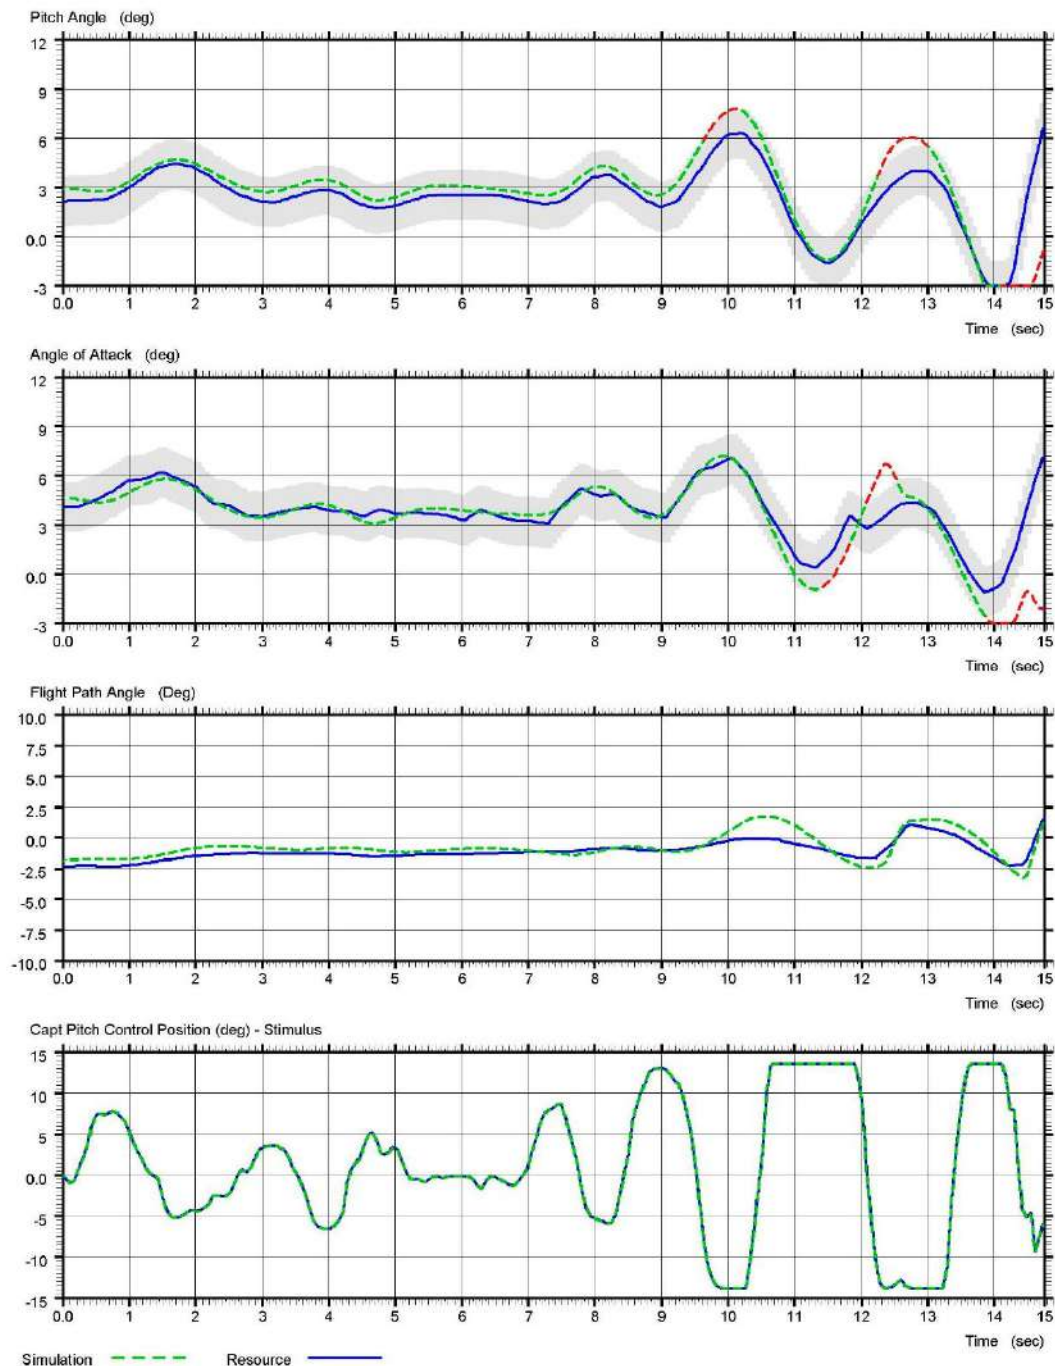
Fig. 55. The simulation outcome (the blue color stands for the recorded parameters, the green one does for the parameters, obtained at the FFS simulation, the red color stands for the region of the exceedance beyond the tube of the QTG (in grey) acceptable limits)

Fig. 55 presents the outcome of the simulation of the pitch attitudes and AOA change immediately prior the aircraft landing. The plot is given in a relative time, the point of the first touchdown corresponds to the value of 12.5 sec.⁶² The plot shows the satisfactory convergence of the recorded parameters and these, obtained at the simulation. The insignificant exceedance of the estimated parameters beyond «the tube» of the QTG acceptable values is explained by the difficulties, mentioned here above, in simulating the ground effect and wind disturbances. At that it is worth noting apart that the material airplane has more damping in pitch channel against the

FFS. The accomplished changes of the pitch and AOA at the unchanged deflection of the elevator are less at the real aircraft. This finding aligns well with the evaluation by the EASA test pilots (see Section 1.18.19 of the Report).

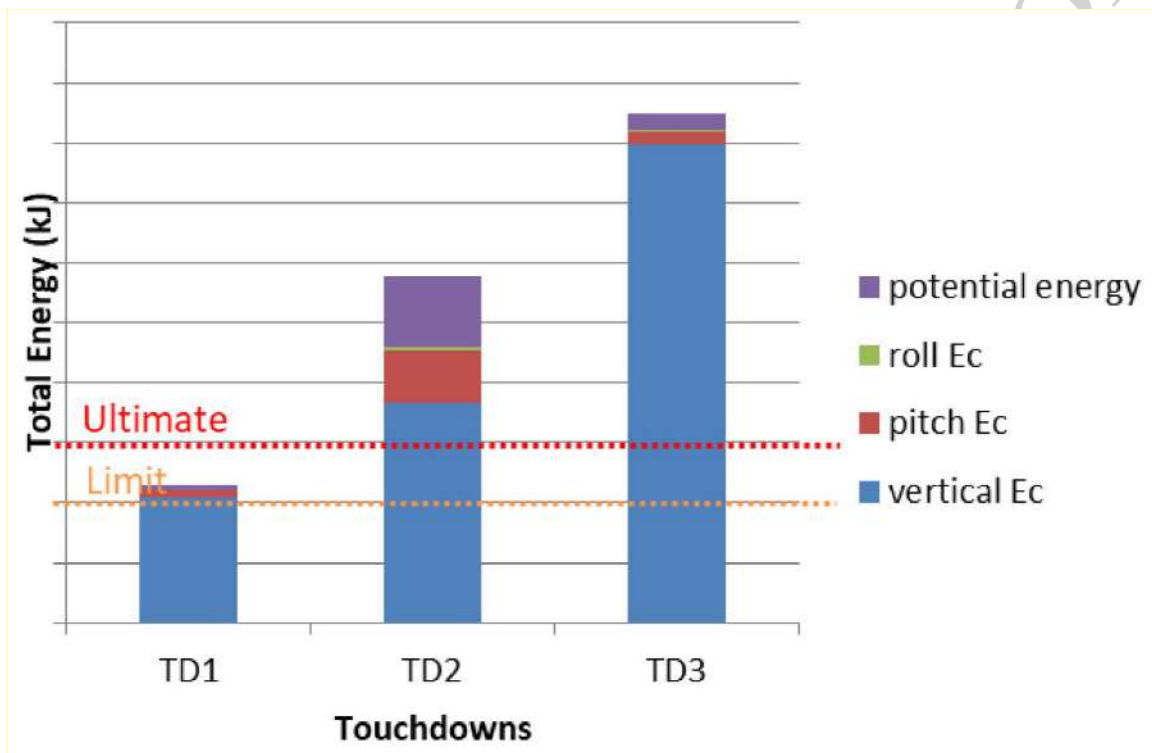
Fig. 56. The total energy contributions by the constituents in the conditions of the flight that ended up with the accident

The ultimate values of the total energy for each of the touchdowns (232 kJ, 583 kJ and 850 kJ respectively) are shown on Fig. 56. The contributions of the total energy constituents for the actual conditions of the landing are marked with the color coding, the red color – out of the angular pitch rate, the green color – out of the roll angular rate, the purple color – out of the potential energy. The Figure shows as well the values (horizontal levels) of the total energy for the occurrences of landing with the maximum allowable landing weight with the vertical velocities of 3.05 m/s (the occurrence of the absorption of the operational energy, consistent with the

At the second touchdown, the vertical acceleration had been 5.85G at least, the design vertical speed of descent had been 4.2 m/s. The calculated value of the absorbed energy for the actual landing weight was ~ 190 % against the ultimate loads values (for the vertical speed at touchdown of 3.74 m/s). Such a significant amount of absorbed energy, in addition to the increased vertical speed of descent, is linked with the intensive rotation of the aircraft in pitch at the point of touchdown (Fig. 56). The ultimate loads, having been applied on the MLG, had been equal to 1111 kN (113.3 tons). As by the results of the analysis, presented in the Report «Analysis of the implications of the MLG legs destruction or the performance of landing with one or more landing

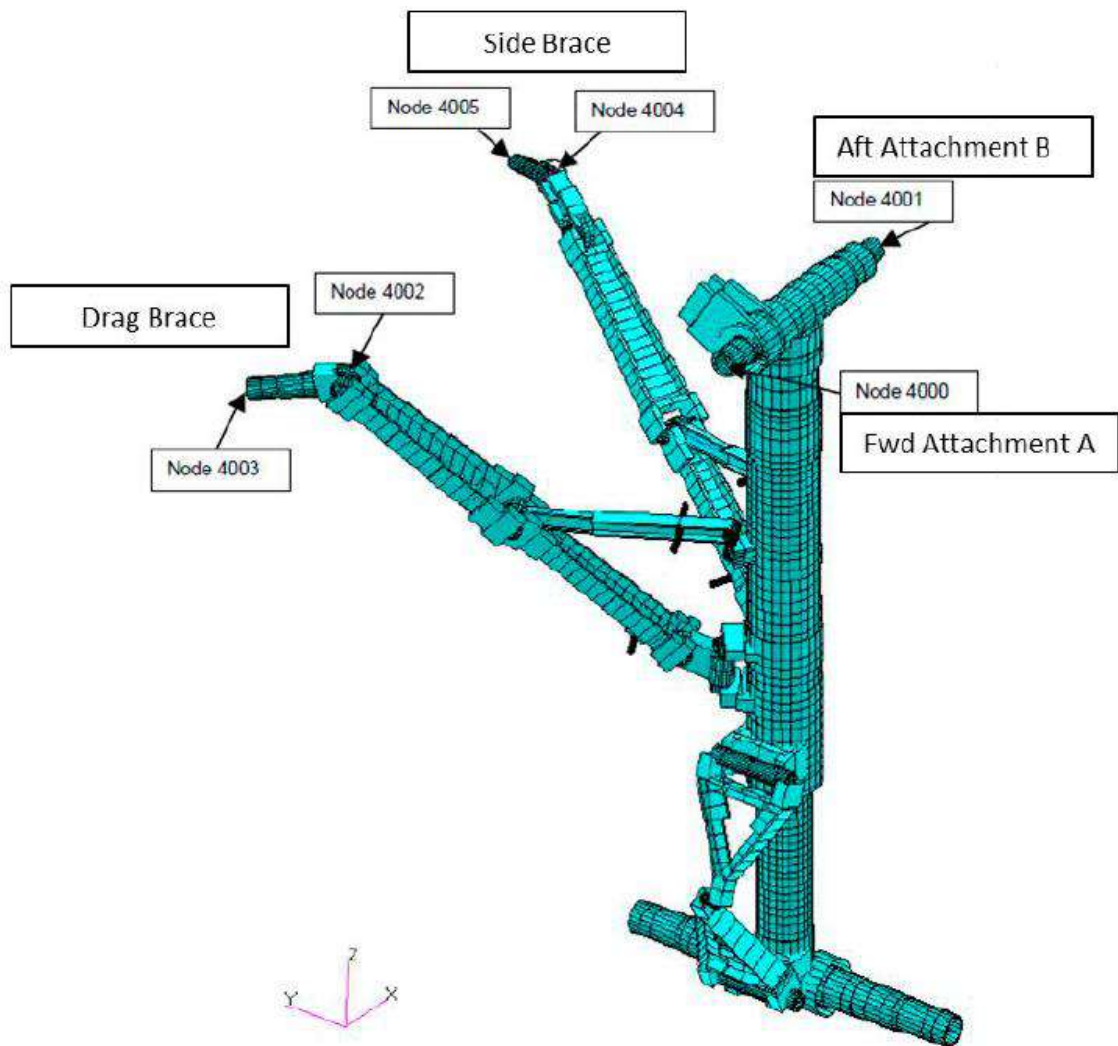
Fig. 58. The left MLG leg finite element model

Proceeding from the value of the absorbed energy at the second touchdown the source data had been obtained for the loading of the MLG leg at the simulation (see the Table here below). The loads are applied at the axle center of the leg.

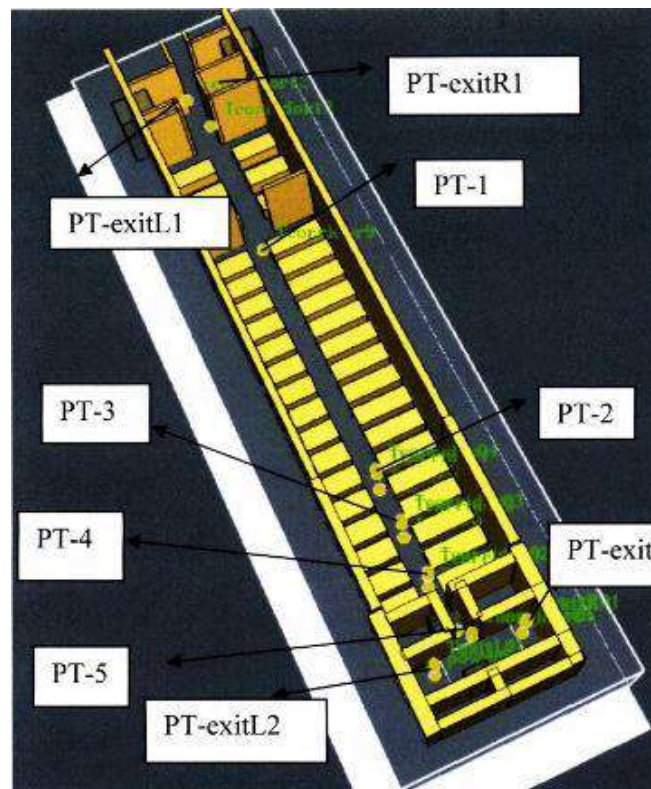
Fig. 64. 3D model of the RRJ-95B aircraft cabin, the target points are marked with yellow dots

The computations were the evidence that the development of fire at the area of the aircraft fuselage FR40 – 46 very quickly results in the temperature increase of more than 600°C at the level of 1.7 off the floor at the region of the PT-2, PT-3 and PT-4 target points both at the opened and the closed left rear door of the aircraft.
