INTERSTATE AVIATION COMMITTEE

FINAL REPORT

ON THE RESULTS OF THE AIR ACCIDENT INVESTIGATION

Type of occurrence	Fatal accident
Type of aircraft	RRJ-95 (RRJ-95B model) airplane
Nationality and registration marks	RA-89098
Owner	VEB Leasing, JSC
Operator	Aeroflot, PJSC
Aviation authority	FATA
Place of occurrence	Sheremetyevo aerodrome, Moscow region, Russian Federation; reference position: 55°58'06.20" N, 37°24'07.20" E
Date and time	May 05, 2019, 18:30 local time (15:30 UTC), daytime

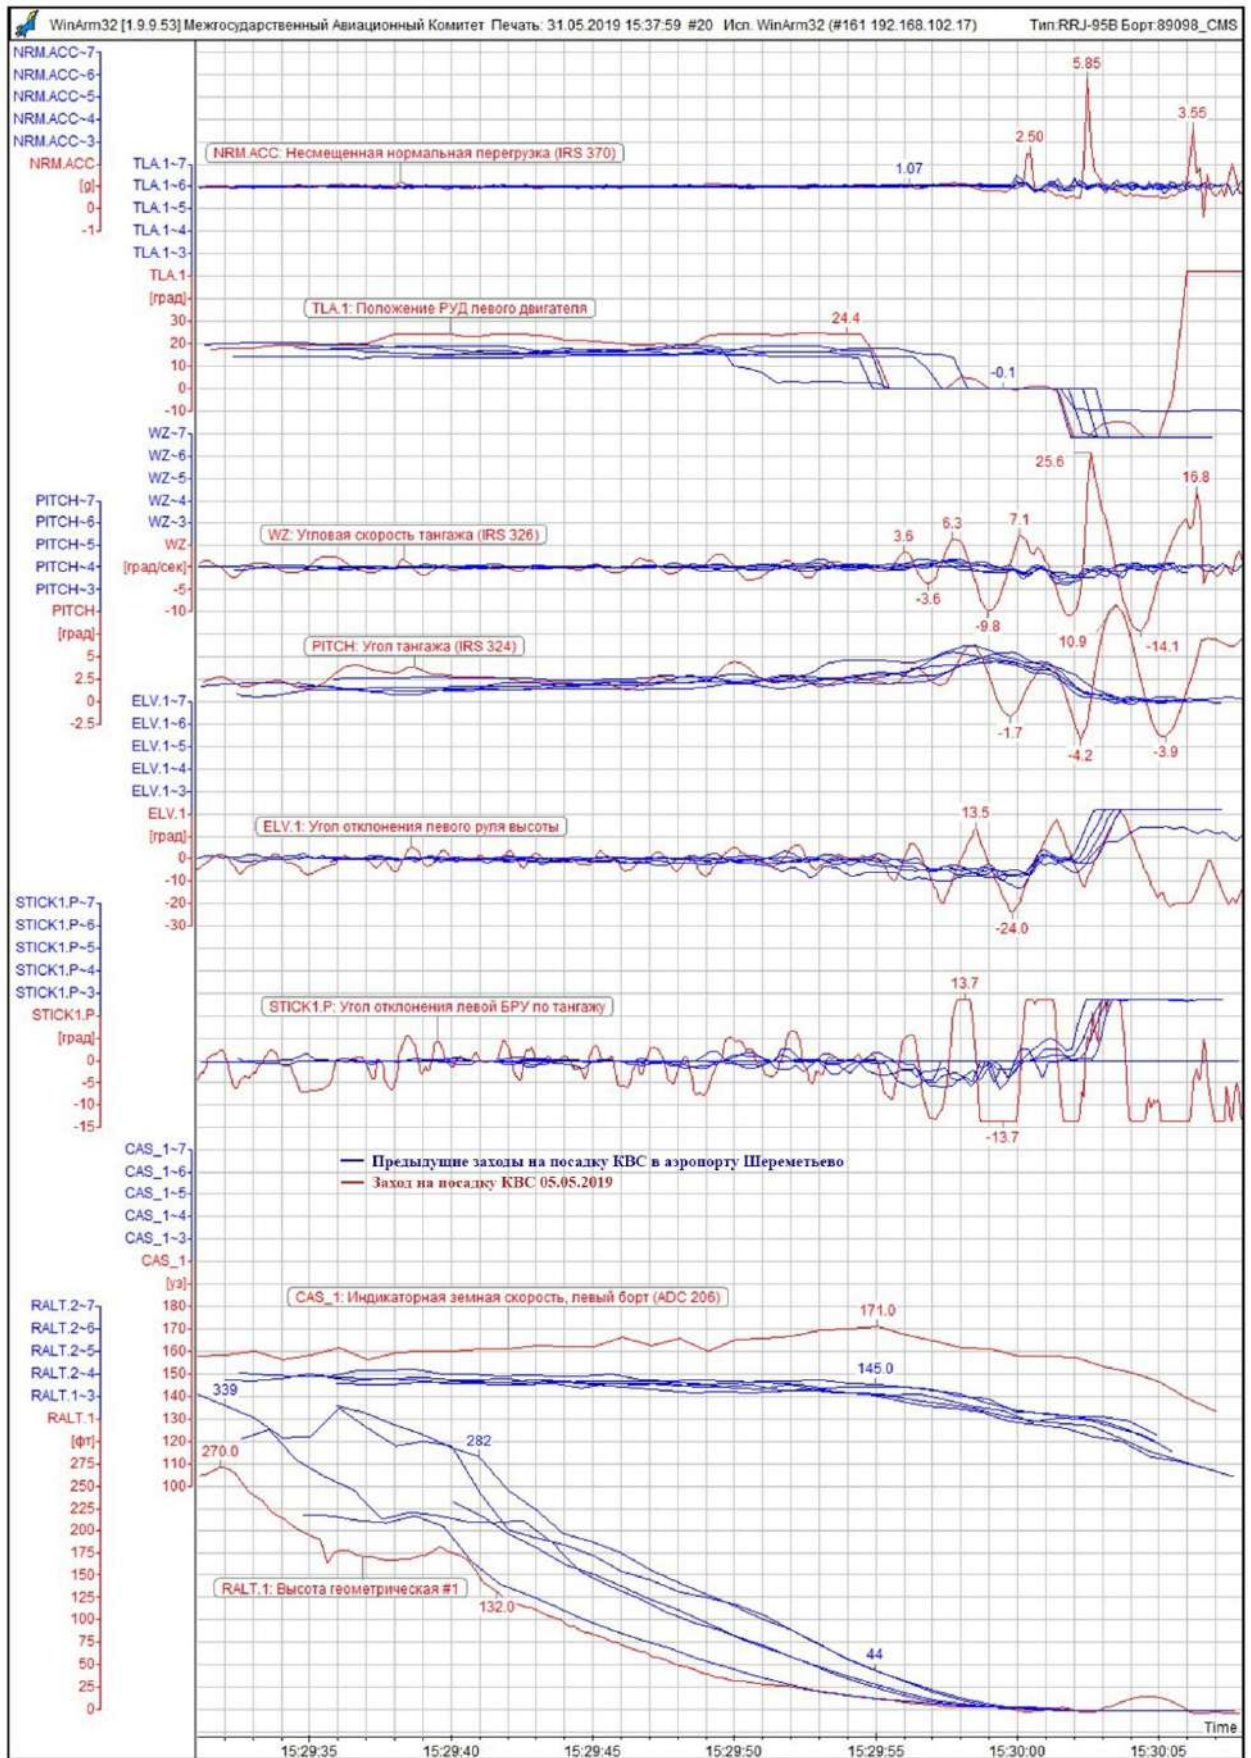
Fig. 65. The comparative analysis of the approaches, performed by the PIC

The investigation team carried out the comparative analysis of the final approaches by the PIC to the Sheremetyevo aerodrome RWY 24L at the FBWCS operation in NORMAL MODE performed manually (with the A/P and A/T disengaged), with the flight that ended up with the accident (Fig. 65). The Figure is the evidence that the sidestick pitch inputs into the flight that ended up with the accident, throughout its entire glideslope leg, were much larger in amplitude, oscillatory in nature, which had led to the substantial change in the pitch motion parameters.

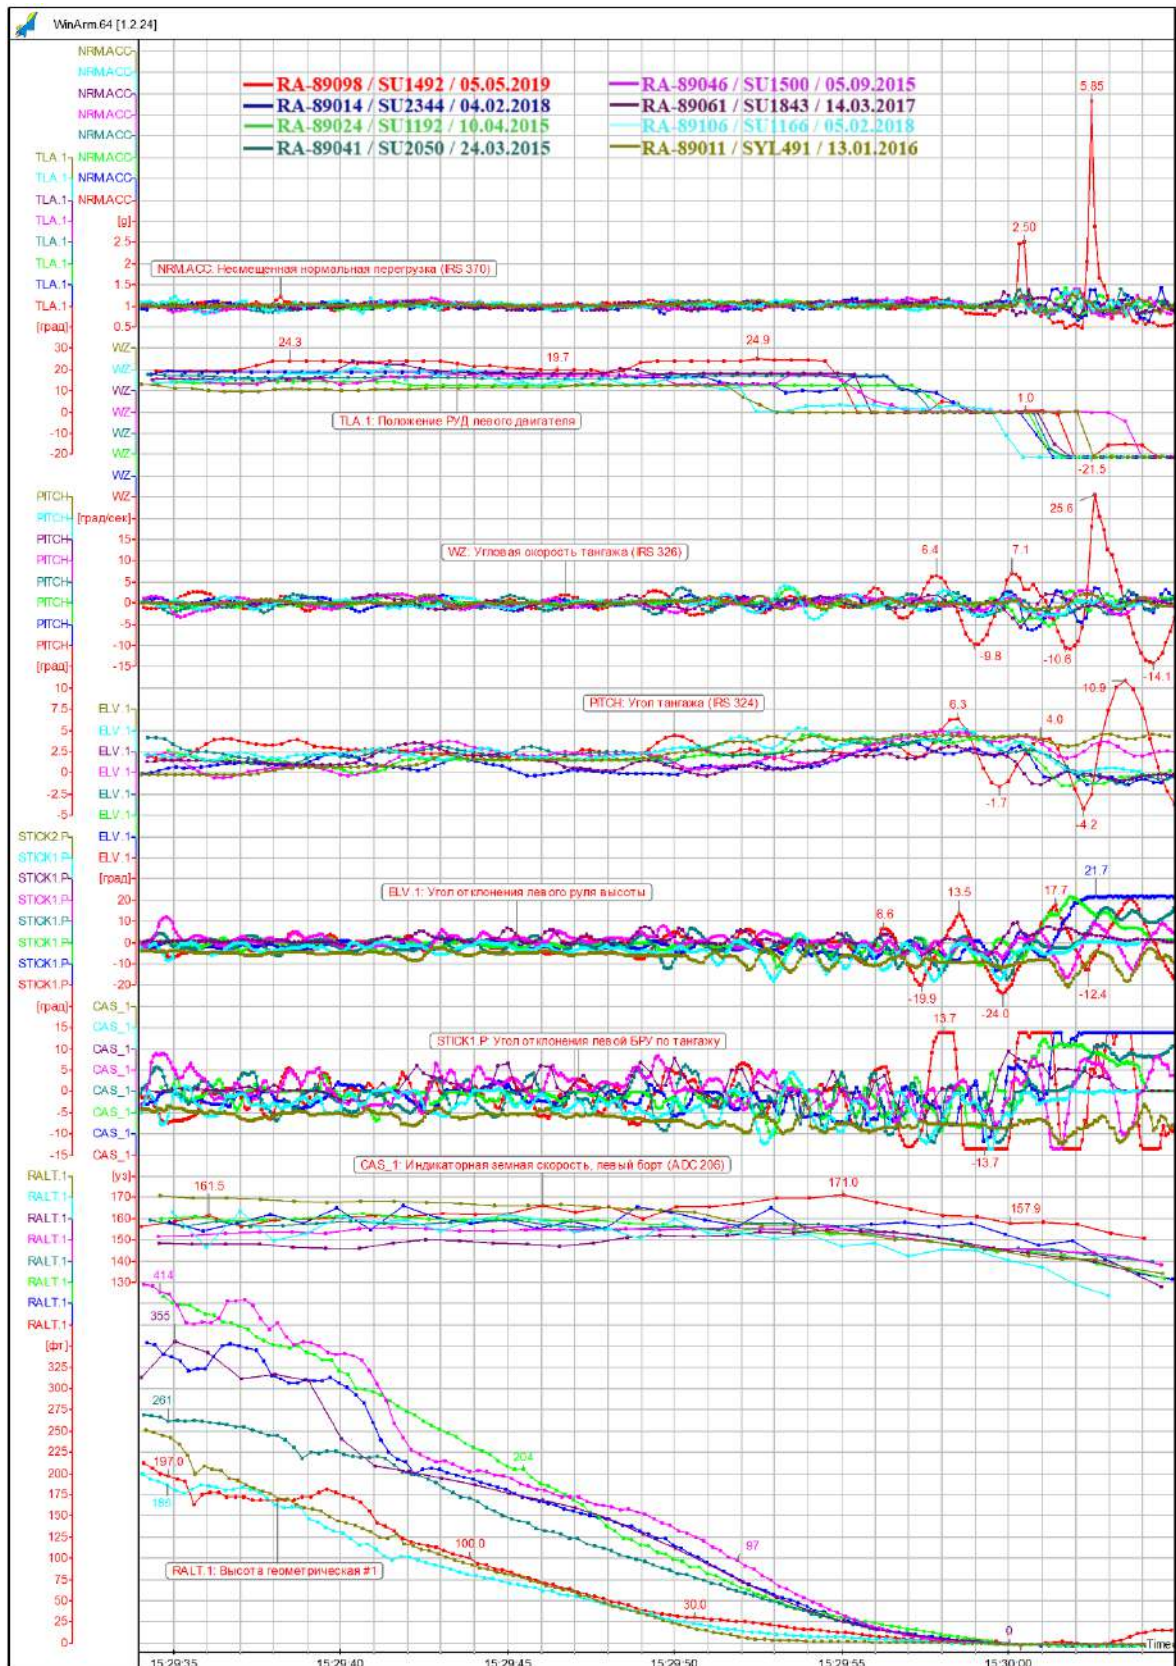
Fig. 66. The comparative analysis of the approaches in DIRECT MODE

The similar «sweeping» inputs were also observed at the approaches, performed in DIRECT MODE by another flight crews. The investigation team has reviewed 7 flights, the

landing in which had been performed in DIRECT MODE. Six flights out of these were performed by the Aeroflot flight crews and one flight (the RA-89011 airplane), operated by the Yakutiya airline flight crew. Fig. 66 presents the plots of the pitch channel basic parameters change into the glideslope flight vs the flight that ended up with the accident.

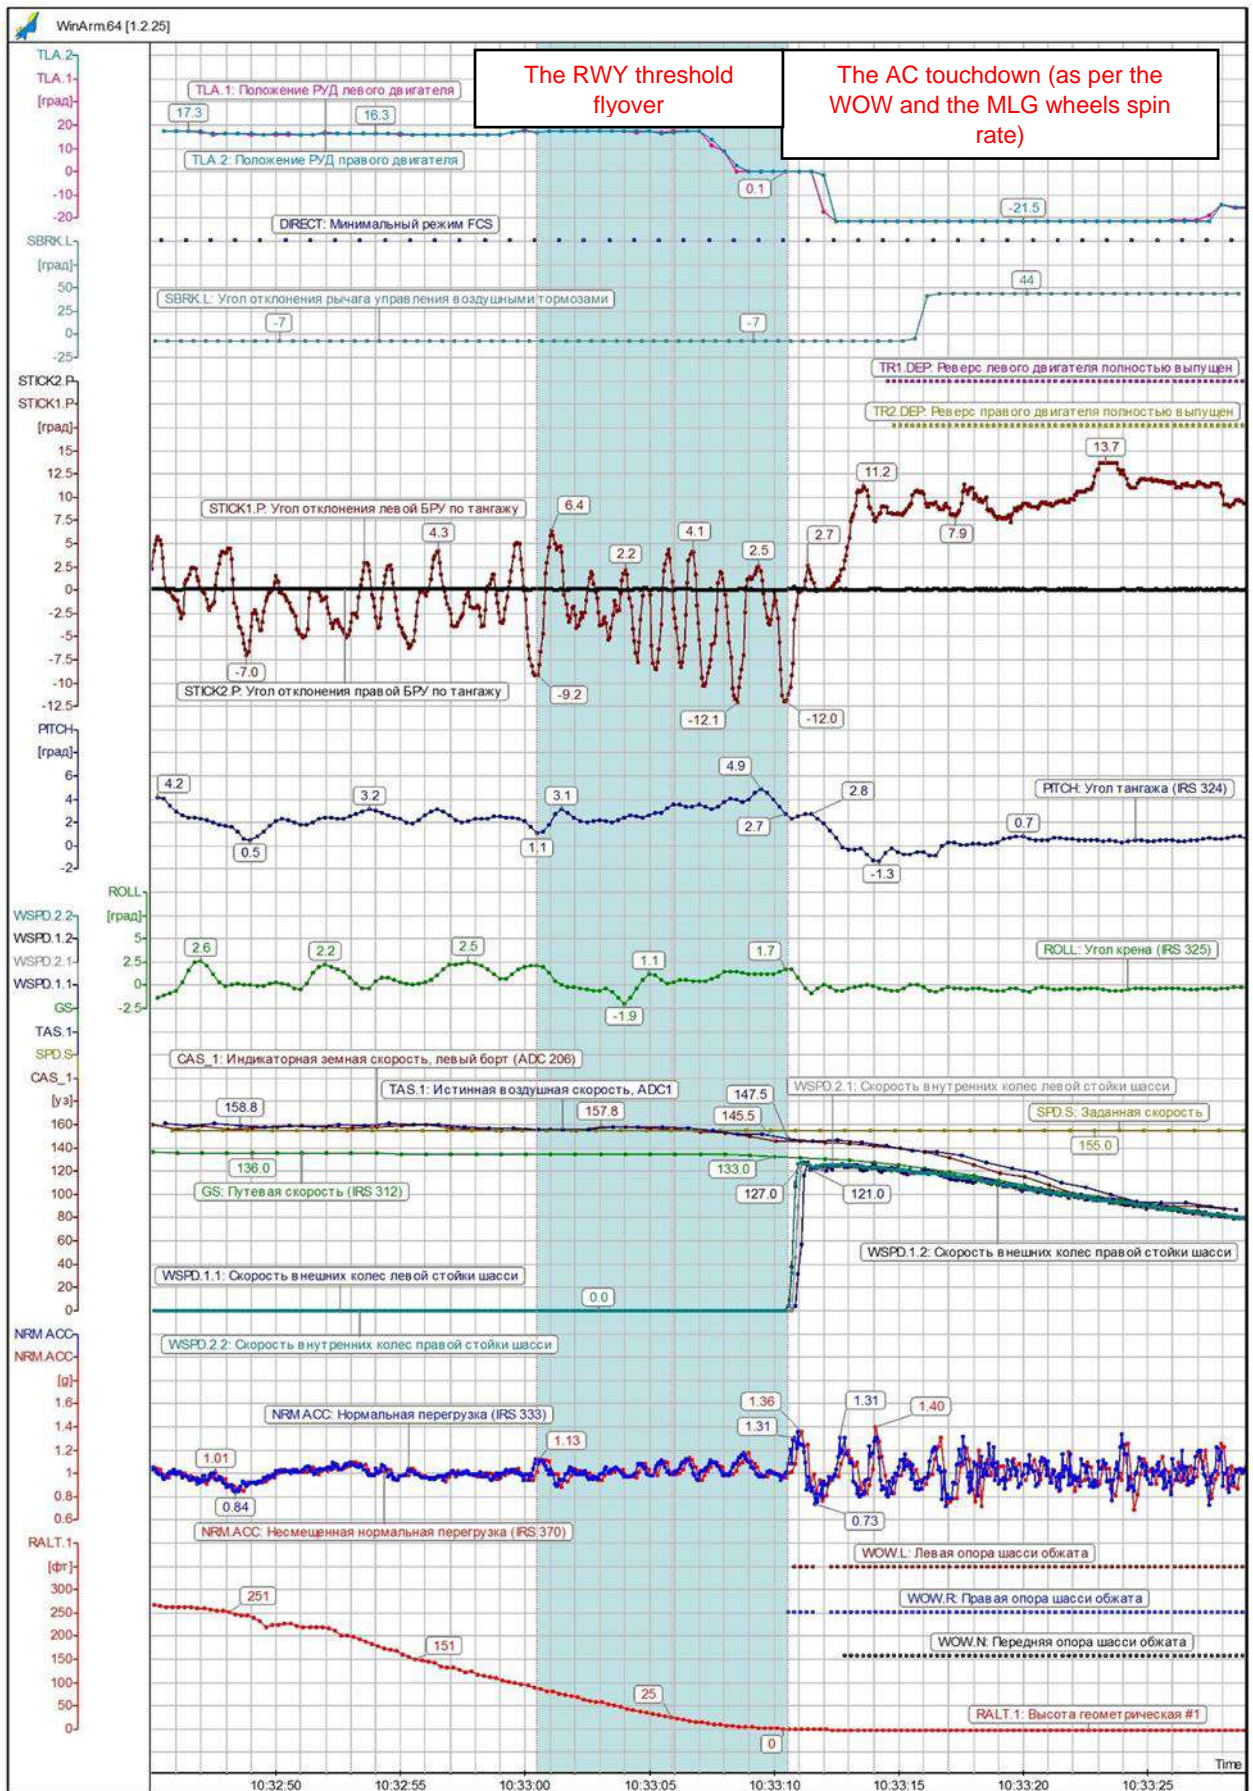
Fig. 67. The approach and landing in DIRECT MODE of the RA-89041 airplane on 24.03.2015

Fig. 67 presents the plots of the parameters change at the approach and landing of the RA-89041 aircraft. The following features are observed:

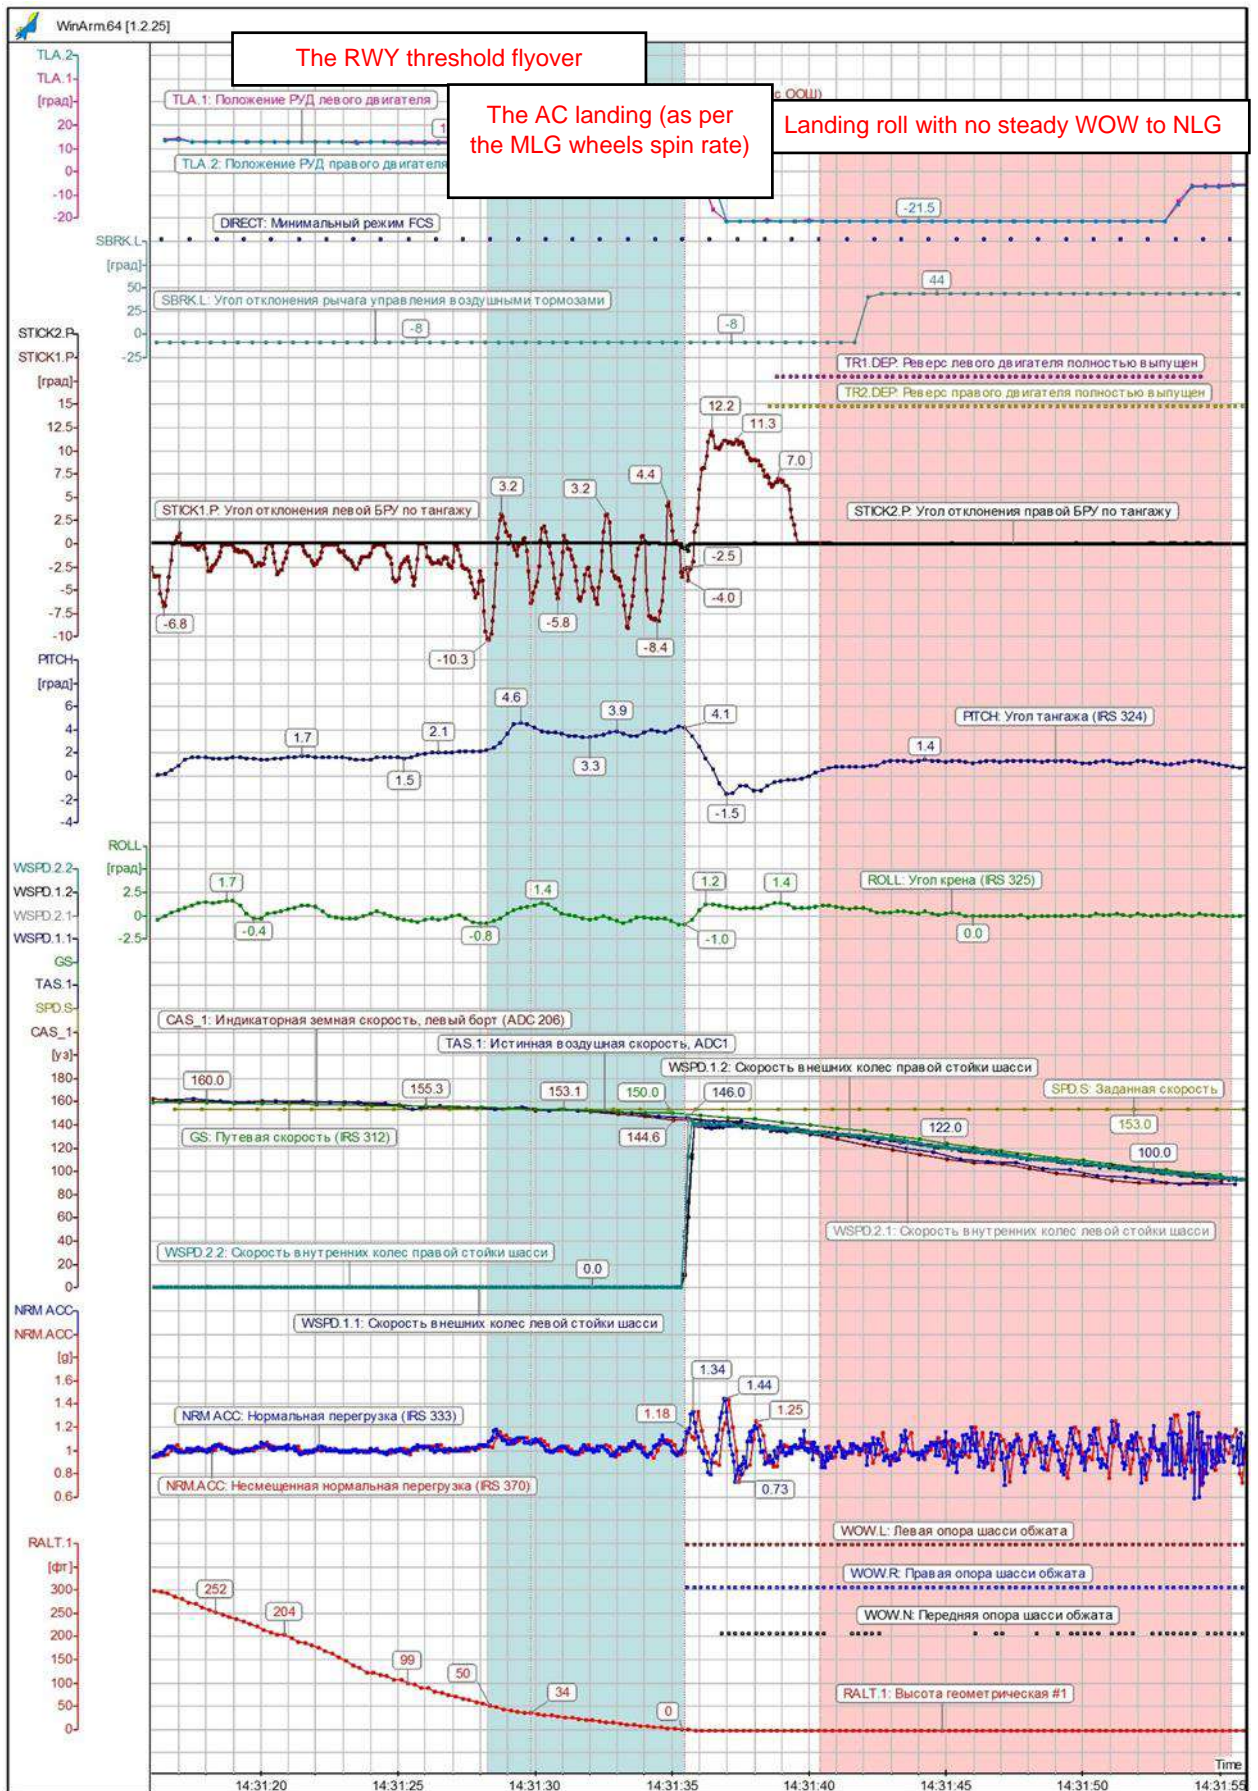
Fig. 68. The approach and landing in DIRECT MODE of the RA-89024 aircraft on 10.04.2015

Fig. 68 presents the plots of the parameters change at the approach and landing of the RA-89024 aircraft. The following features are observed:

- the amplitude alternating sidestick inputs of a high frequency at the flare and immediately before it (on the Figure the region is highlighted with the grey color);
- the RWY threshold flyover at the altitude of 34 ft.;
- the forward sidestick inputs after the RWY threshold flyover up to 3.2°, after the TL setting to the IDLE detent – up to 4.4°;
- the long-time landing roll with no «steady» WOW to the NLG (on the Figure the region is highlighted with the red color);
- first the TR were actuated, the speedbrakes were manually deployed afterwards.

In NORMAL MODE the nose-up moment from the deployment of speedbrakes and spoilers is substantially less than in DIRECT MODE. Fig. 68 shows that after the deployment of speedbrakes at the neutral sidestick the landing roll until the speeds of about 90 kt were reached had been proceeded with no steady WOW to NLG.

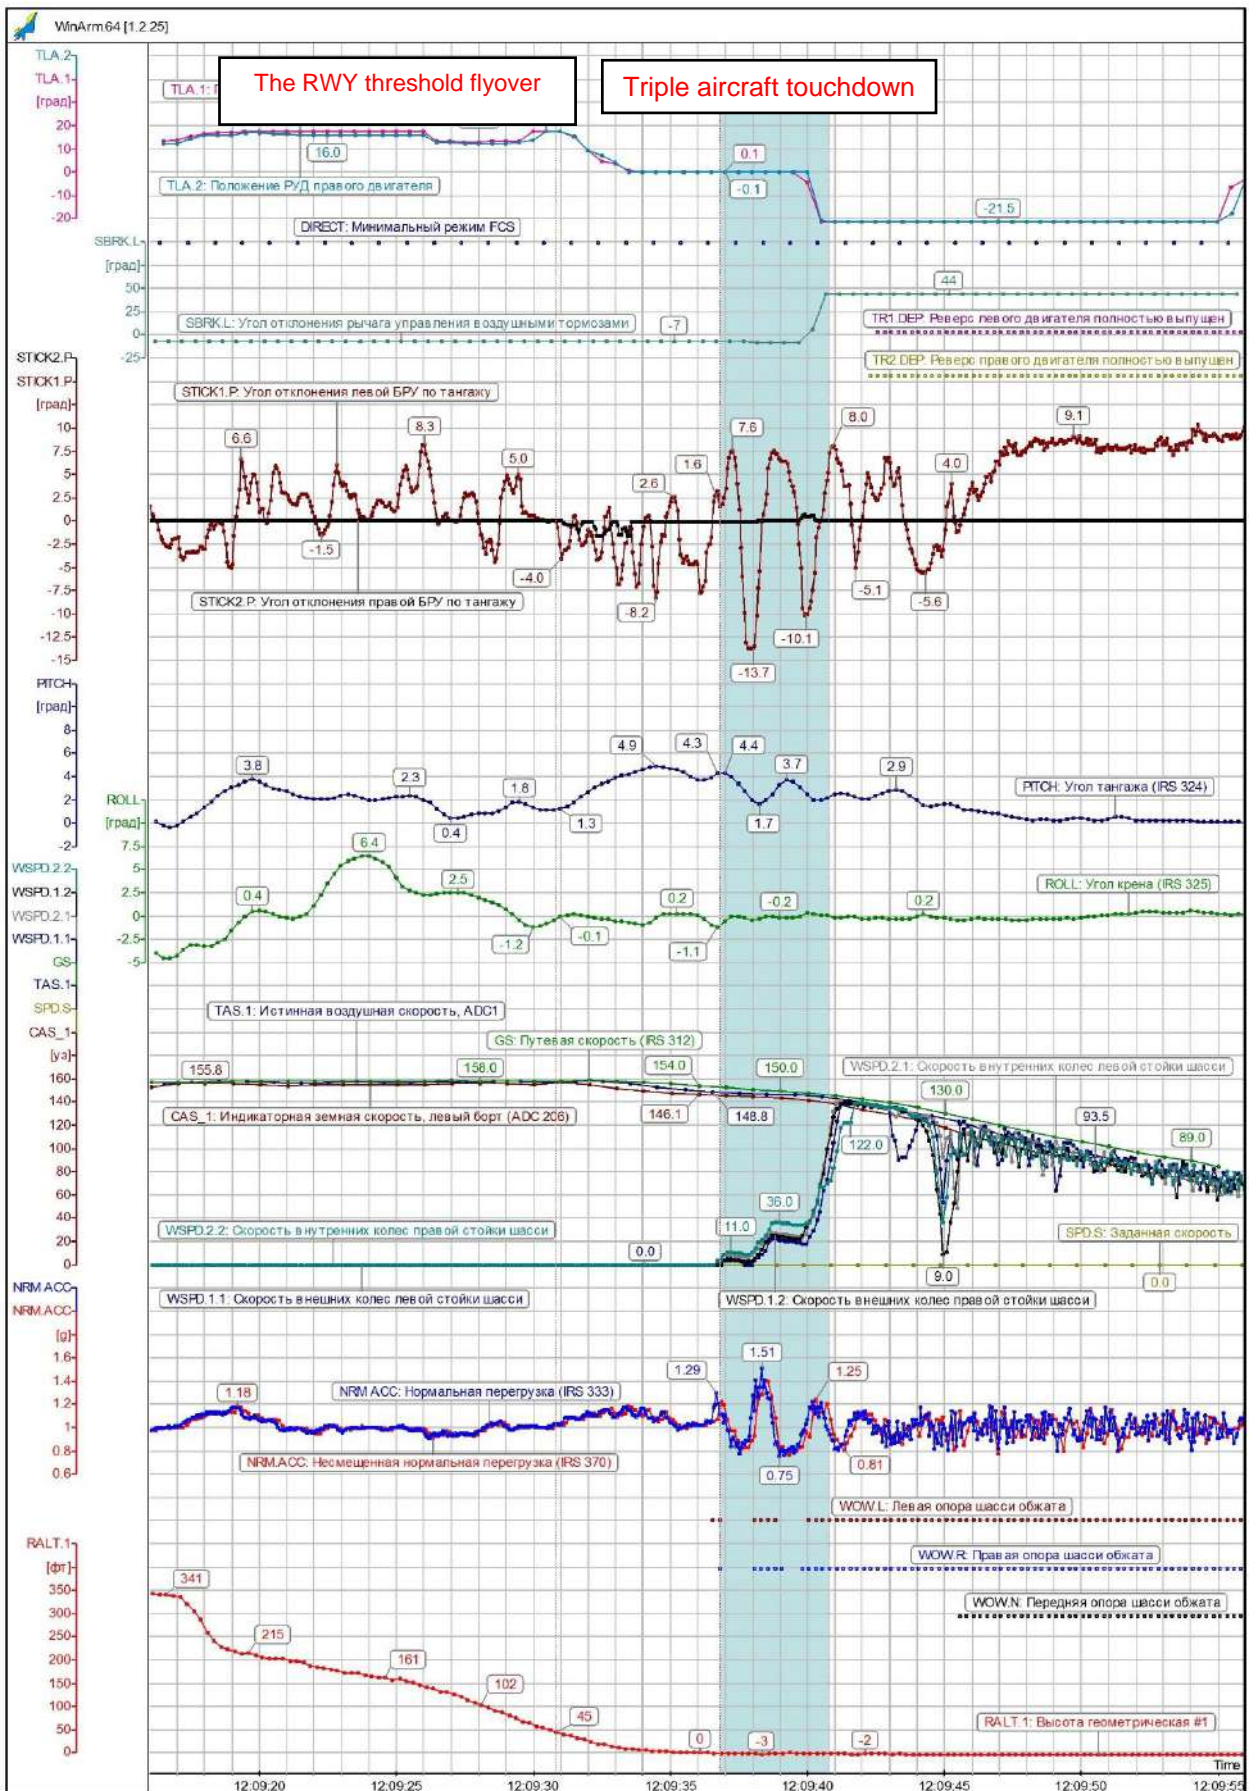
Fig. 69. The approach and landing in DIRECT MODE of the RA-89046 aircraft on 05.09.2015

Fig. 69 presents the plots of the parameters change at the approach⁷² and landing of the RA-89046 aircraft. The following features are observed:

- the amplitude alternating sidestick inputs of a high frequency at the flare and immediately before it with the «dual input»;
- the forward sidestick input of 2.6° at flare;
- there had been two aircraft bounces off the RWY (it is highlighted on the Figure);
- into the bounces the sidestick amplitude alternating inputs (half travel forward and up to the full aft inputs);
- the high-rate sidestick inputs at the point of the touchdowns;
- first (at the third touchdown) there had been a manual deployment of the speedbrakes, the TR were actuated afterwards;
- the «prolonged» lowering of the NLG
- the forward sidestick input at the landing roll

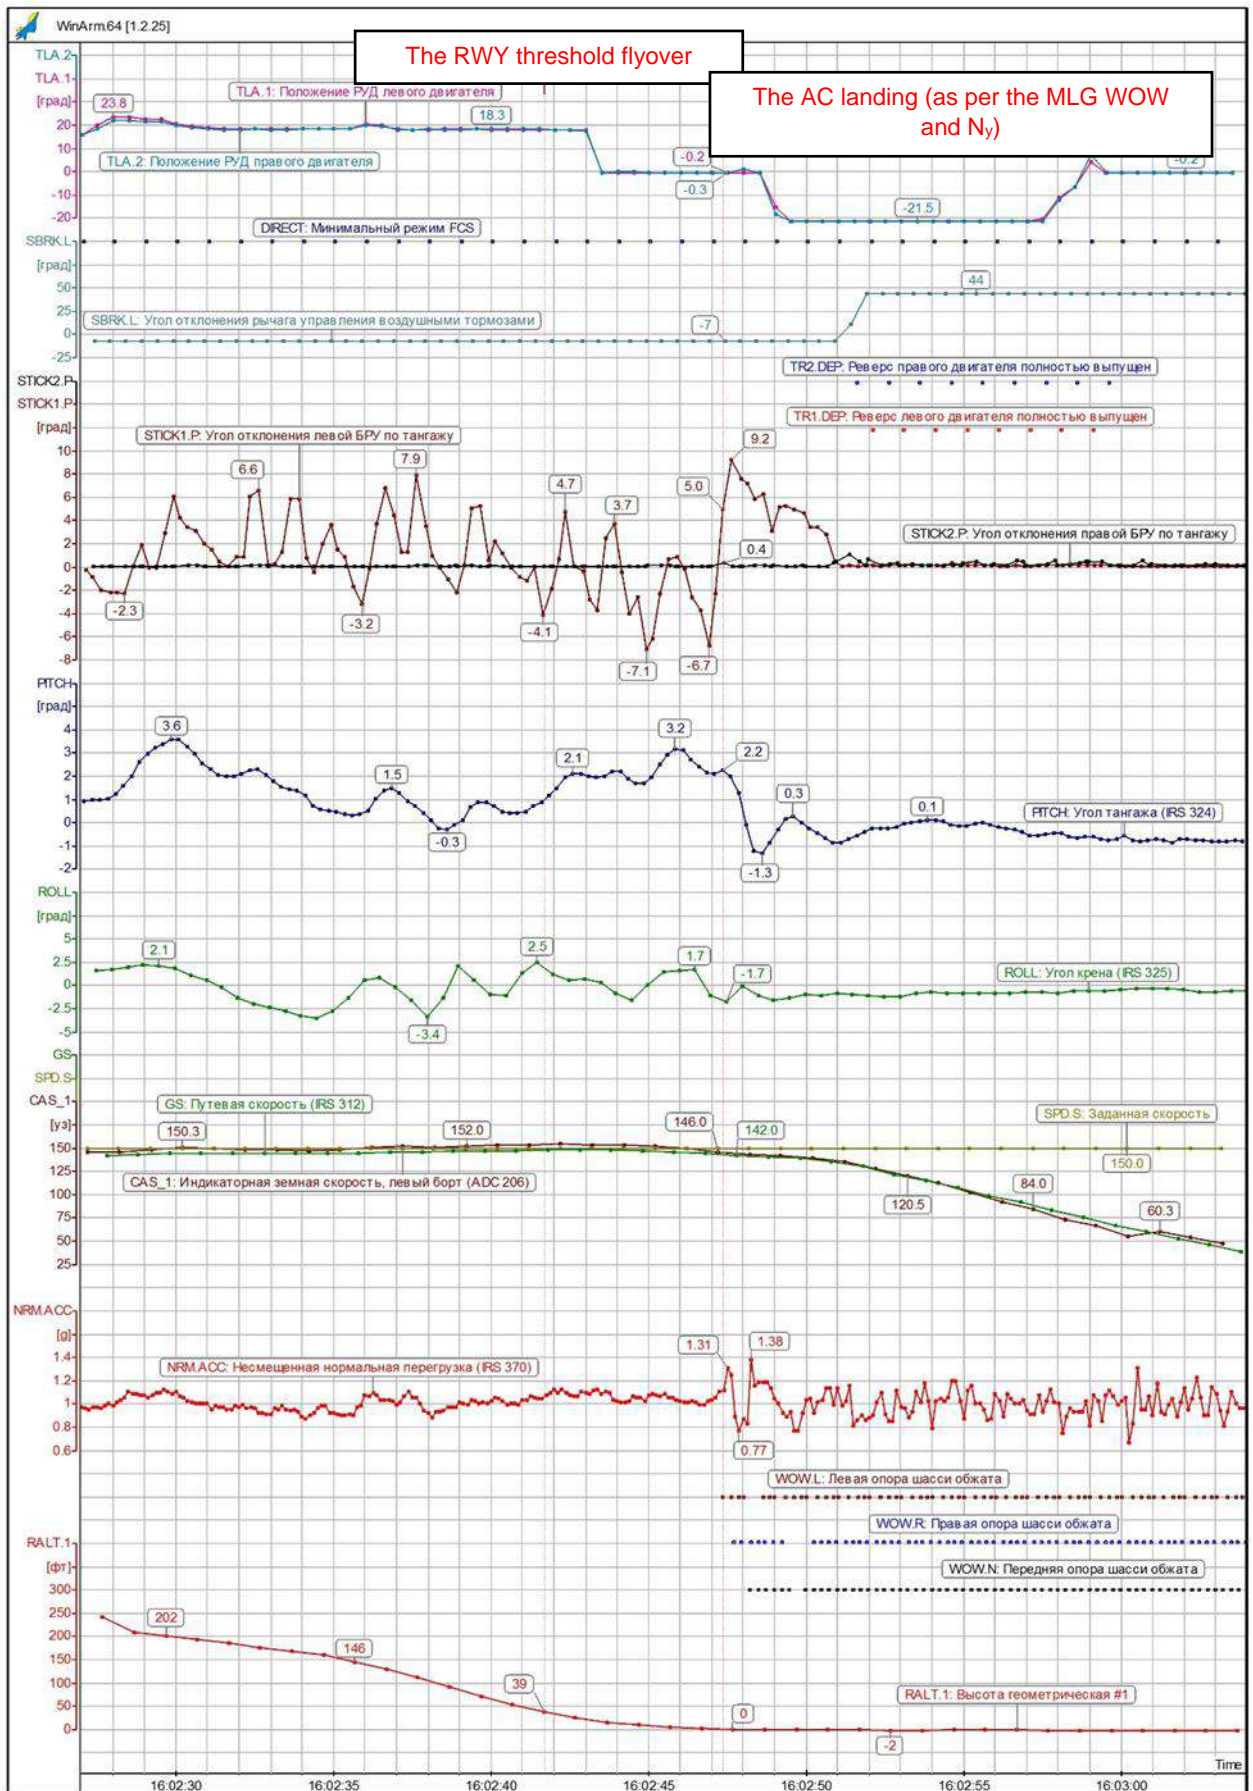
Fig. 70. The approach and landing in DIRECT MODE of the RA-89061 aircraft on 14.03.2017

Fig. 70 presents the plots⁷³ of the parameters change at the approach and landing of the RA-89061 aircraft. The following features are observed:

- the FBWCS reversion to DIRECT MODE occurred in the landing configuration into the glideslope leg of the flight at the altitude less than 500 ft., when the aircraft had been fully trimmed in the automatic flight;
- the amplitude alternating sidestick inputs of a high frequency at the flare and immediately before it;
- the forward sidestick inputs after RWY threshold flyover up to 4.7°, at the flare – up to 3.7°;
- at the point of landing the pitch was equal to ~ 2° to nose-up;
- first the TR were actuated, the speedbrakes were manually deployed afterwards.

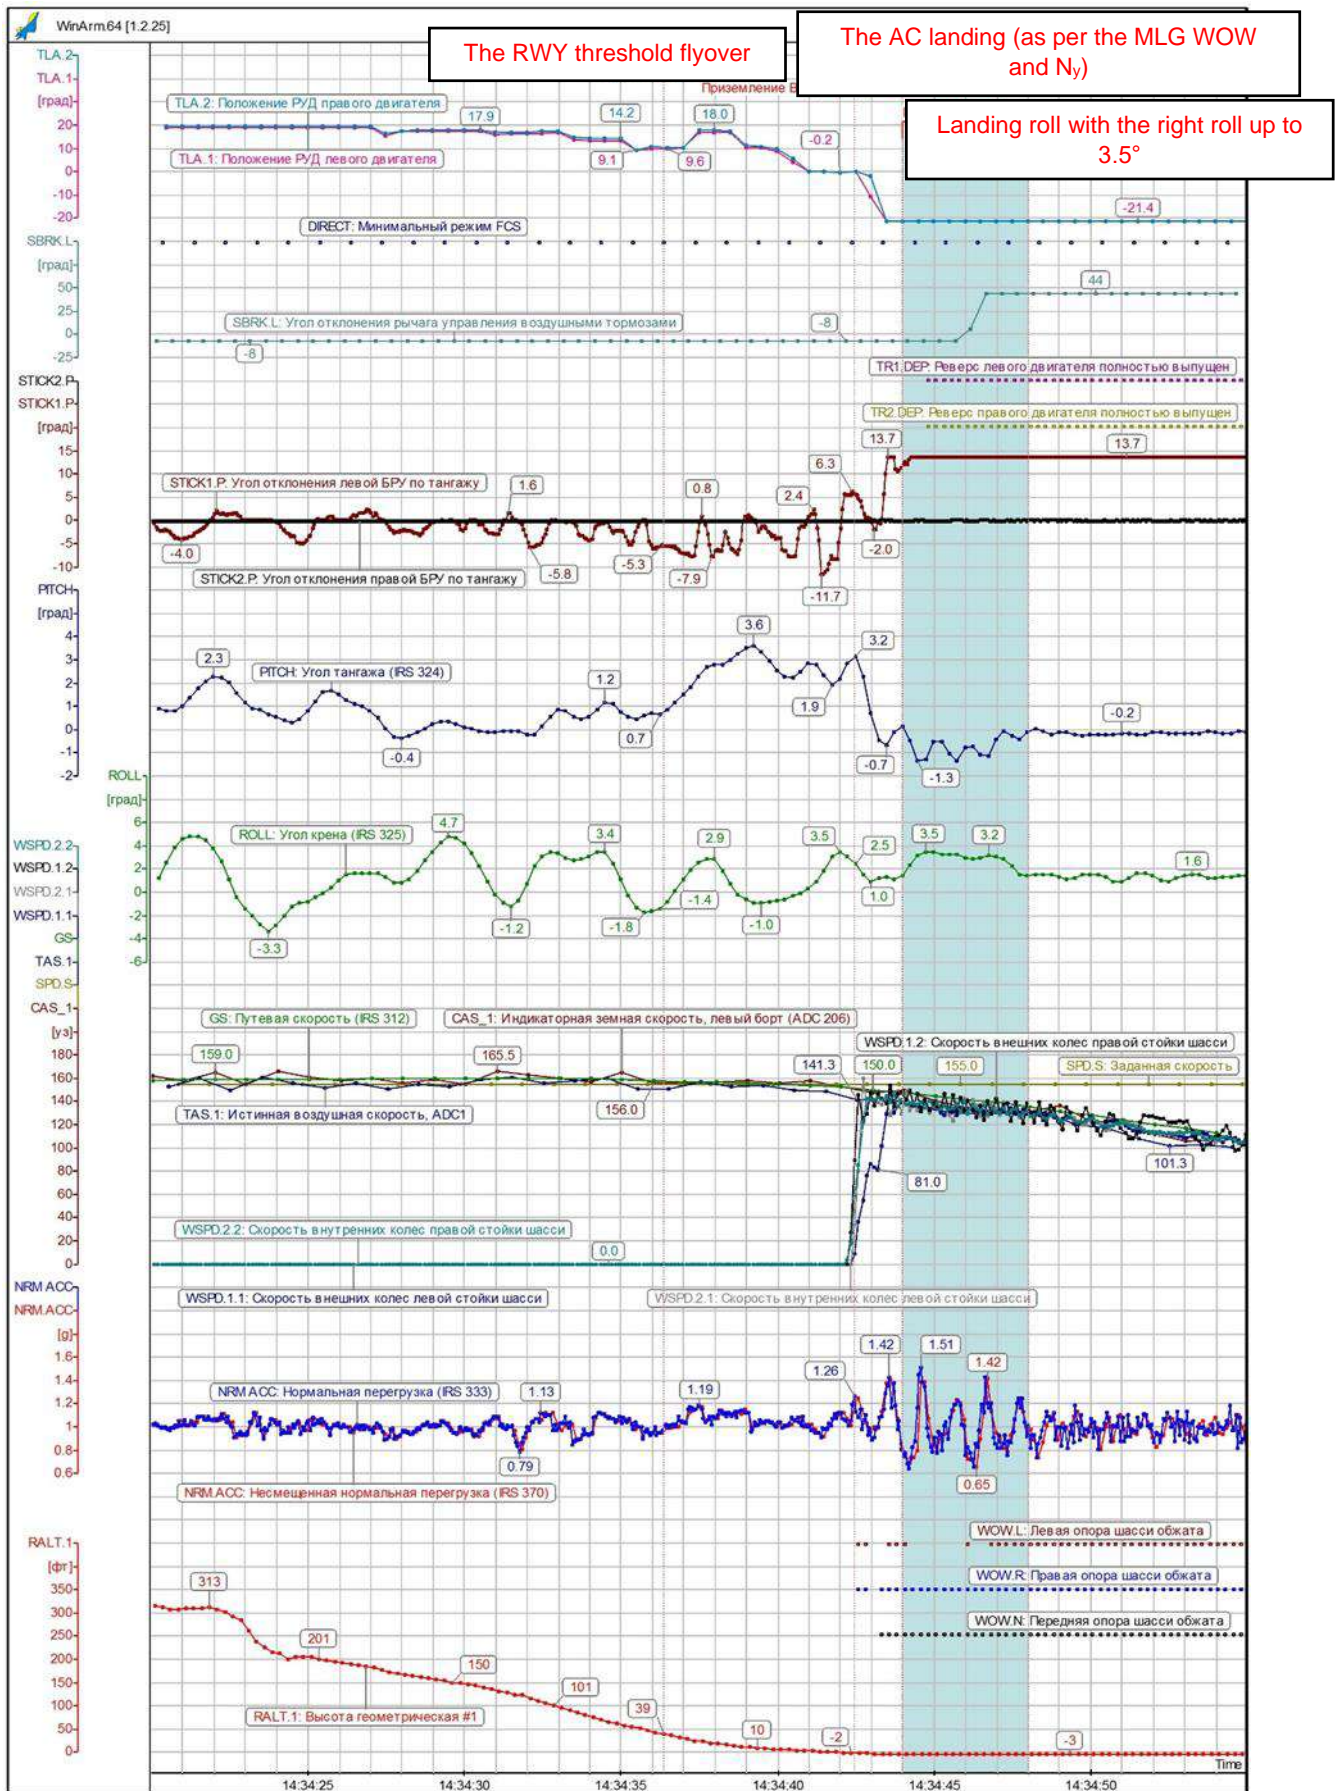
Fig. 71. The approach and landing in DIRECT MODE of the RA-89014 aircraft on 04.02.2018

Fig. 71 presents the plots of the parameters change at the approach and landing of the RA-89014 aircraft. The following features are observed:

- the forward sidestick inputs of more than 2.4° at flare;
- at the point of landing the pitch value is equal to $\sim 3^\circ$ to nose up, the right roll of $\sim 3^\circ$;
- initially the landing roll with the right roll of up to 3.5° (it is highlighted on the plot) with the stop of the left MLG WOW discrete signal record;
- first the TR were actuated, the speedbrakes were manually deployed afterwards;
- full forward sidestick input at the landing roll.

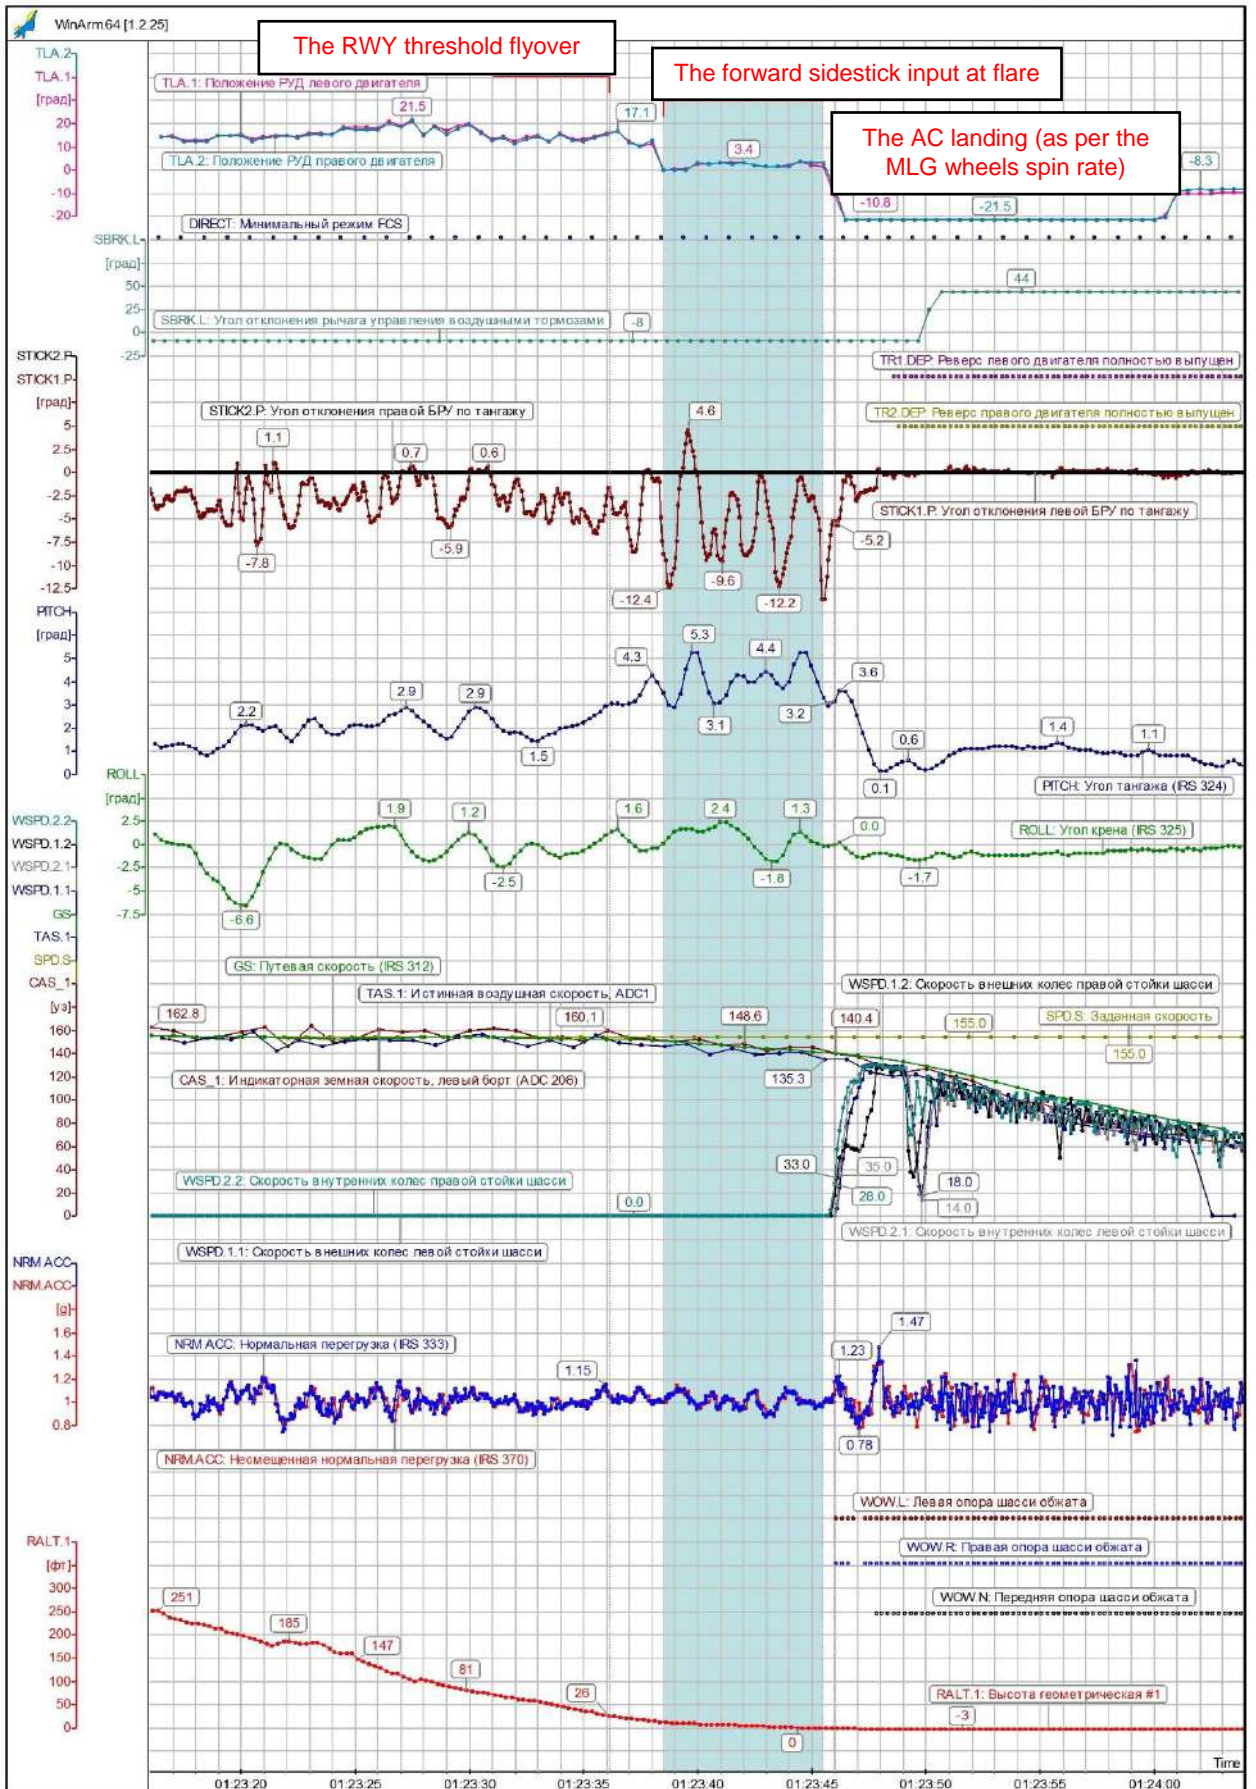
Fig. 72. The approach and landing in DIRECT MODE of the RA-89106 aircraft on 05.02.2018

Fig. 72 presents the plots of the parameters change at the approach and landing of the RA-89106 aircraft. The following features are observed:

- the RWY threshold flyover at the altitude of 26 ft.;
- the prolonged flare (it is highlighted on the plot);
- the amplitude alternating sidestick inputs of a high frequency at flare up to the nearly full back inputs and the forward input up to 4.6°;
- another bounce off the RWY, the first touchdown at the distance of 770 m off the RWY entry threshold, the second one at the distance of 865 m;
- first the TR were actuated, the speedbrakes were manually deployed afterwards.

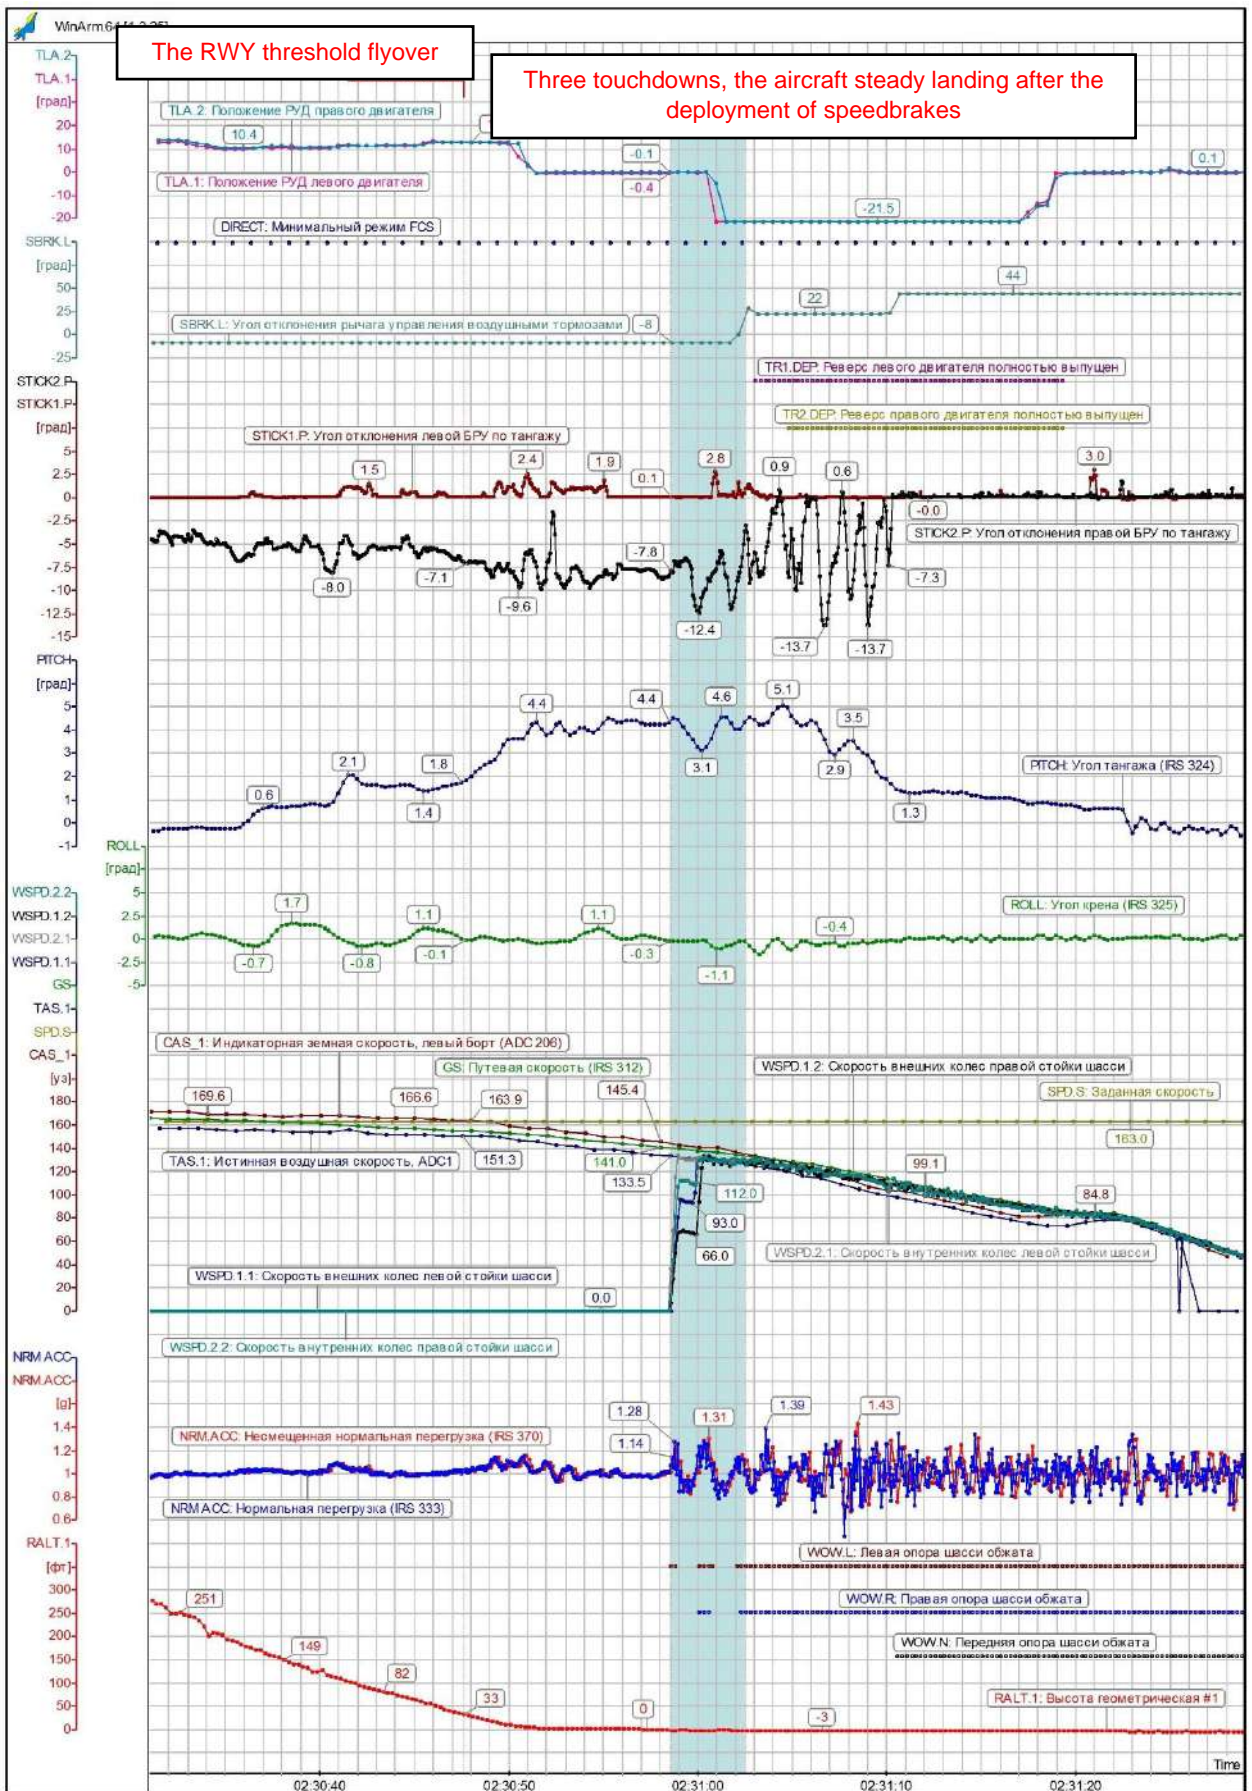
Fig. 73. The approach and landing in DIRECT MODE of the RA-89011 aircraft on 13.01.2016

Fig. 73 presents the plots of the parameters change at the approach and landing of the RA-89011 aircraft. The following features are observed:

- the RWY threshold flyover at the altitude of 33 ft.;
- the prolonged flare;
- DUAL INPUT on the final leg, including the flare, one of the sidesticks had been repositioned forward up to 1.9°;
- two aircraft bounces off the RWY (highlighted on the Figure), the first touchdown at the distance of 865 m off the RWY threshold, the third one – at the distance of 1150 m. Into the bounces off the RWY the high-rate sidestick inputs were observed, at that the second sidestick had been repositioning forward (dual input);
- at the third touchdown the TR and the manual speedbrakes deployment occurred nearly simultaneously.

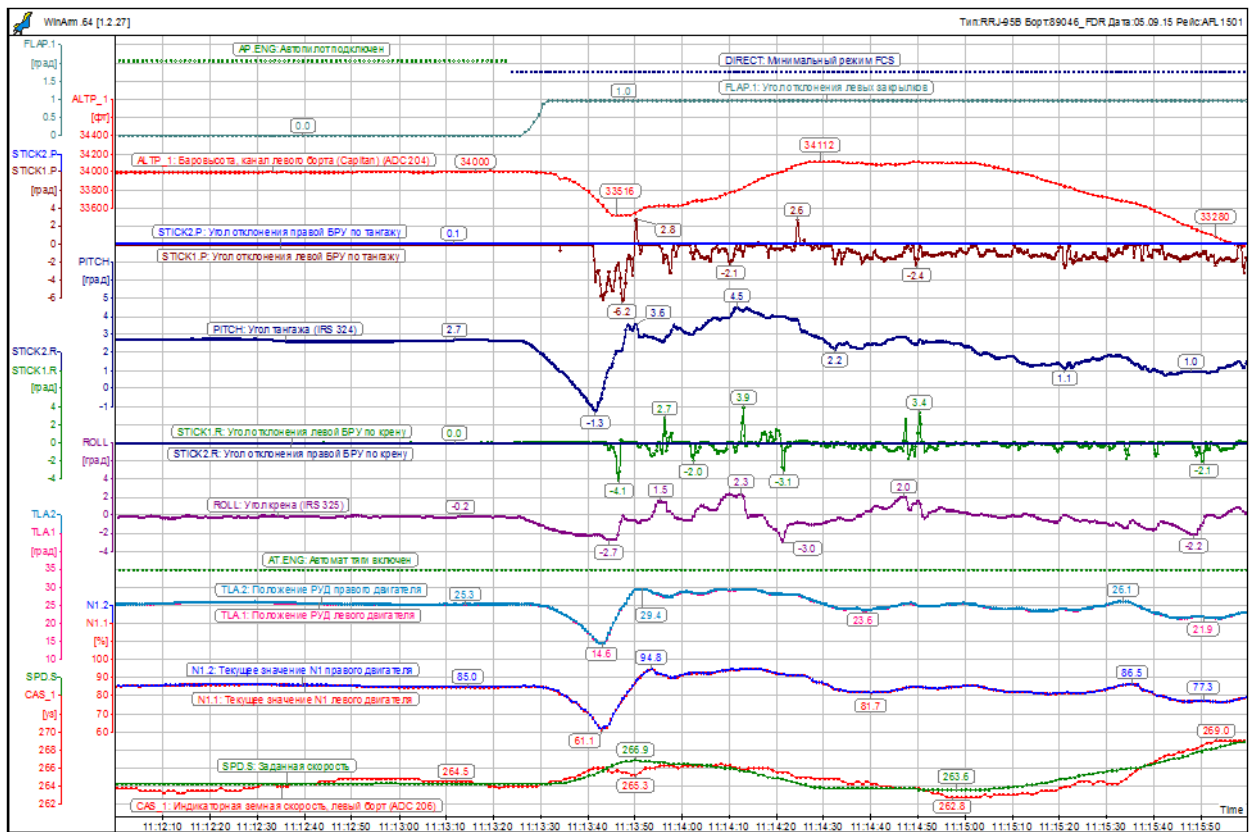
Fig. 74. The RRJ-95 RA-89046 aircraft flight data of 05.09.2015, the FBWCS reversion to DIRECT MODE

The FCS reversion to DIRECT MODE occurred at 11:13:25 in the progress of the cruise flight on FL340 and at the IAS of about 265 kt, the TLA was 25.3°, N1 - 85 % (Fig. 74). The aircraft had been flown in the automatic mode. The first control inputs by the crew after the reversion to DIRECT MODE, accompanied by the AP disconnect, had been recorded not earlier than in about 17 sec. Since then the aircraft pitch smoothly changed from 2.7° to nose-up to 1.3° to nose-down. Eventually the aircraft «ran away» by about 500 ft. down from the cruise FL. This evidence shows the flight crew's insufficient situational awareness and the inadequate monitoring of the flight parameters and the AP operation.
