INTERSTATE AVIATION COMMITTEE

FINAL REPORT

ON THE RESULTS OF THE AIR ACCIDENT INVESTIGATION

Type of occurrence	Fatal accident
Type of aircraft	RRJ-95 (RRJ-95B model) airplane
Nationality and registration marks	RA-89098
Owner	VEB Leasing, JSC
Operator	Aeroflot, PJSC
Aviation authority	FATA
Place of occurrence	Sheremetyevo aerodrome, Moscow region, Russian Federation; reference position: 55°58'06.20" N, 37°24'07.20" E
Date and time	May 05, 2019, 18:30 local time (15:30 UTC), daytime

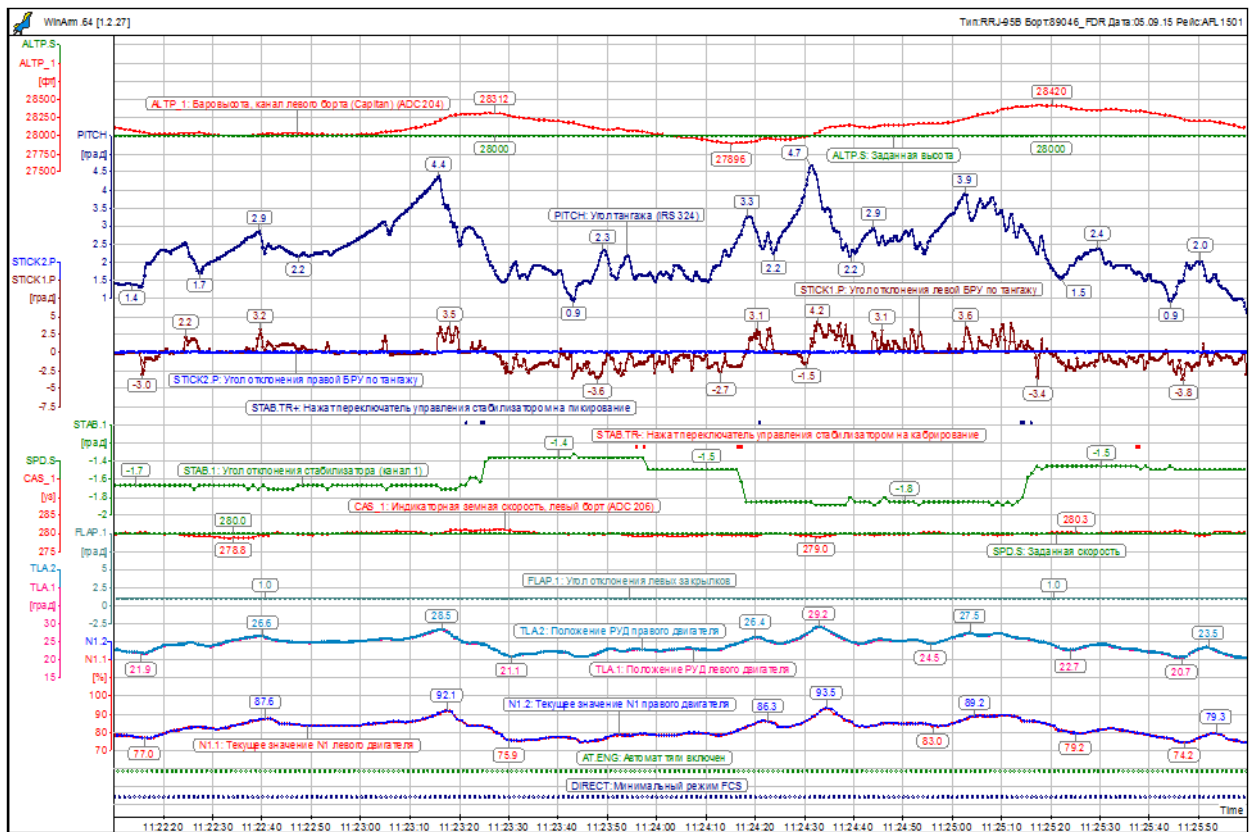
Fig. 75. The RRJ-95 RA-89046 aircraft flight data of 05.09.2015, the flight on FL280

Fig. 75 presents the flight data of the flight on FL280. Apparently the piloting was focused on the maintenance of the target altitude. The flight was proceeded at the IAS of about 280 kt that was maintained by the A/T. That is to say, after 10 minutes approximately from the FBWCS reversion to DIRECT MODE the crew, in non-compliance to the FCOM, did not disengage the A/T. The A/T was disengaged at no earlier than 11:41:25.

At the beginning of the interval under consideration the stabilizer is deflected to 1.7° to nose-up. The plot is the evidence that this setting is clearly excessive against the current flight parameters. At the sidestick release to neutral the aircraft was starting to pitch up intensely. Further on the pilot undertook several stabilizer resettings to both nose-up and nose-down and, finally, set it to the 1.8° position, which, naturally, did not improve the situation – at the sidestick return to neutral the aircraft continued to pitch up, the departure off the target altitude amounted to more than 400 ft. It was just the subsequent stabilizer setting to the 1.5° to nose-up that slightly rectified the situation.

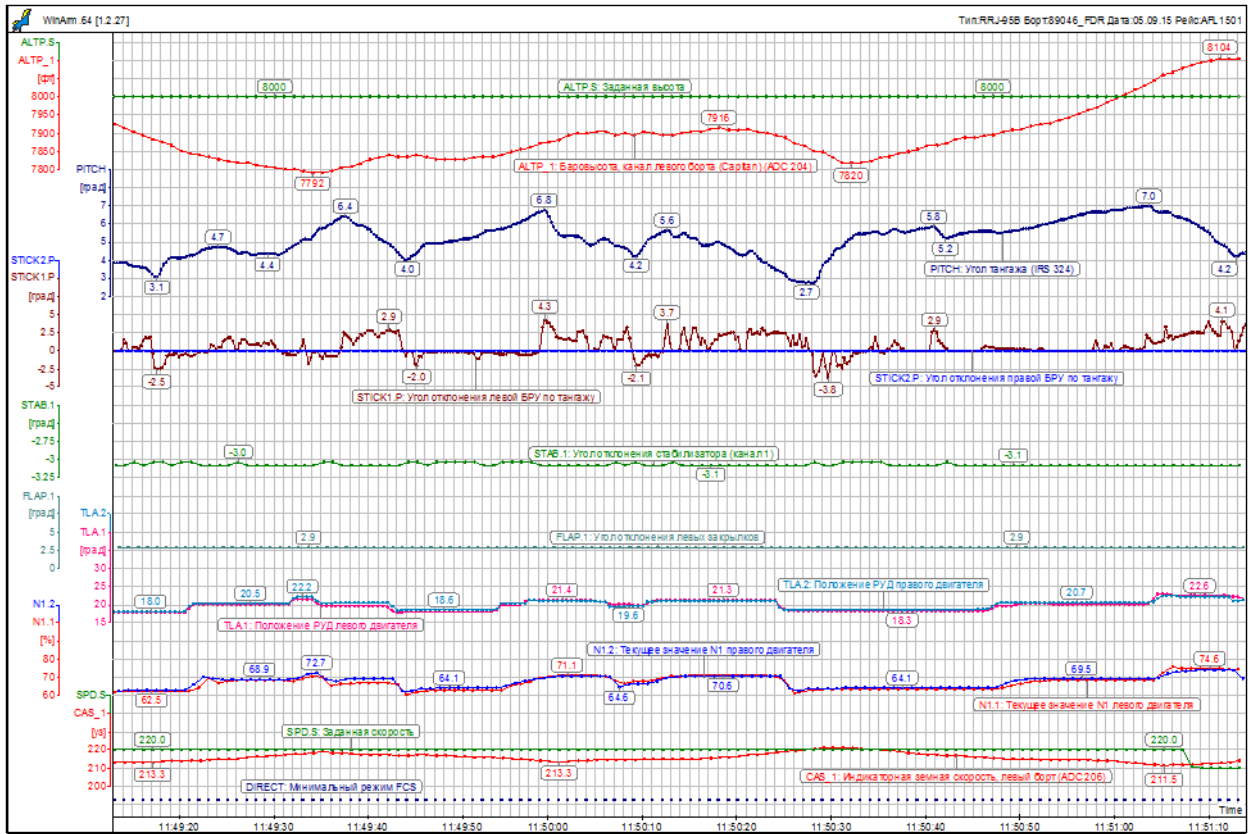
Fig. 76. The RRJ-95 RA-89046 aircraft flight data of 05.09.2015, the flight on FL80

A similar pattern with the aircraft pitching up at the release of the sidestick to neutral was repeated when trying to maintain the FL80 (Fig. 76). At this stage the pilot never attempted to trim the aircraft.

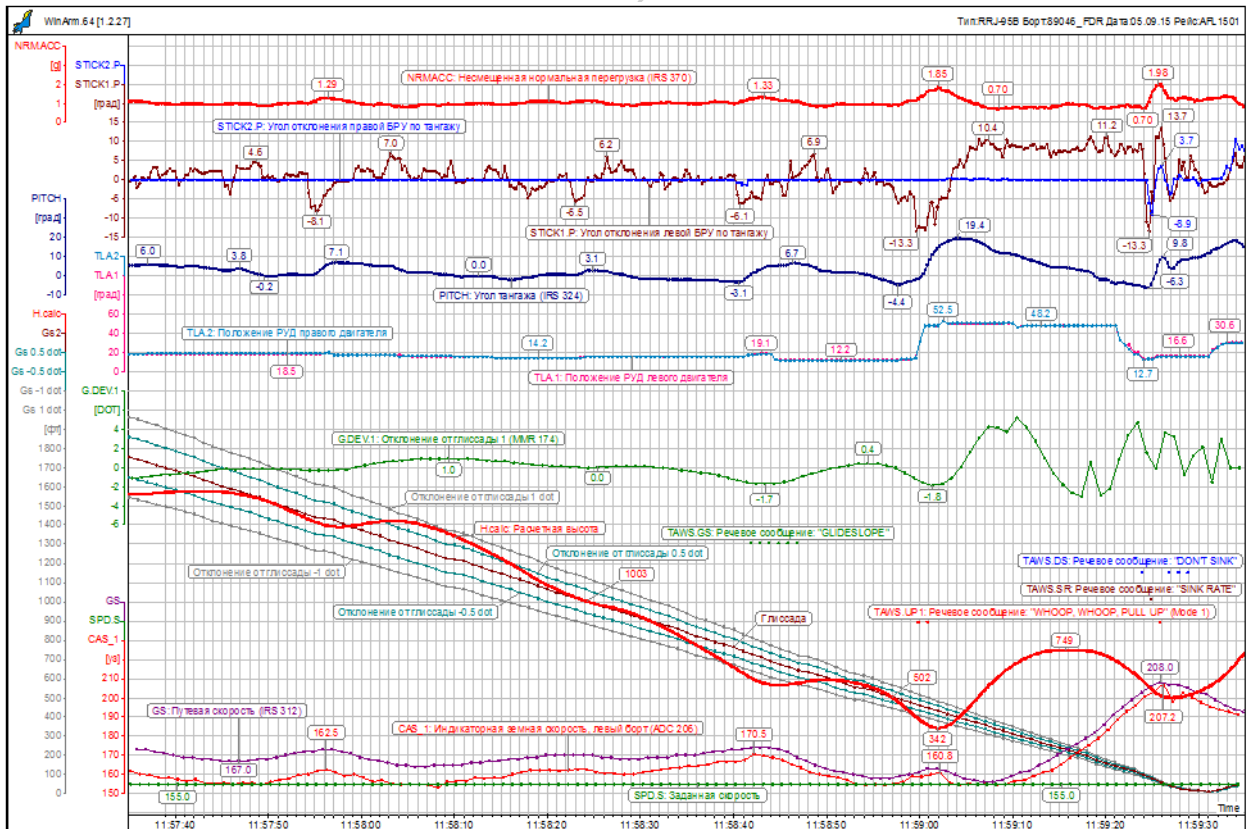
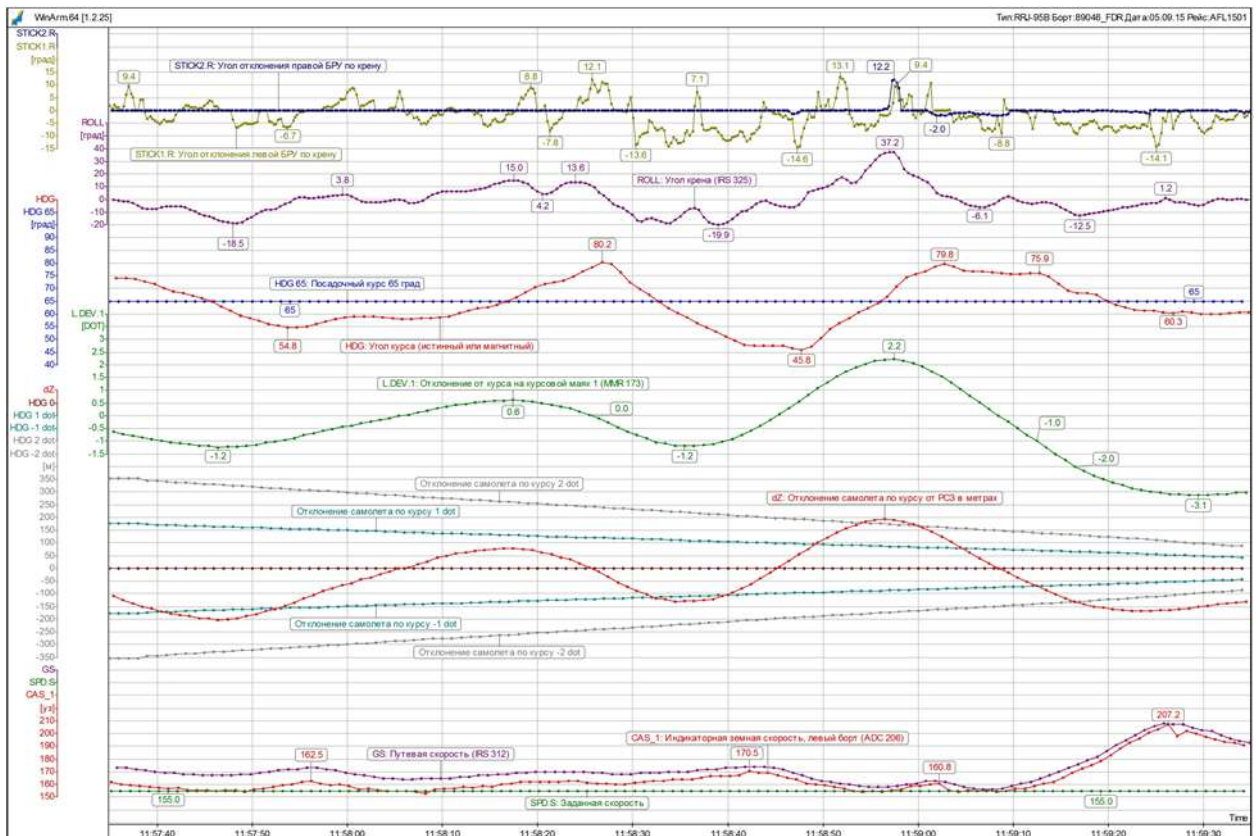
Fig. 77. The RRJ-95 RA-89046 aircraft flight data of 05.09.2015, the first approach, the pitch channel

Fig. 78. The RRJ-95 RA-89046 aircraft flight data of 05.09.2015, the first approach, the lateral channel

The approach was unstabilized. At the altitudes below 1000 ft. the pitch was changing between 4.4° to nose-down and 6.7° to nose-up, the deviations off the glideslope amounted to 1.6 dot down, which at the altitude of about 600 ft. above the RWY threshold resulted in the glideslope warning activation. The crew continued the approach. At the lateral channel the deviations off the extended RWY axis were between 1.2 dot to the left and 2.2 dot to the right, the roll values were close to 20° to the left and 37° to the right. Moreover the dual input was recorded in the roll channel. The go-around was initiated by the crew from the altitude of 380 ft. above the RWY threshold until after the TAWS PULL UP warning activation. In the progress of go-around after the initial climb of about 750 ft. above the RWY threshold there occurred the high-rate descent to the altitude of 500 ft. with the activation of the TAWS DON'T SINK, SINK RATE and PULL UP. Concurrently the dual input in pitch was recorded.

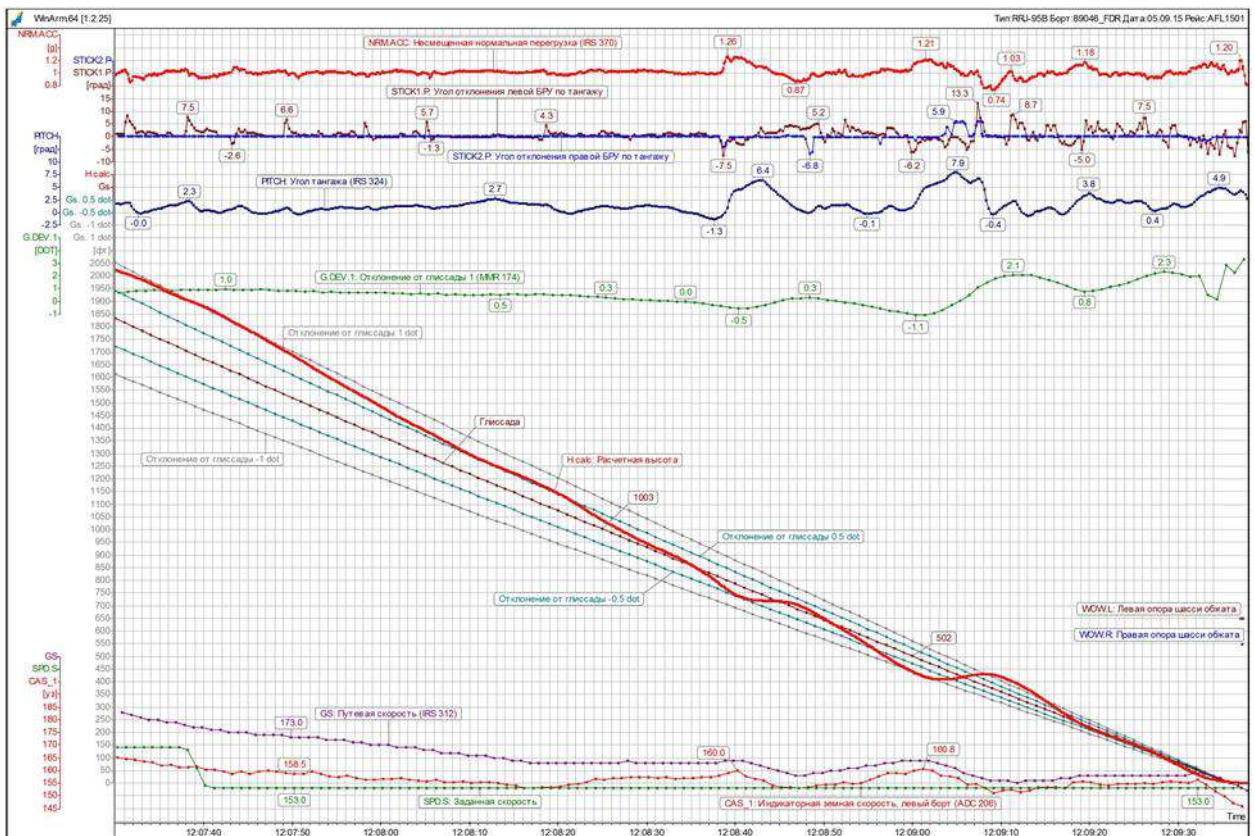
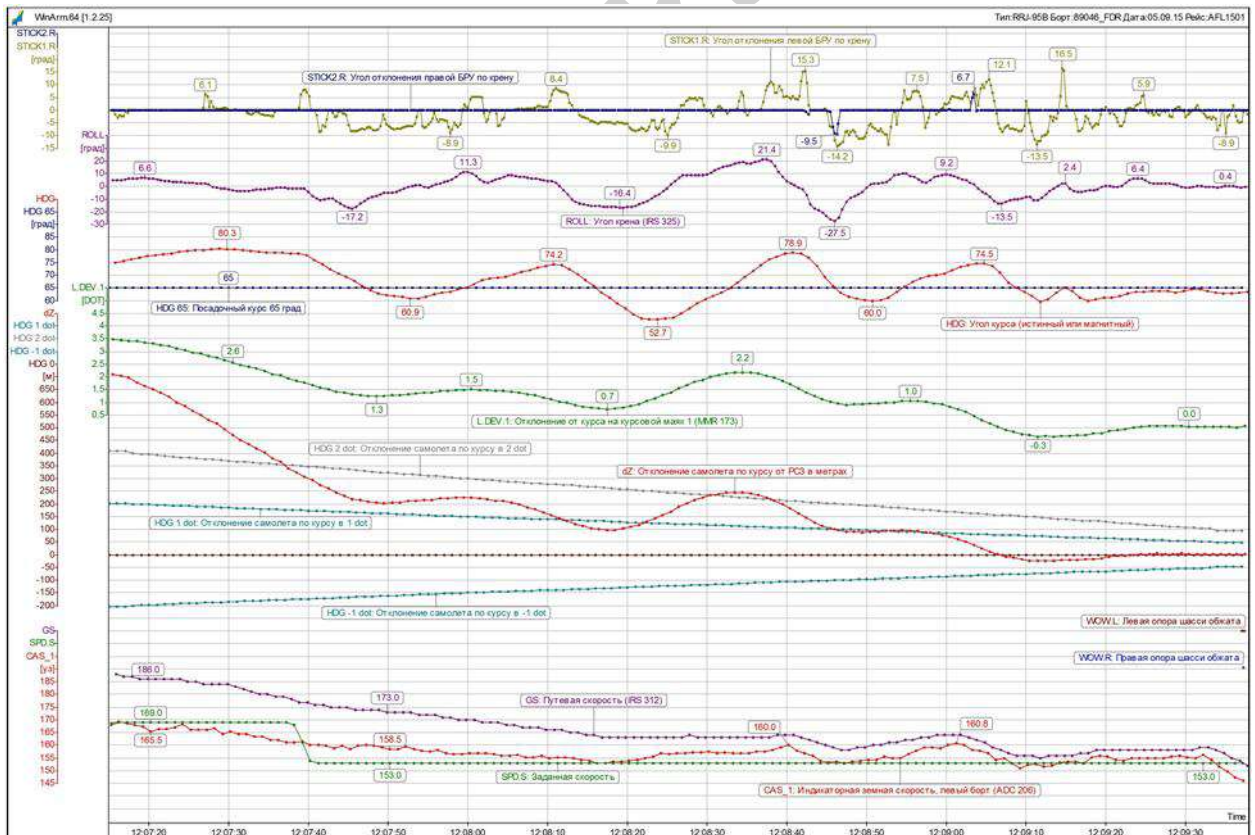
Fig. 79. The RRJ-95 RA-89046 aircraft flight data of 05.09.2015, the second approach, the pitch channel

Fig. 80. The RRJ-95 RA-89046 aircraft flight data of 05.09.2015, the second approach, the lateral channel

The second approach was unstabilized as well. At the altitudes below 1000 ft. the pitch was changing between 1.3° to nose-down and 6.4° to nose-up, the deviations off the glideslope reached

1.1 dot down up to 2.1 dot up. In the lateral channel the deviations off the extended RWY axis amounted to up to 2.2 dot to the right, the roll values approached 27° to the left and 21° to the right. Dual input was recorded in both channels. The deviation at touchdown is outlined here above (see Fig. 69). At that, despite all the above mentioned failures, deviations and peculiarities the air incident(s) had not been declared as to this flight⁷⁵. The investigation team has not been communicated whether the operator had undertaken the internal investigation.

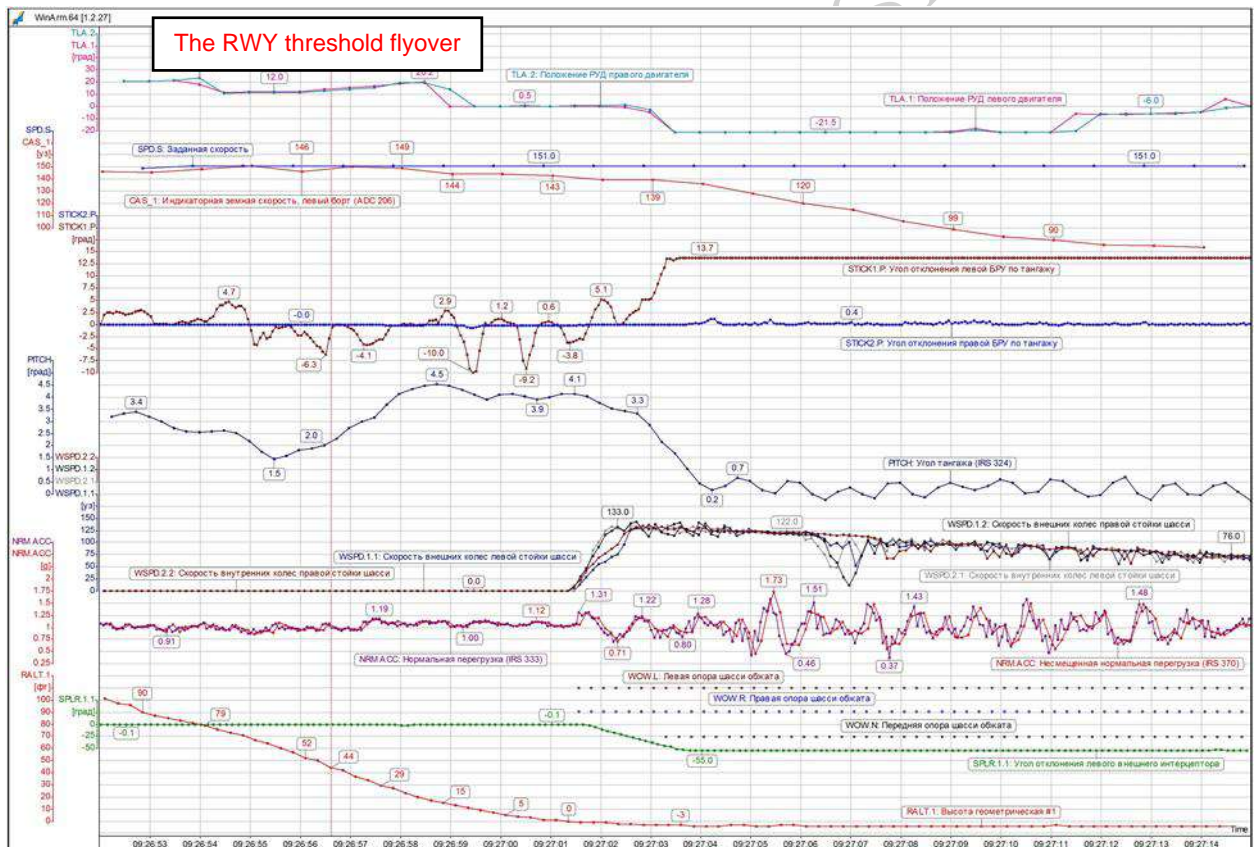
Fig. 81. The flight data at the landing performance by the PIC aboard the RA-89014 aircraft on 27.02.2019

- the oscillatory alternating sidestick inputs, including beyond neutral to nose-down⁷⁶ (Fig. 81 and Fig. 83). Through a number of flights the back sidestick inputs by up to nearly full travel (11°-12°) had been observed;
- the long-term aircraft float above the RWY and the excessively soft touchdown with the MLG wheels spinning, but without the activation of the WOW signals (kiss landing) and automatic speedbrakes deployment. The sidestick input beyond neutral up to the steady WOW to MLG legs (Fig. 82);

However, the full forward sidestick input at the landing roll contributes to the increased load application on the airplane structure (the NLG primarily) and the adverse pitch oscillations (Fig. 81).

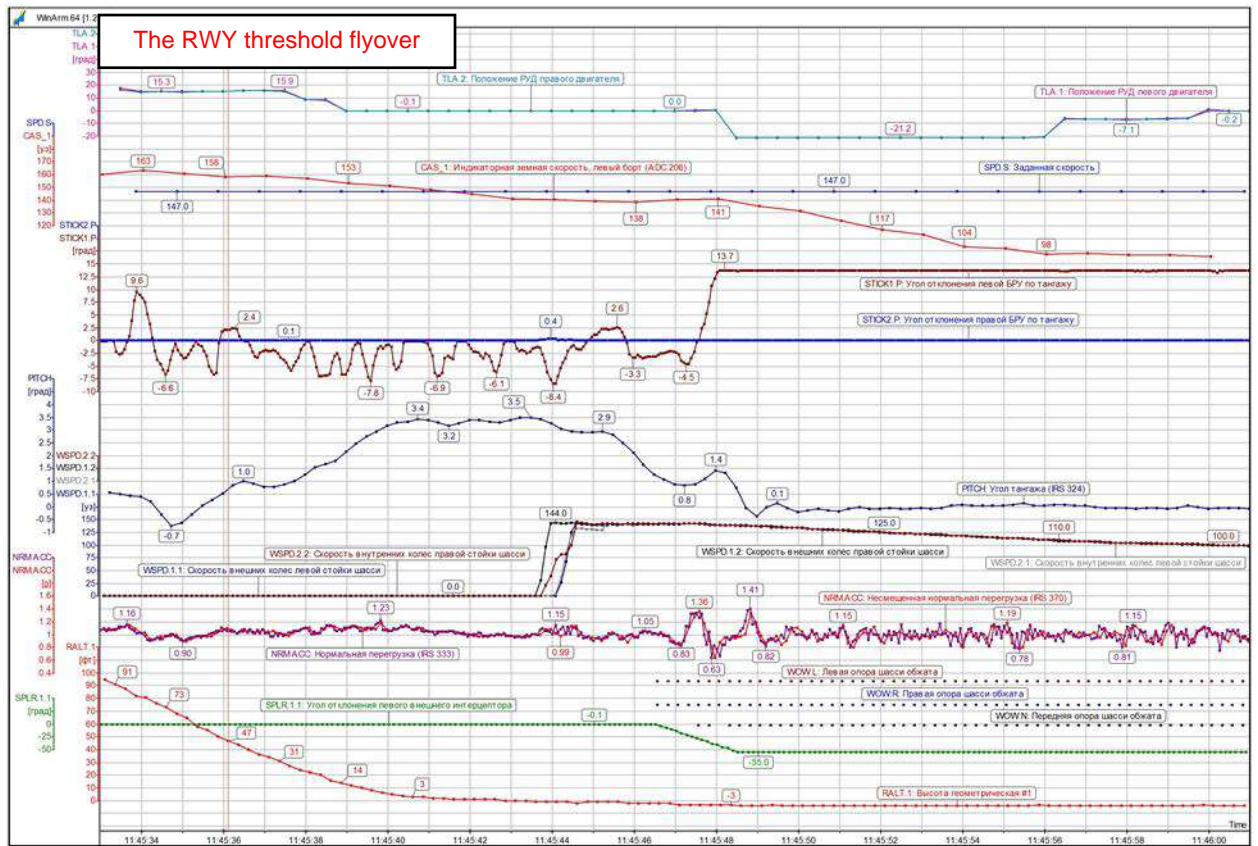
Fig. 82. The flight data at the landing performance by the PIC aboard the RA-89104 aircraft on 01.05.2019

- the pitch dispersion over a wide range at landing (from 2.7° to nose-up up to 7.7° to nose-up) (Fig. 83 and Fig. 84). Into both flights the piloting technique at flare and landing is far from perfect;
- the performance of landing at significant pitch rate to nose-down (the unsettled pitch value) (Fig. 85), the landing without the WOW signal to MLG legs, the virtually simultaneous activation of the WOW signal to all the three LG legs is noted;
- the excessively abrupt NLG lowering with the considerable acceleration, its consecutive separation and the increase of pitch rate are stated (Fig. 82 and Fig. 85).

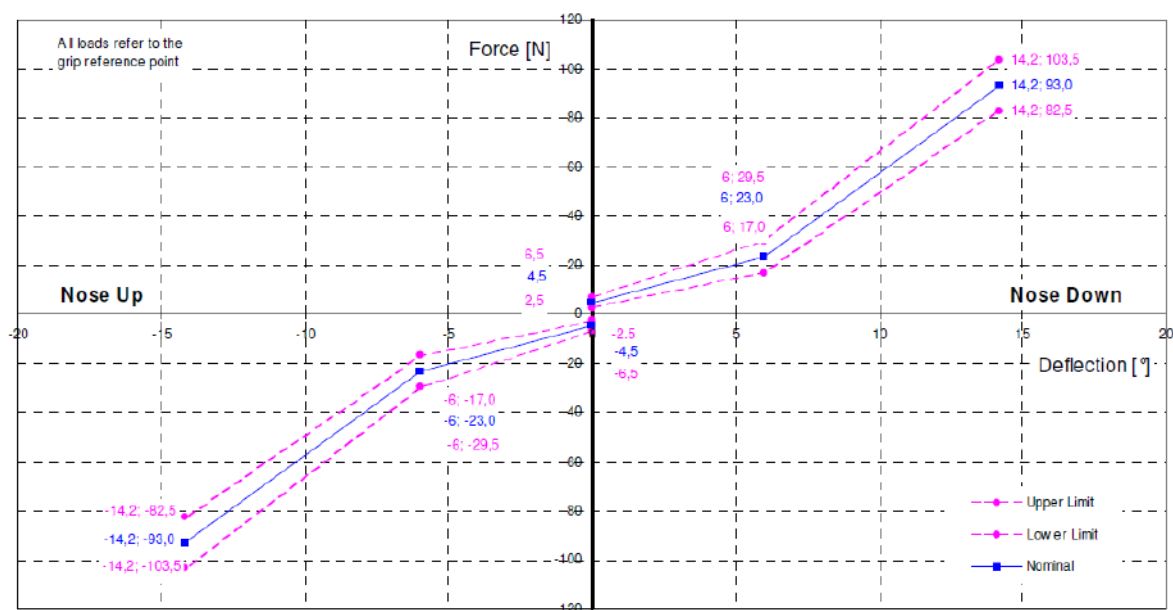
Fig. 86. The sidestick static characteristic in pitch

⁷⁶ As shown on Fig. 86, in the neutral position the sidestick features the «preload tightening», which the pilot is to overcome for the sidestick «breakaway» from neutral. In such a way even the minor sidestick inputs cannot occur «randomly».

The static force characteristic of the sidestick along the pitch axis is within the limits, indicated on Fig. 86.

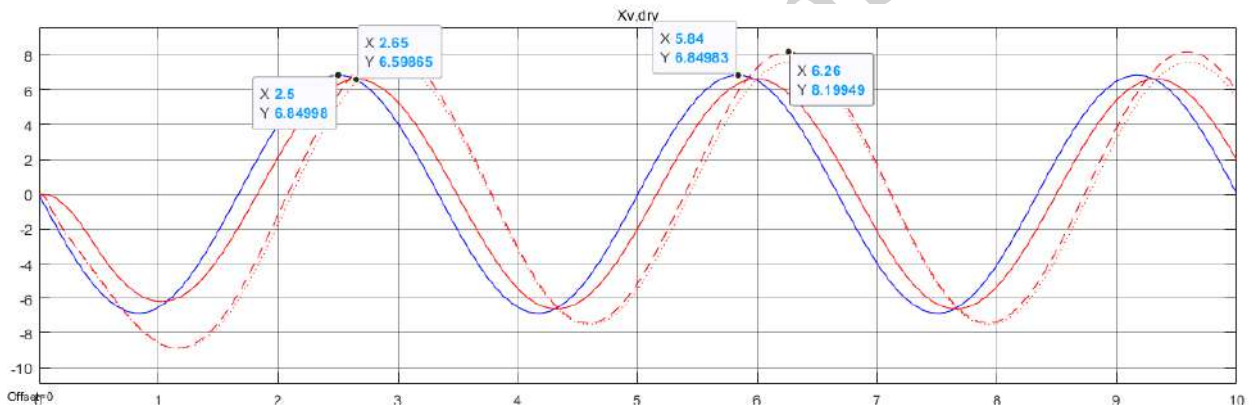
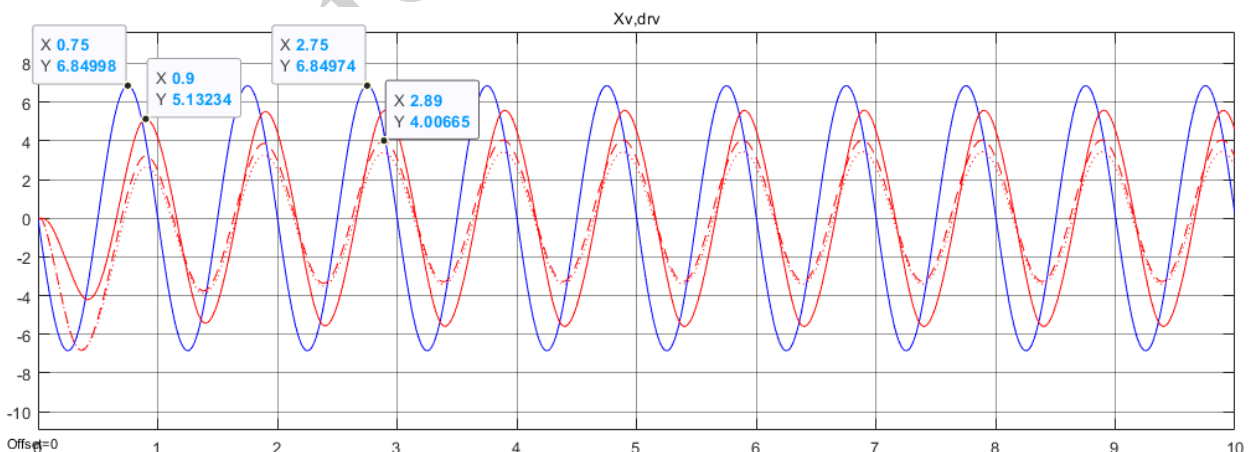
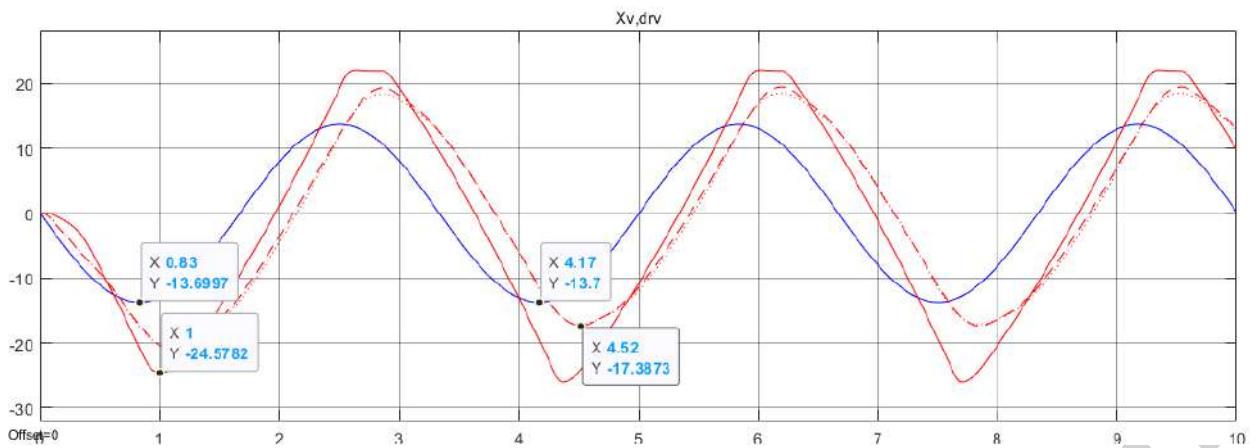
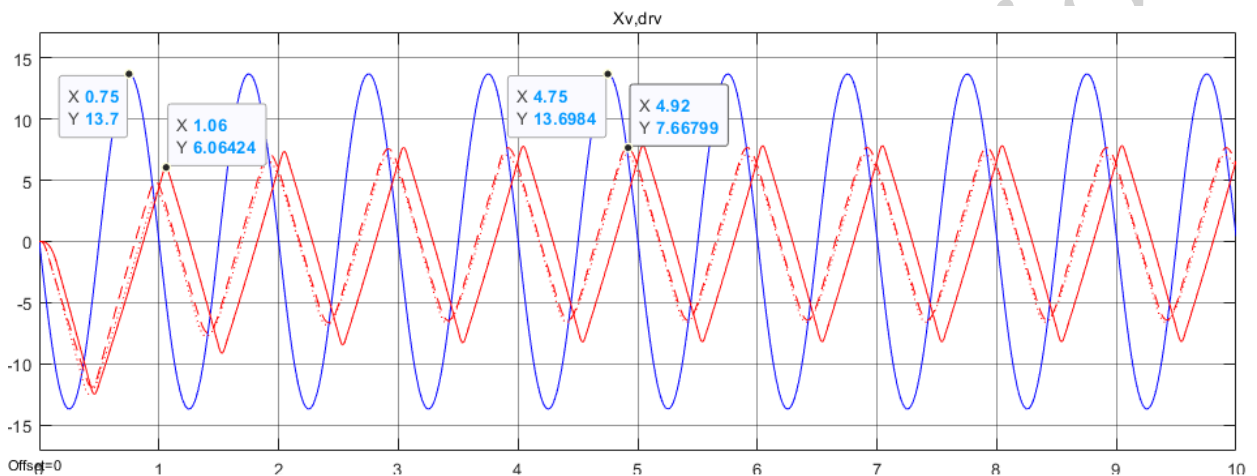
Fig. 87. DM-NM, sidestick=6.85° (50% of travel), frequency 0.3 Hz, $\tau(\text{DM}) \approx 0.15$ sec, $\tau(\text{NM}) \approx 0.42$ sec

Fig. 88. DM-NM, sidestick=6.85° (50% of travel), frequency 1 Hz, $\tau(\text{DM}) \approx 0.15$ sec, $\tau(\text{NM}) \approx 0.14$ sec

Fig. 89. DM-NM, sidestick=13.7° (100% of travel), frequency 0.3 Hz, $\tau(\text{DM}) \approx 0.17$ sec, $\tau(\text{NM}) \approx 0.35$ sec

Fig. 90. DM-NM, sidestick=13.7° (100% of travel), frequency 1 Hz, $\tau(\text{DM}) \approx 0.31$ sec., $\tau(\text{NM}) \approx 0.17$ sec.

The presented plots are the evidence that at the harmonic deflection of the sidestick by 50 % of travel the elevator response equivalent lag in NM or DM is either virtually the same (at the 1 Hz frequency), or the lag is greater in NM (at the 0.3 Hz frequency). At the harmonic deflection of the sidestick by 100 % of travel in NM the lag is greater at the 0.3 Hz frequency and less (by 0.14 sec) at the 1 Hz frequency.

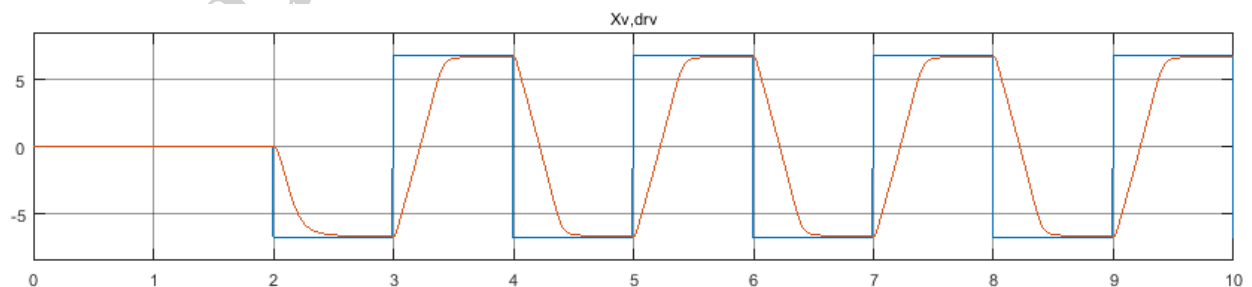
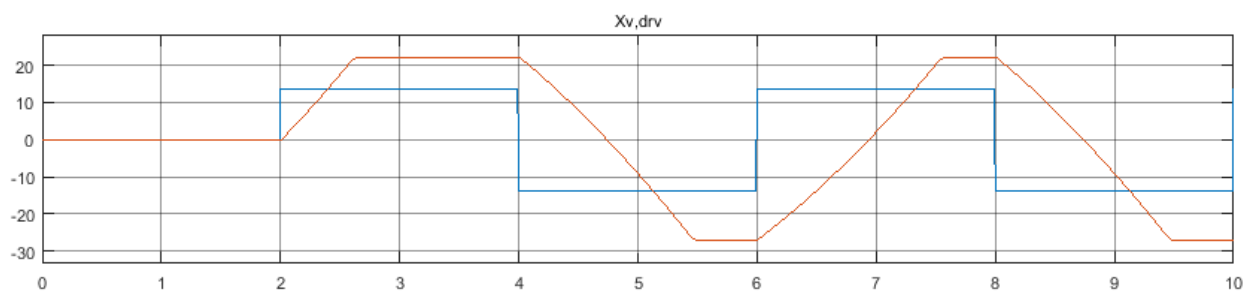
At the step sidestick deflection with its keeping retained the lag time is totally determined by the actuator maximum rate and the more is the amplitude of the input step deflection, the more is the lag time. For instance Fig. 91 and Fig. 92 show the sidestick – elevator path transient responses plots in an open loop for the FBWCS DIRECT MODE (VCAS = 170 kt) at the sidestick input by the half-travel and at the maximum deflection. As for these figures the blue color shows the sidestick deflection in degrees, whereas the red color stands for the elevator response (in degrees as well).

Fig. 91. DM, sidestick=6.8°(50% of travel), $\tau \approx 0.44$ sec

Fig. 92. DM, sidestick=13.7°(100% of travel), $\tau \approx 1.5$ sec.

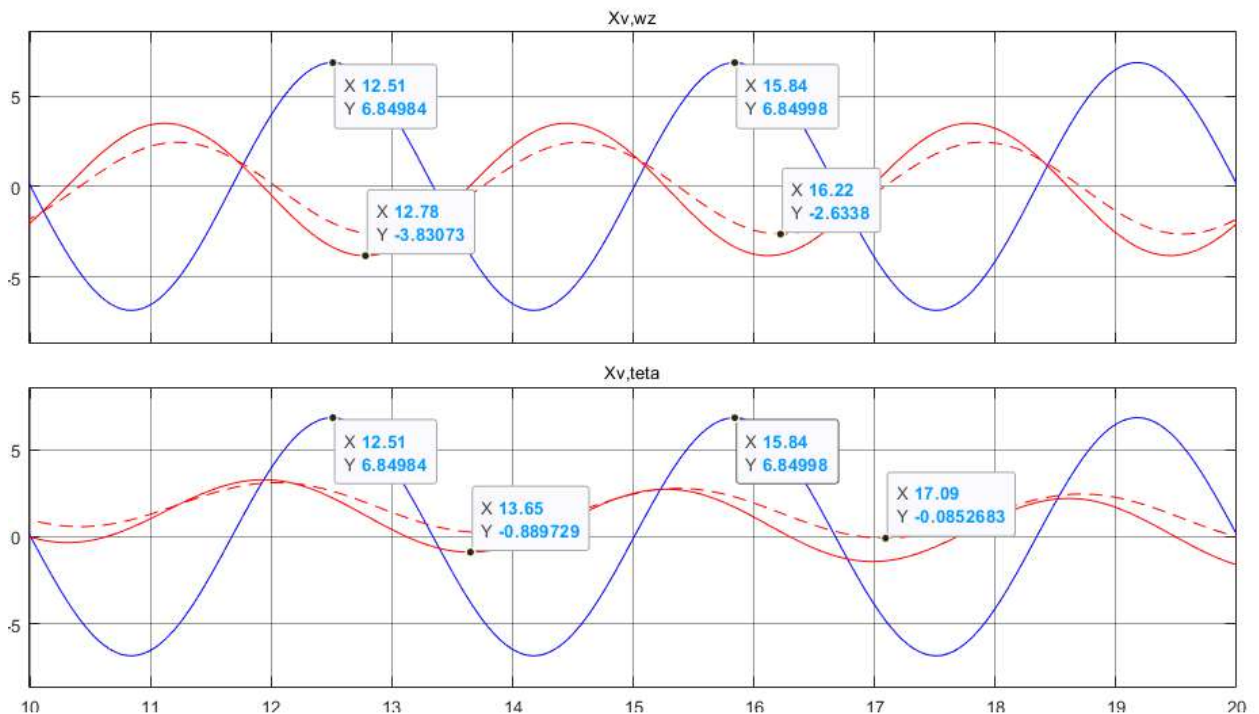
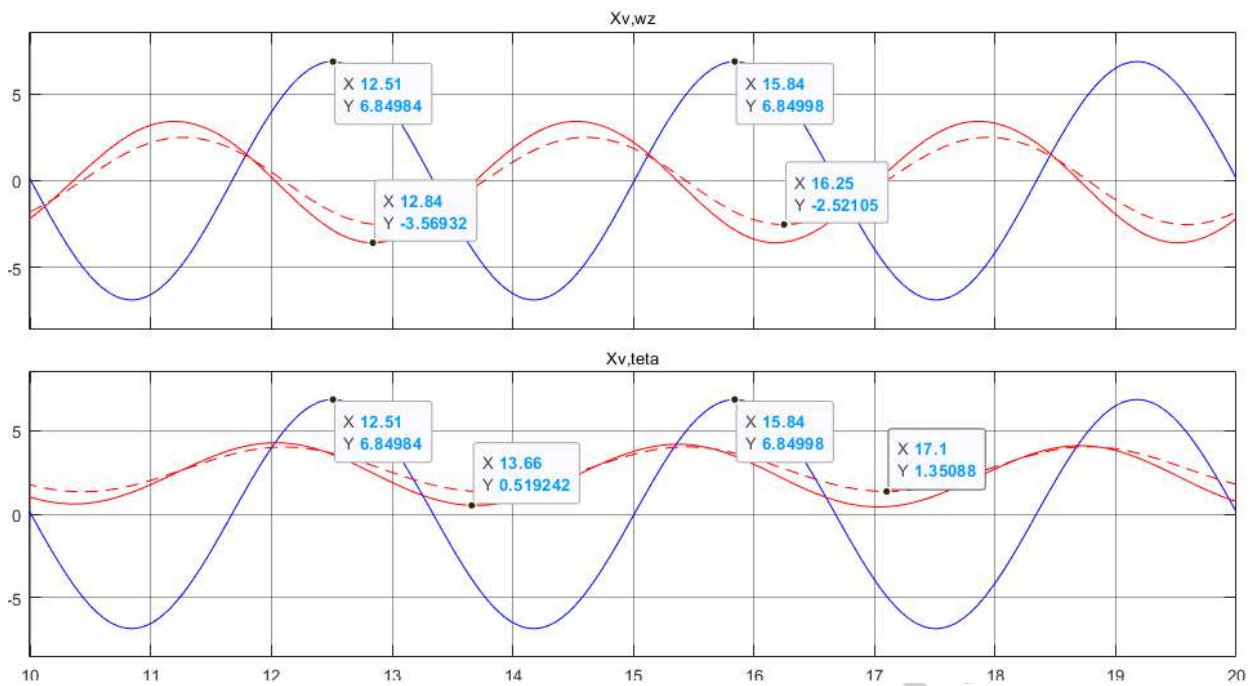
Fig. 93. The angular motion transient responses at the harmonic half-travel sidestick deflection, DM-NM, $H_{AGL} = 9$ ft.

Fig. 94. The angular motion transient responses at the harmonic half-travel sidestick deflection, the DM-NM mode, $H_{AGL} = 60$ ft.

The upper part of each of the figures shows the sidestick – pitch angular rate (« X_v, w_z »). As for DIRECT MODE the lag is equal to ~ 0.3 sec, for NORMAL MODE is of ~ 0.4 sec. The magnitude of the lag is largely independent of the altitude of flight.

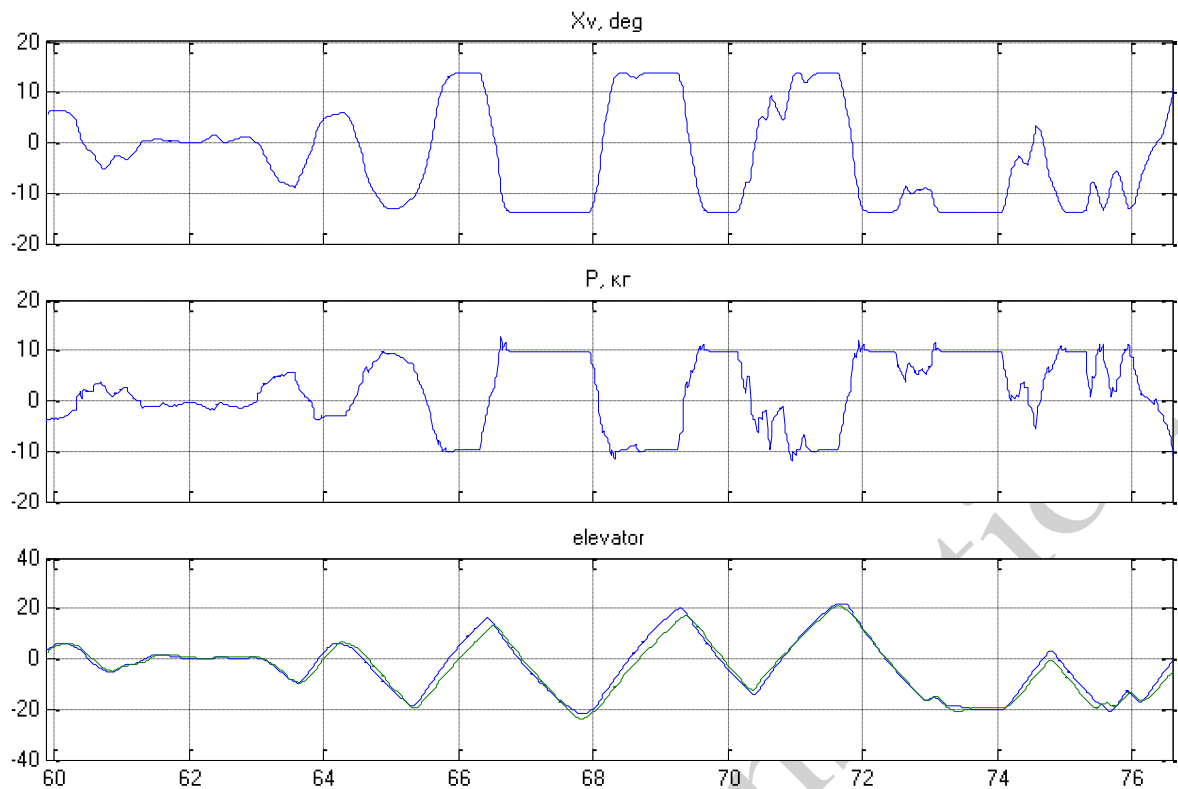
Fig. 95. The parameters of the sidestick-elevator path of the RRJ-95B RA-89098 aircraft at the landing on May 05, 2019⁸¹

Fig. 95 presents the results of the simulation of the sidestick – elevator path at the landing into the RRJ-95B aircraft flight that ended up with the accident on May 05, 2019 taking into account the dynamics of the aircraft motion.

The given plots show the satisfactory convergence of the results of the simulation with the FDR record, including the region of the first bounce as well. The obtained degree of convergence allows concluding that this model can be used to study the effect of the flight conditions change against the landing leg.

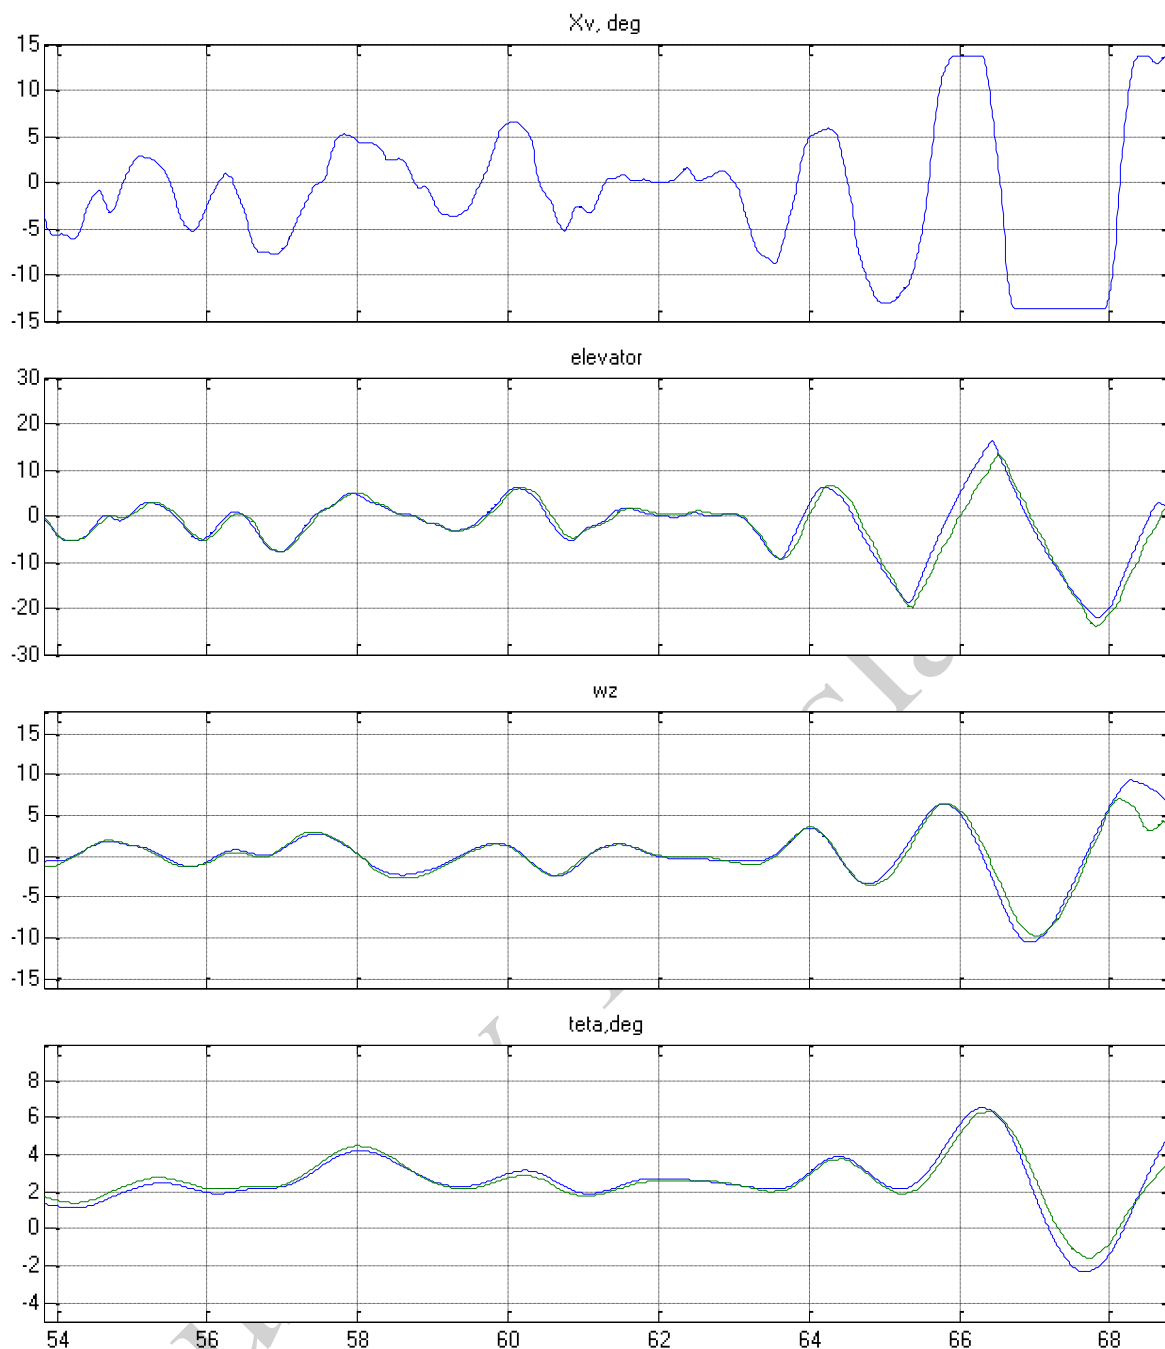
Fig. 96. The results of the simulation of the RRJ-95B RA-89098 aircraft pitch motion at the landing on May 05, 2019

Fig. 96 presents the results of the simulation of the sidestick – pitch attitude path angular motion into the RRJ-95B RA-89098 flight environment.

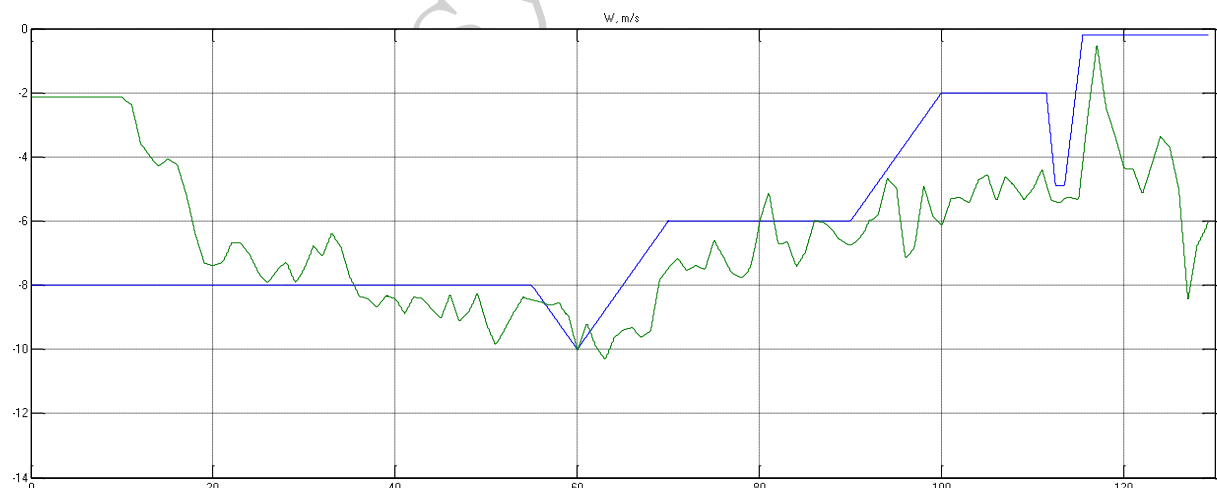
Fig. 97. The comparison of the estimated and recorded horizontal wind component

Fig. 97 demonstrates the results of the simulation, the blue curve represents the estimation of the horizontal wind velocity (in m/sec.), established by the simulation according to the method, described here above, the green curve is for the estimation of the same value as per the FDR record. As for the plot the accepted sign convention is of «-» for headwind, «+» for tailwind.

The estimation of the wind velocity is the evidence that into the flight under consideration it had been the effect of the headwind component that may be split in several spots:

2. from the altitude of 217 m (Trel = 55 sec.) to the altitude of 162 m (Trel = 70 sec), a spot was observed where the velocity of the headwind component first (in 5 sec) increased up to 10 m/s, and then (within 10 sec.) decreased down to 6 m/s;

5. from the altitude of 8 m (Trel = 111.5 sec.) the wind microburst was observed, in which the headwind component first, within 1 second, sharply increased to ~ 5 m/s (Trel = 112.5 sec), and then, from the point of time of Trel = 113.5 sec., in 2 seconds it decreased to almost zero.
