INTERSTATE AVIATION COMMITTEE

FINAL REPORT

ON THE RESULTS OF THE AIR ACCIDENT INVESTIGATION

Type of occurrence	Fatal accident
Type of aircraft	RRJ-95 (RRJ-95B model) airplane
Nationality and registration marks	RA-89098
Owner	VEB Leasing, JSC
Operator	Aeroflot, PJSC
Aviation authority	FATA
Place of occurrence	Sheremetyevo aerodrome, Moscow region, Russian Federation; reference position: 55°58'06.20" N, 37°24'07.20" E
Date and time	May 05, 2019, 18:30 local time (15:30 UTC), daytime

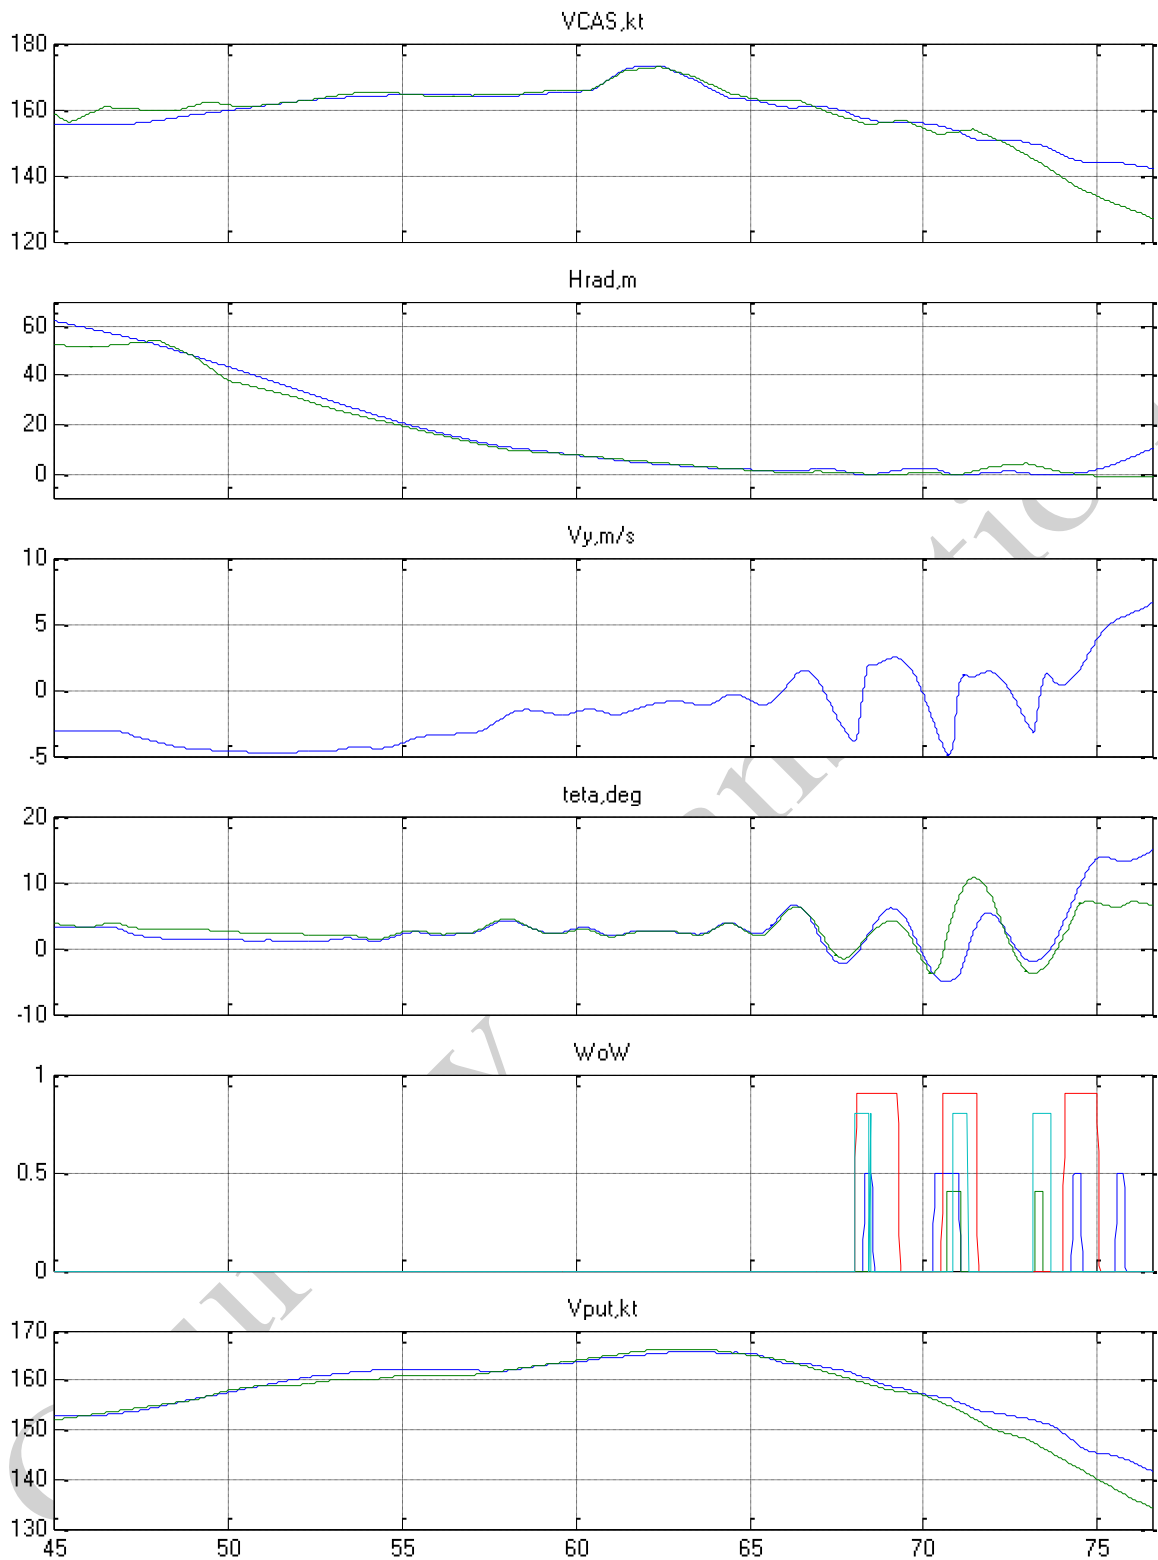
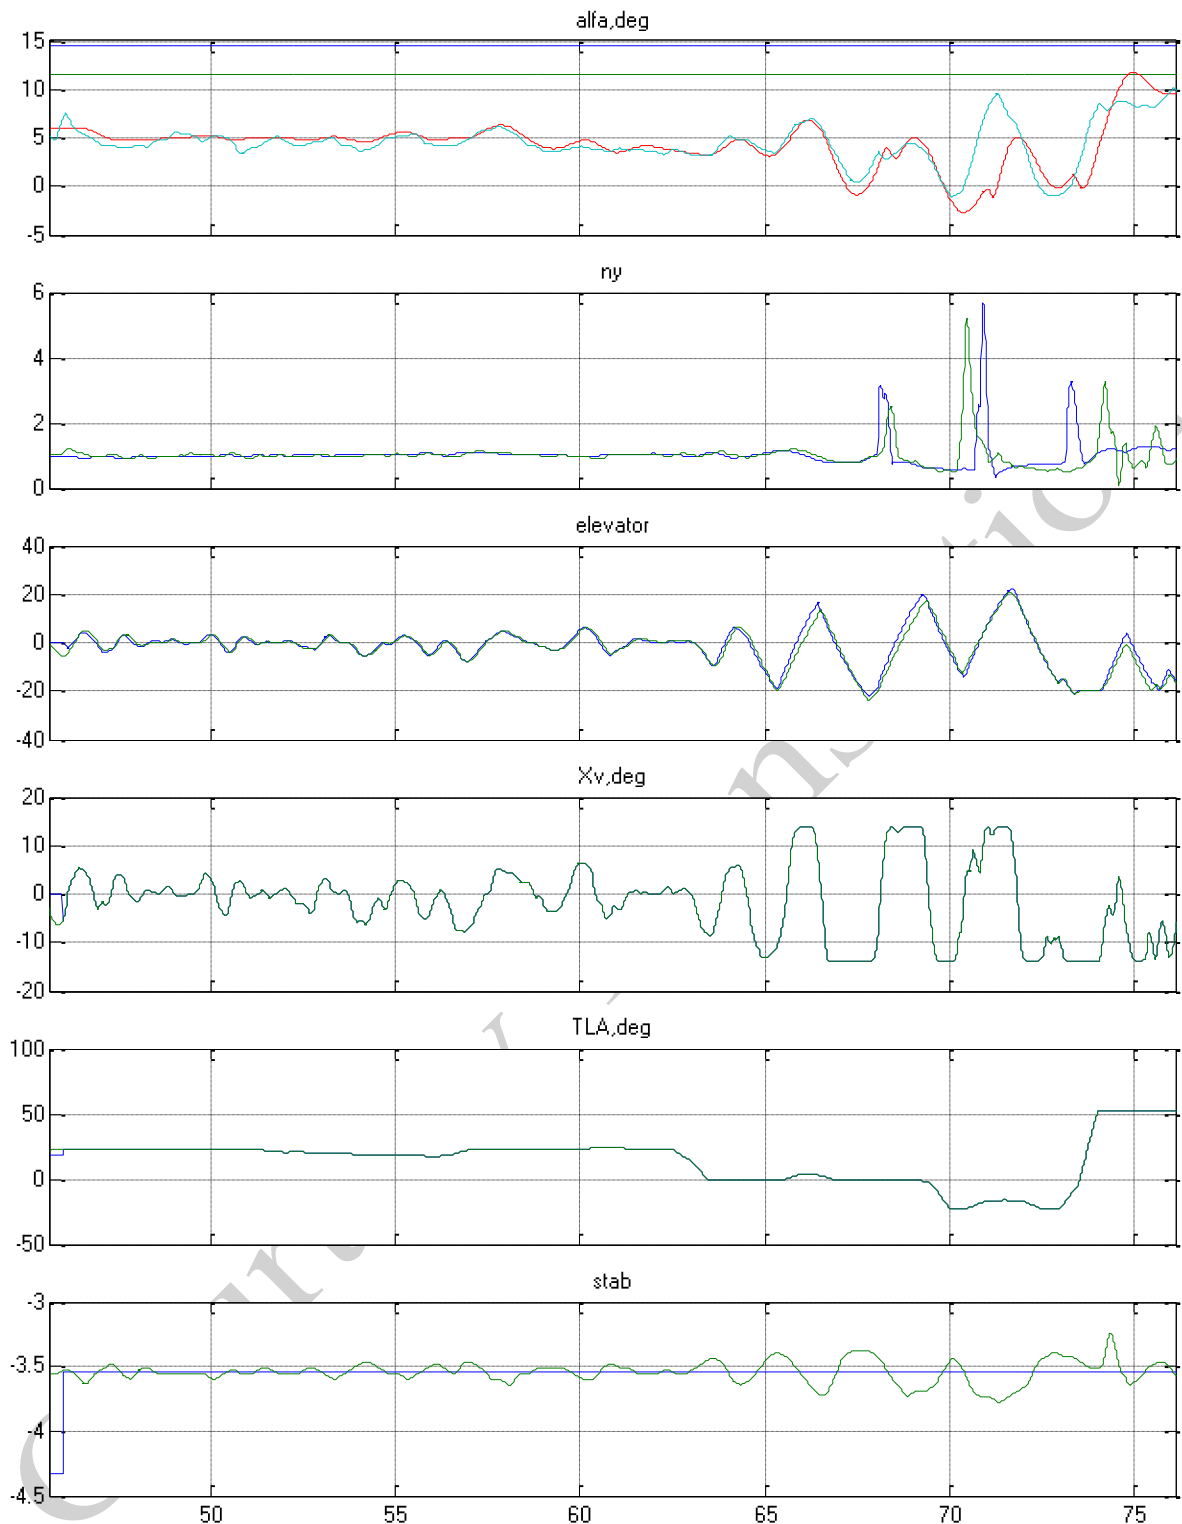
Fig. 98. The comparison of the flight data records and the results of the simulation. The flight path parameters

Fig. 99. The comparison of the flight data records and the results of the simulation. The control parameters

The given plots show the satisfactory convergence of the results of the simulation with the FDR record, including the region of the first bounce as well. The obtained degree of convergence allows concluding that this model can be used to study the effect of the flight conditions change against the landing leg.

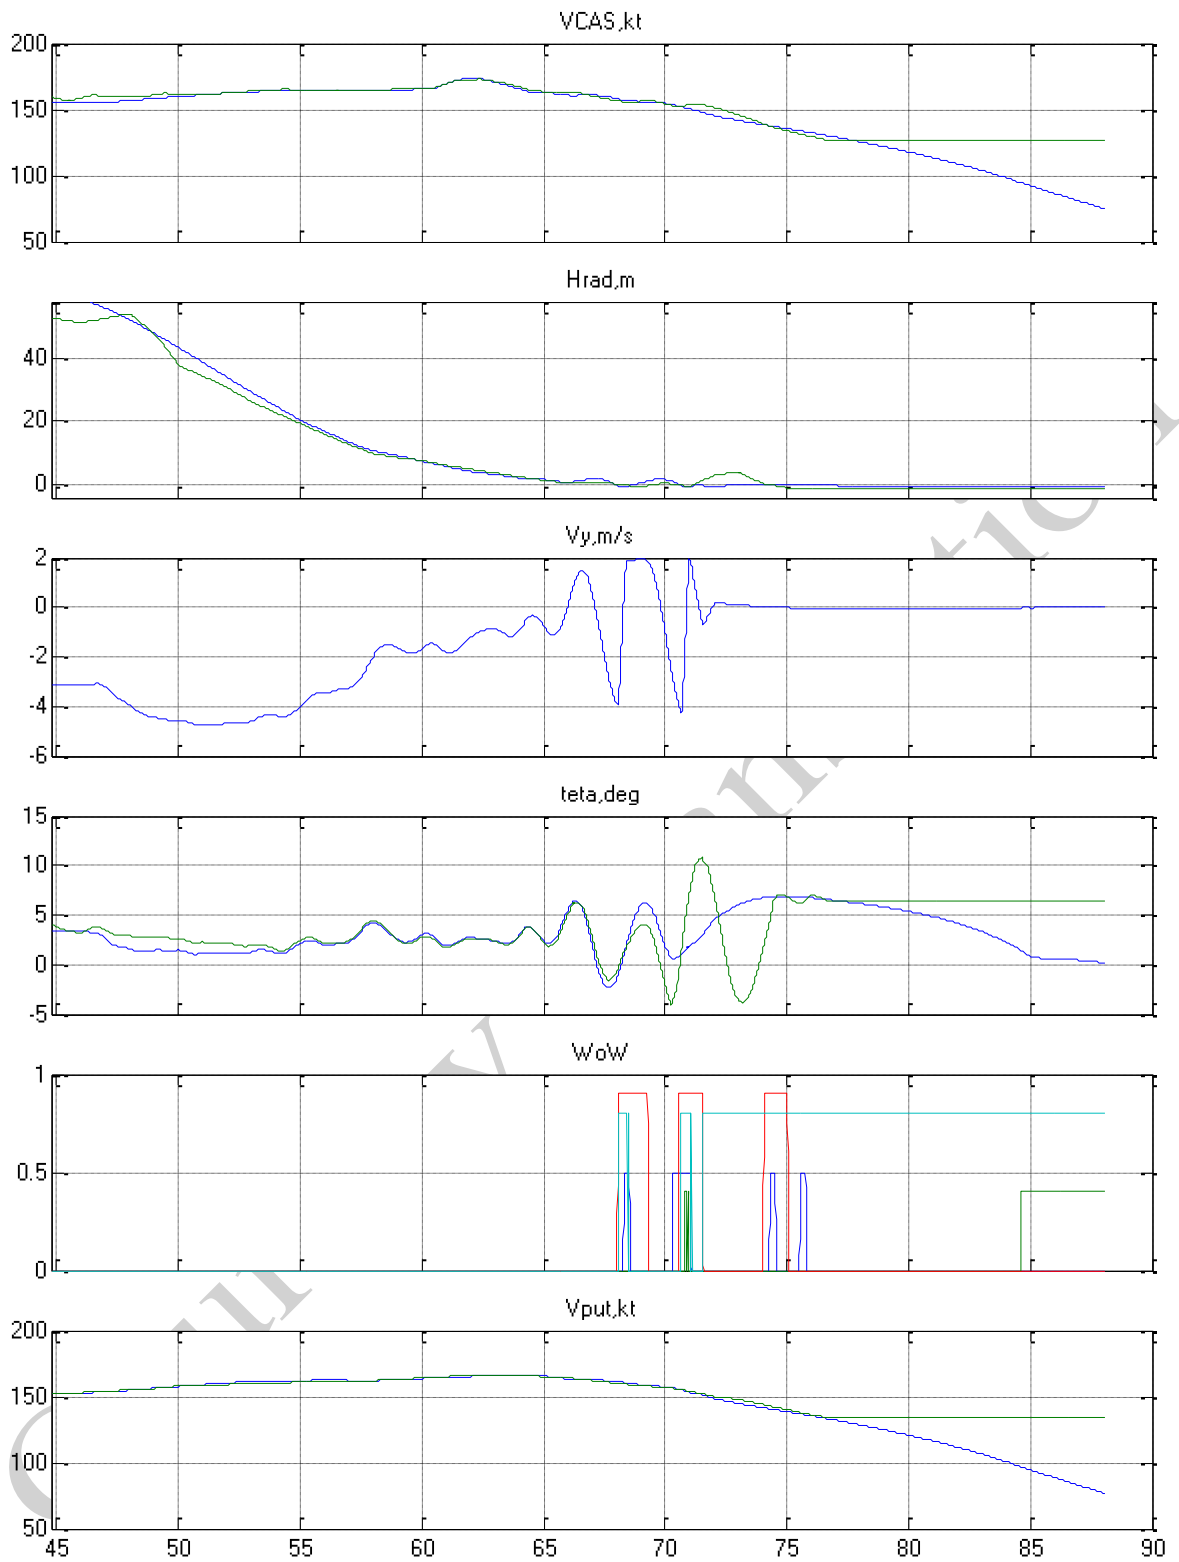
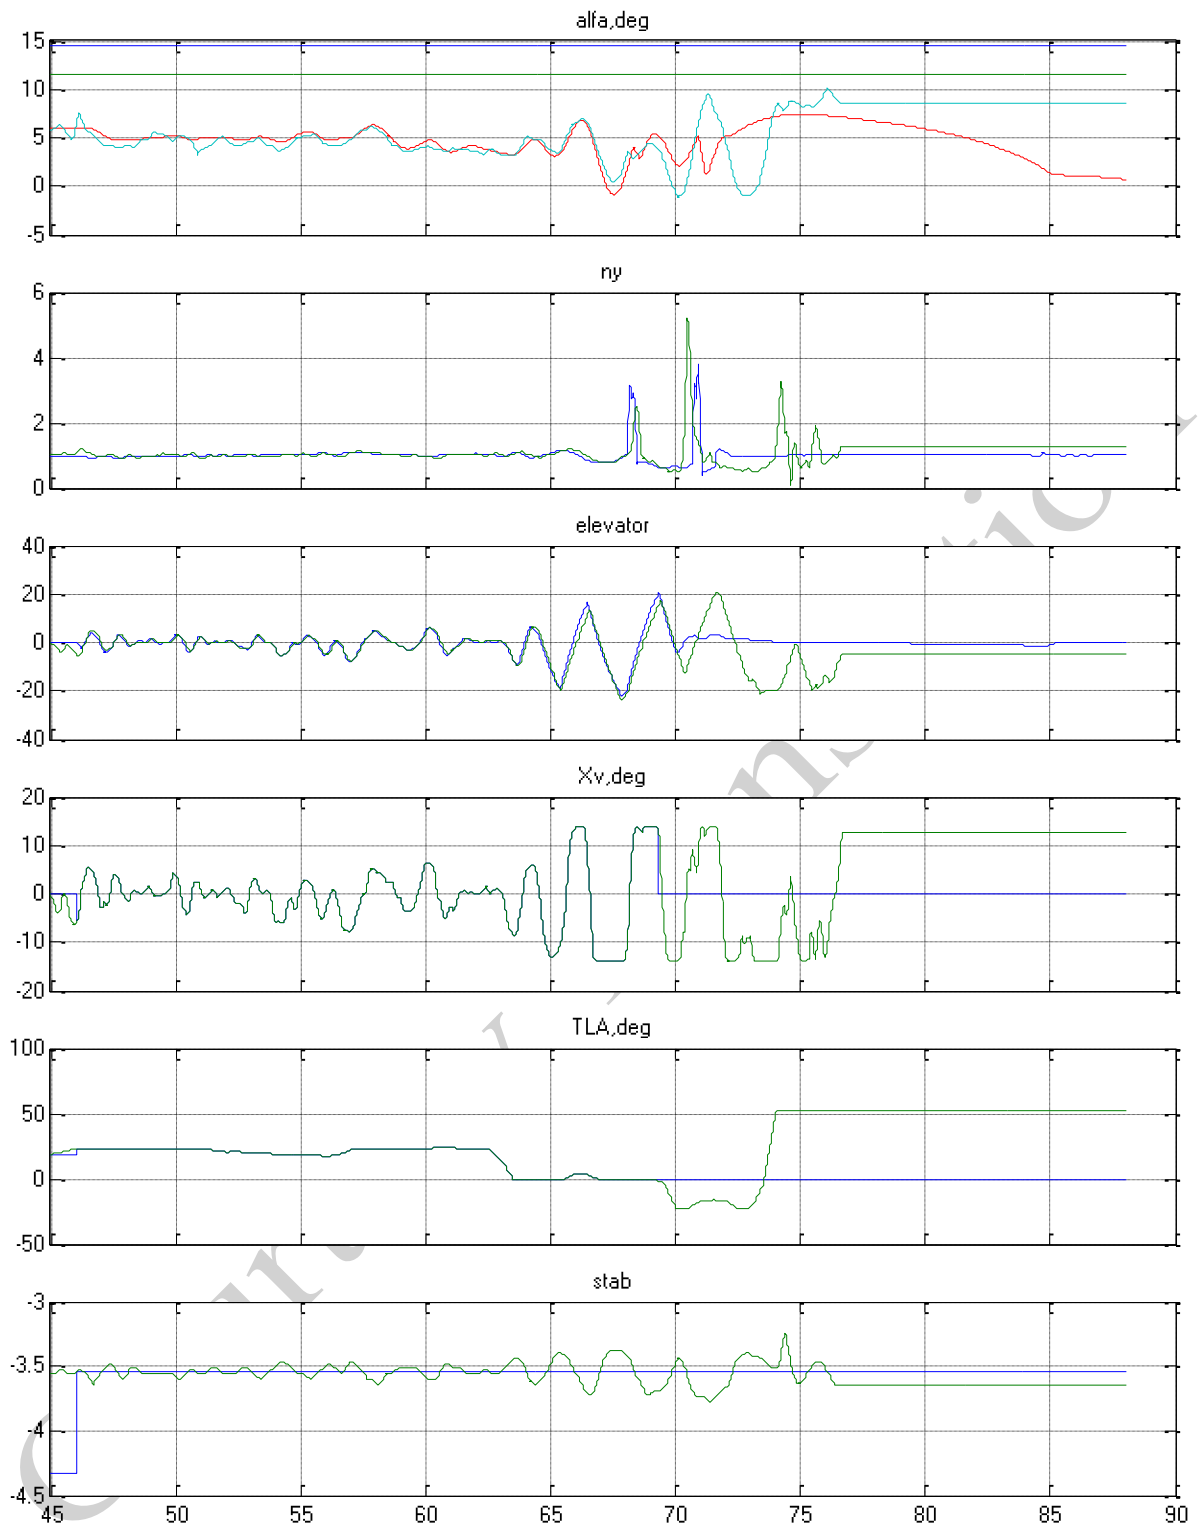
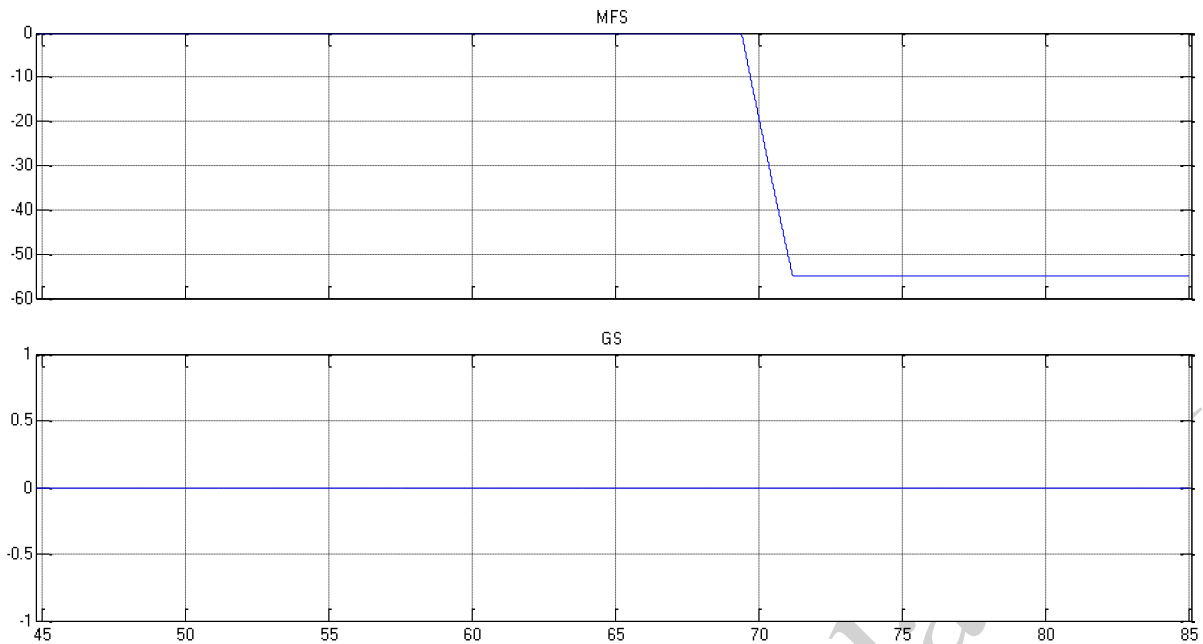
Fig. 100 - Fig. 102 present the results of the simulation. The color coding convention is the same as for the Figures above.

Fig. 100. The flight path parameters

Fig. 101. The control parameters

Fig. 102. The spoilers' operational mode

The analysis of the results is the evidence that the deployment of the spoilers after the first touchdown, while preserving the established way of piloting (prior to the point of the sidestick positioning to neutral at the simulation) does not lead to the elimination of another bounce of the aircraft off the RWY. However, because of the high nose-up moment out of the spoilers deployment, despite keeping the sidestick in the forward position into the first bounce, a significantly lower pitch rate to nose-down is evolved at the aircraft that allows preventing another touchdown with the NLG, coming first. Through this the maximum G that is generated at the second touchdown is significantly decreased (down to $\approx 3.8G$ instead of $\approx 5.85G$) with no occurrence of another bounce.

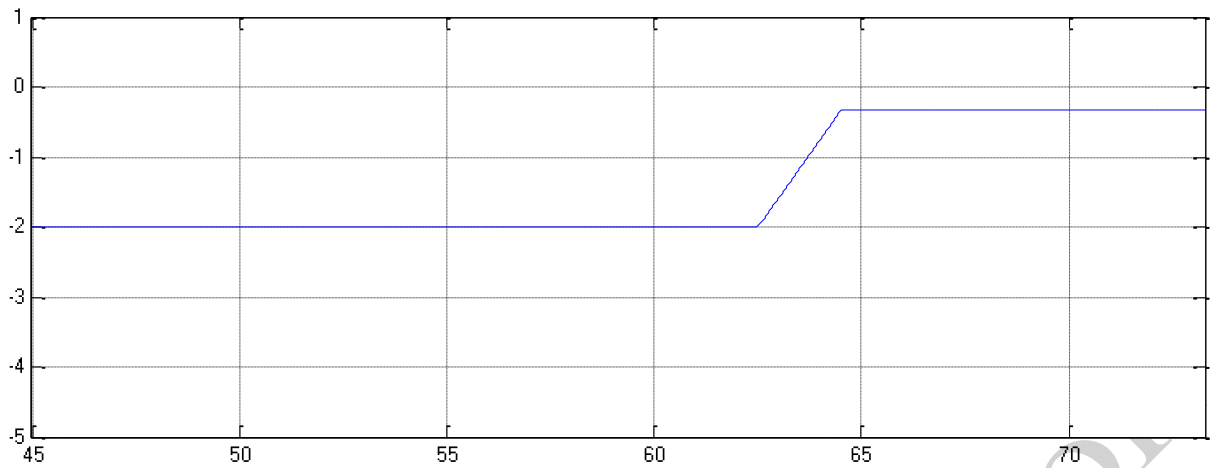
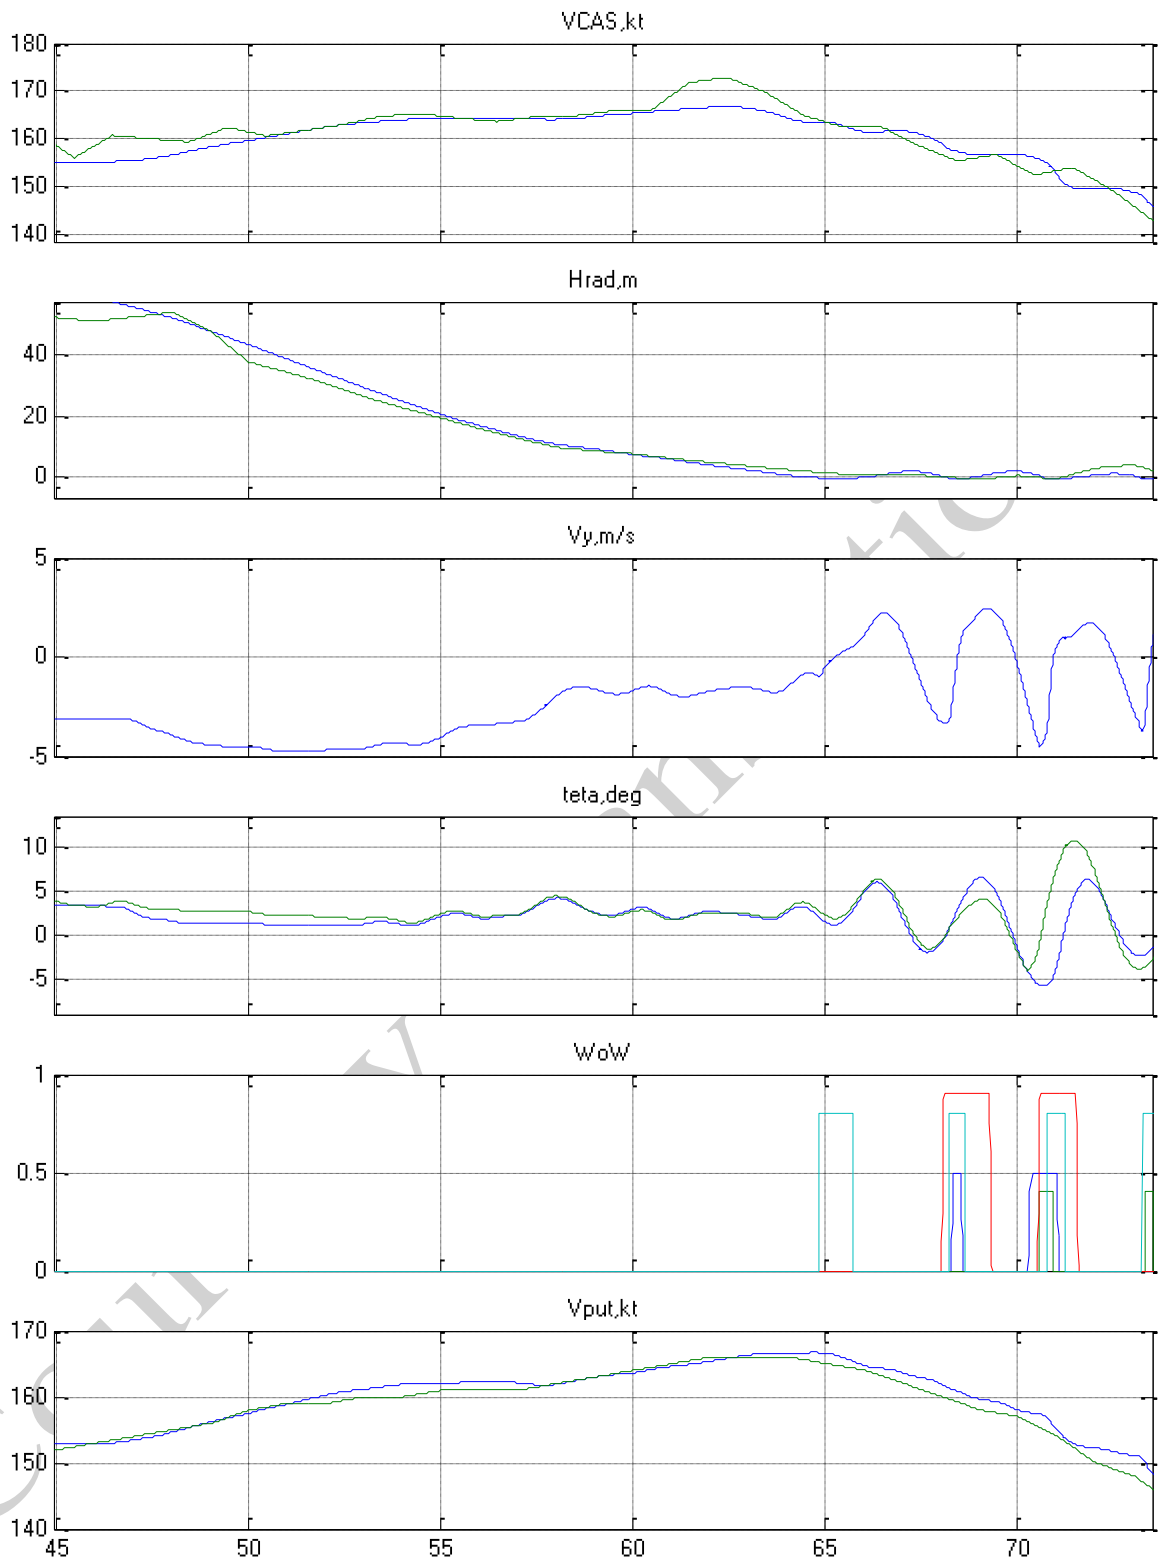
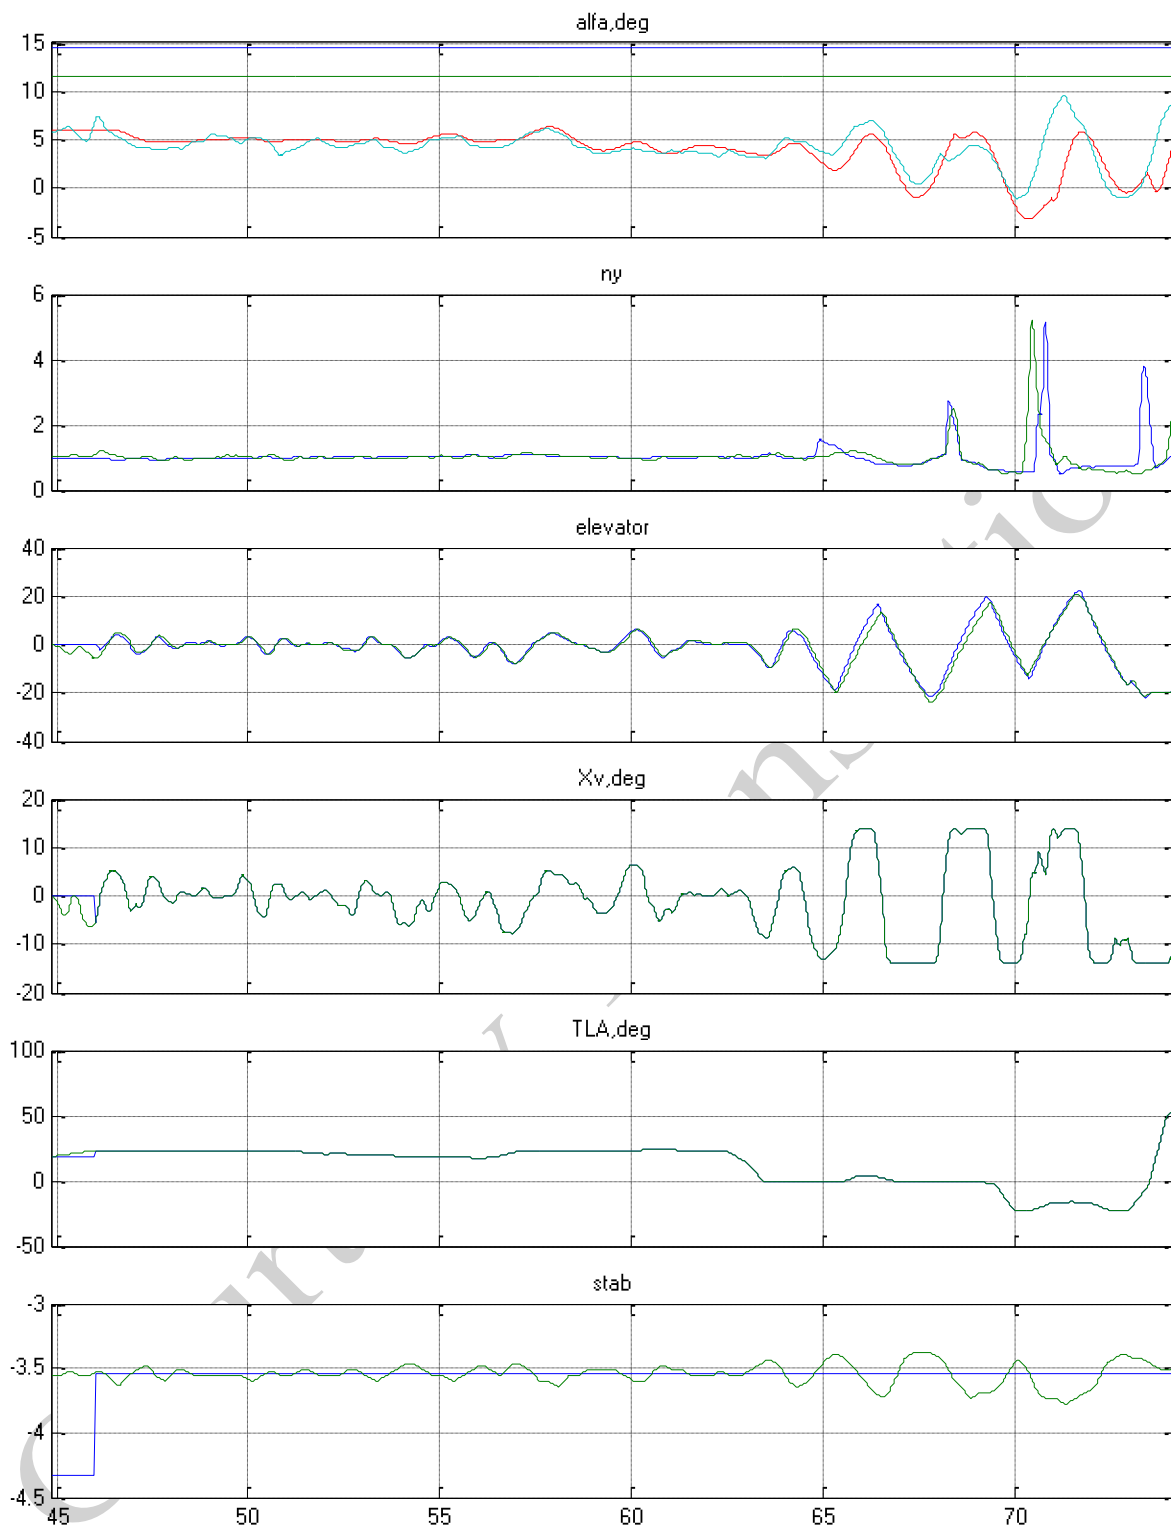
The primary issue of this subsection is to evaluate the impact on the aircraft landing dynamics of the detected wind microburst. Fig. 103 shows the dependence of the wind velocity over time for the simulation of this task.

Fig. 103. The wind velocity at no burst, m/s

Fig. 104. Flight path parameters

Fig. 105. Control parameters

The analysis of the results is the evidence that at no microburst results in the further touchdown with a slight positive pitch attitude at 3 sec. before the «first» touchdown, recorded by the FDR. The touchdown occurs at low vertical speed, while preserving the way of the sidestick control, is accompanied with the instant aircraft separation, at that the further dynamics of the airplane motion is no different from this, recorded by the FDR.

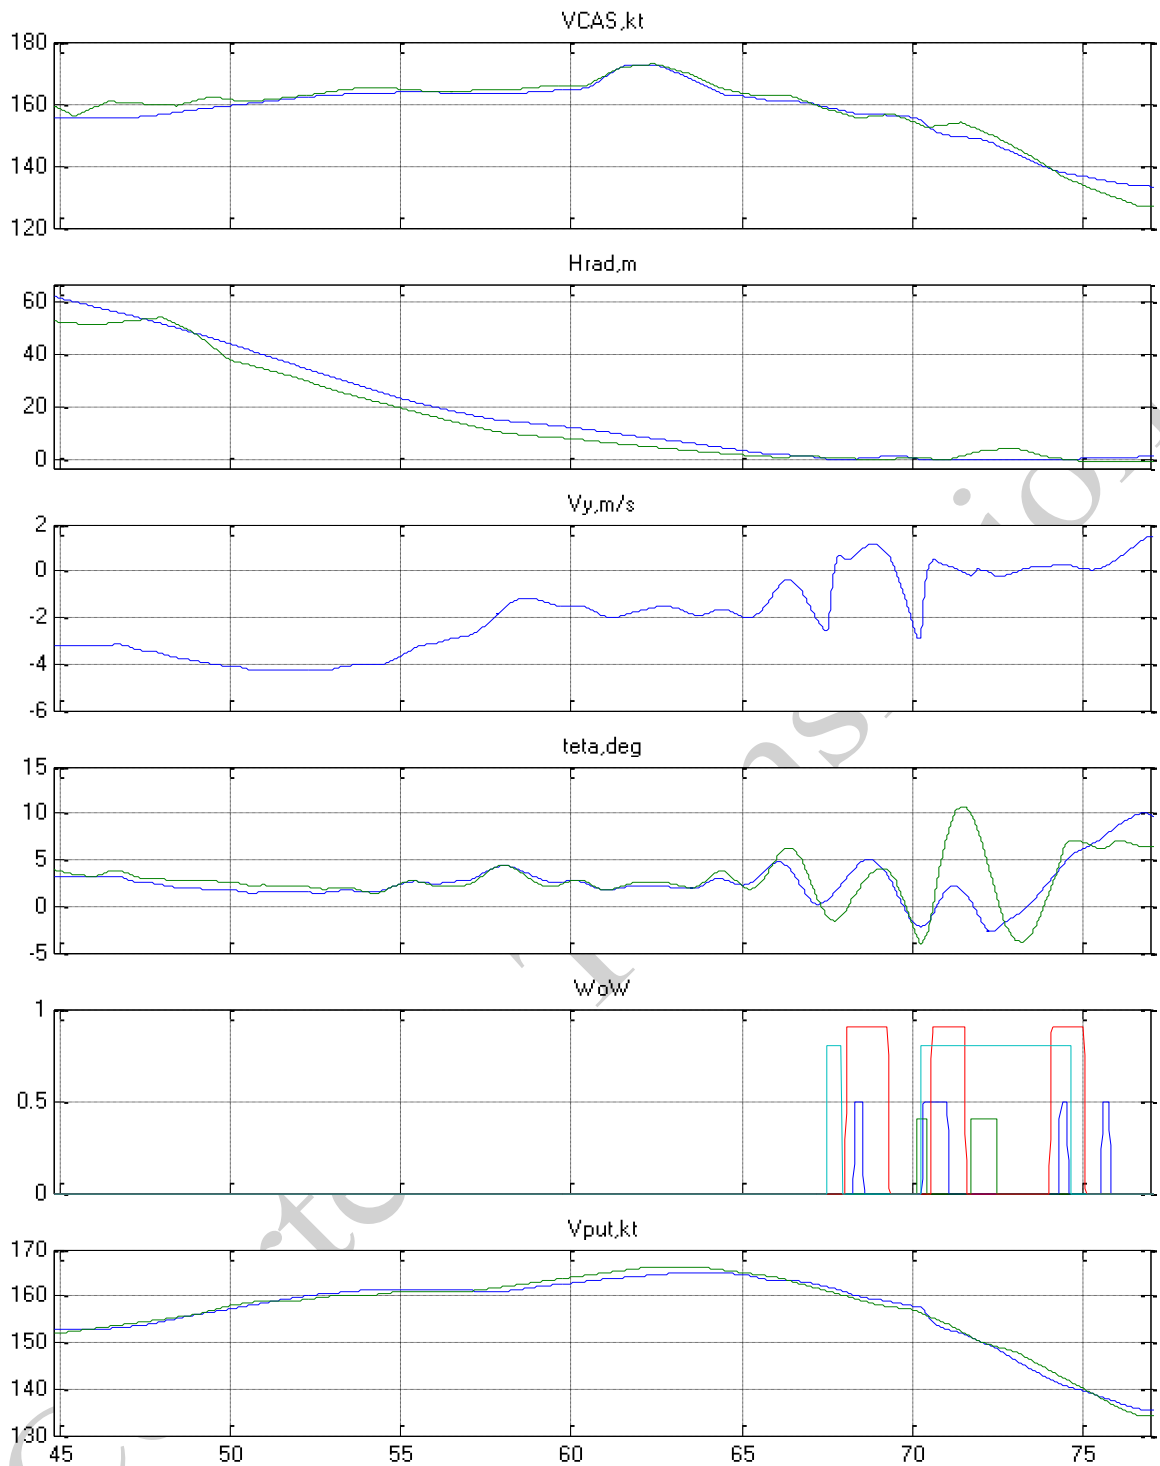
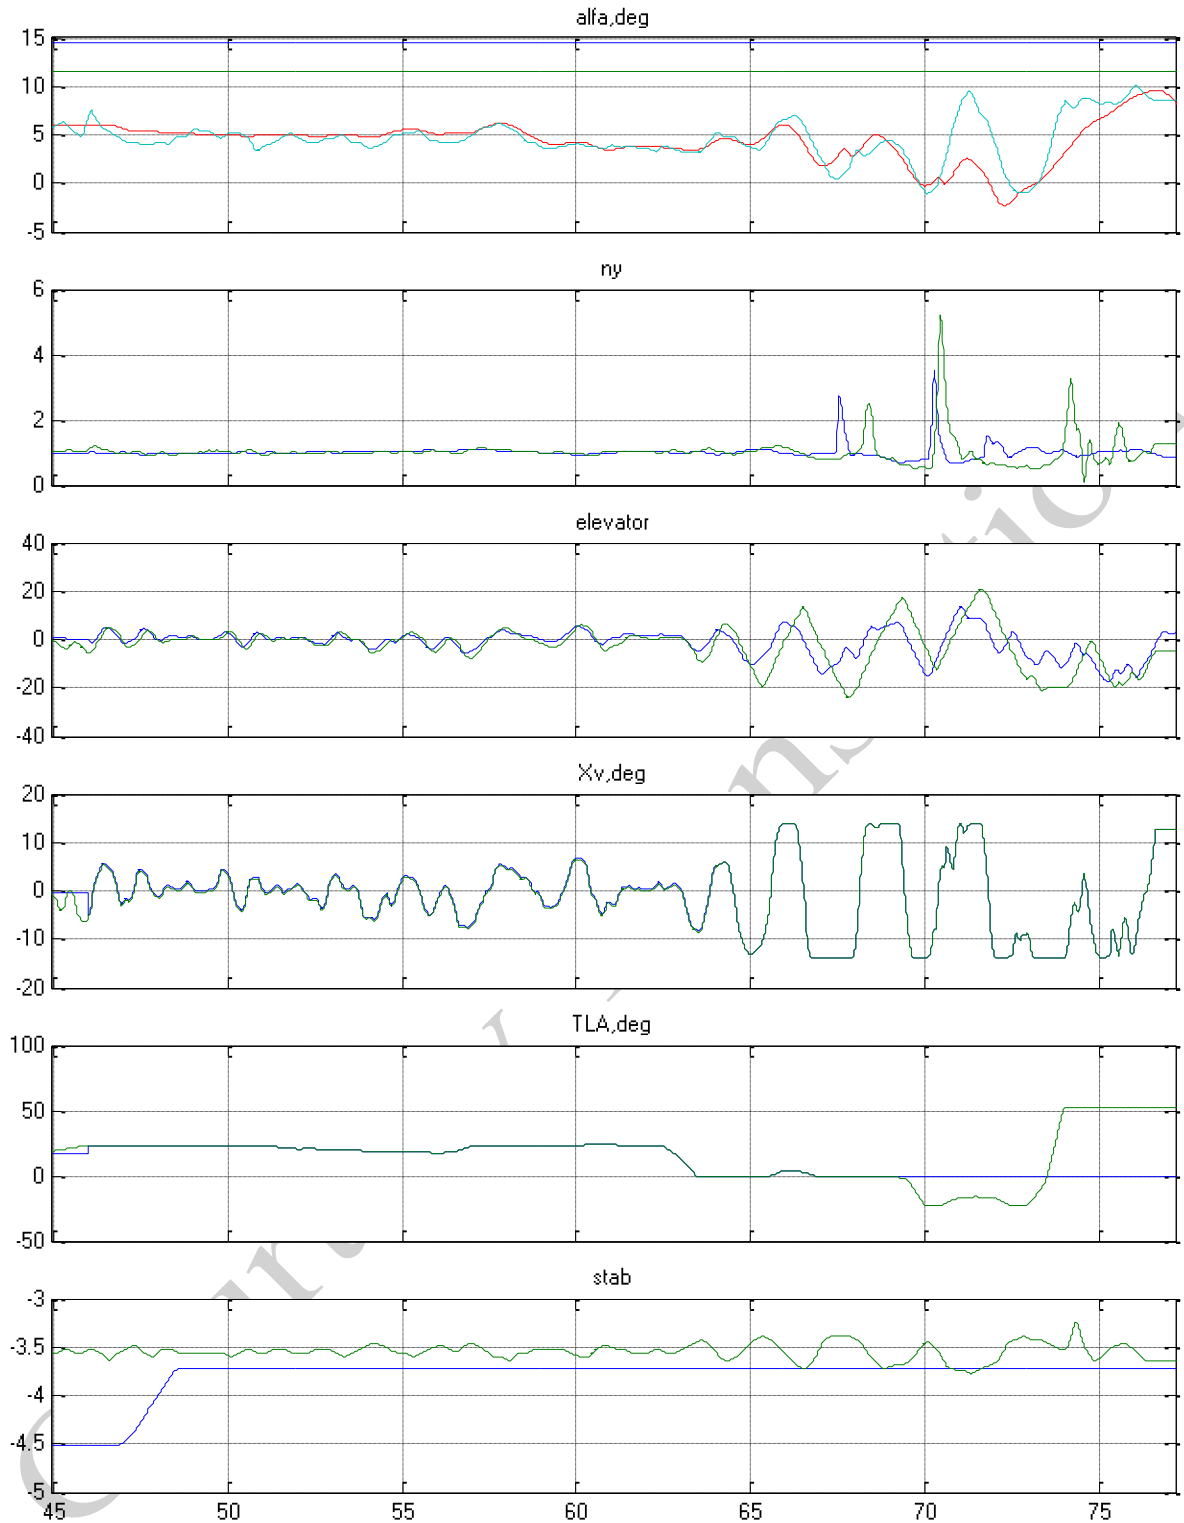
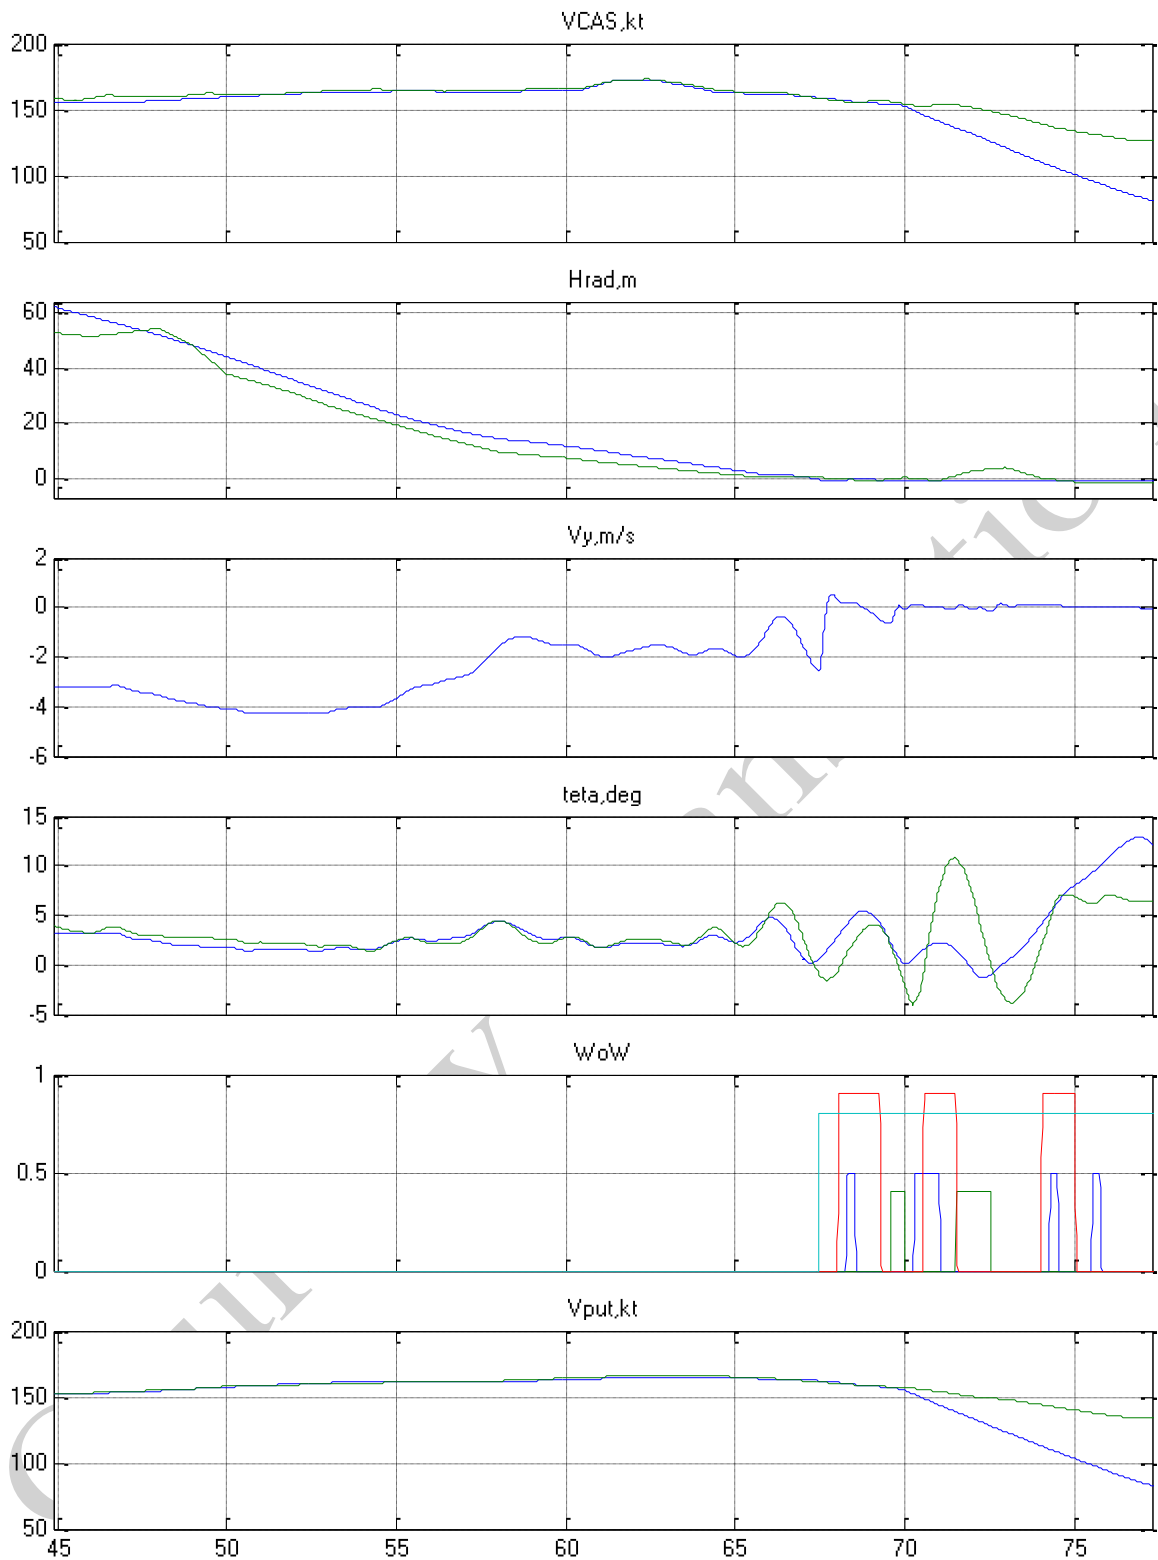
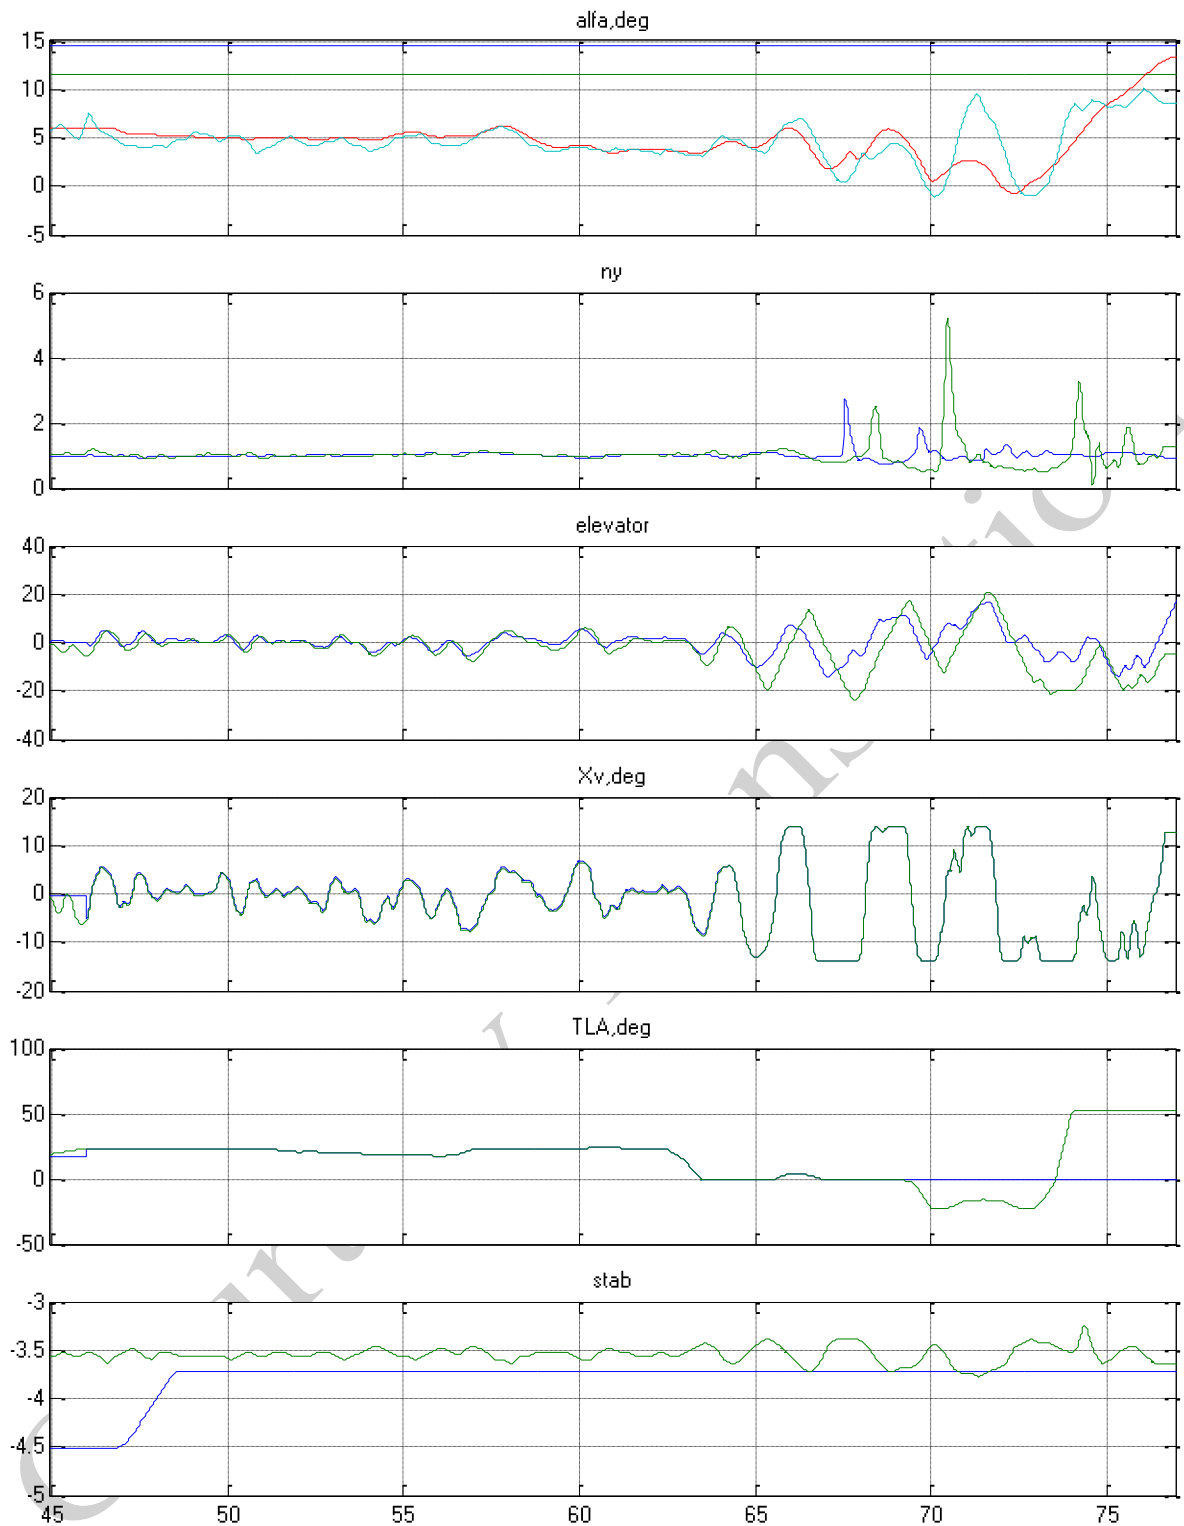
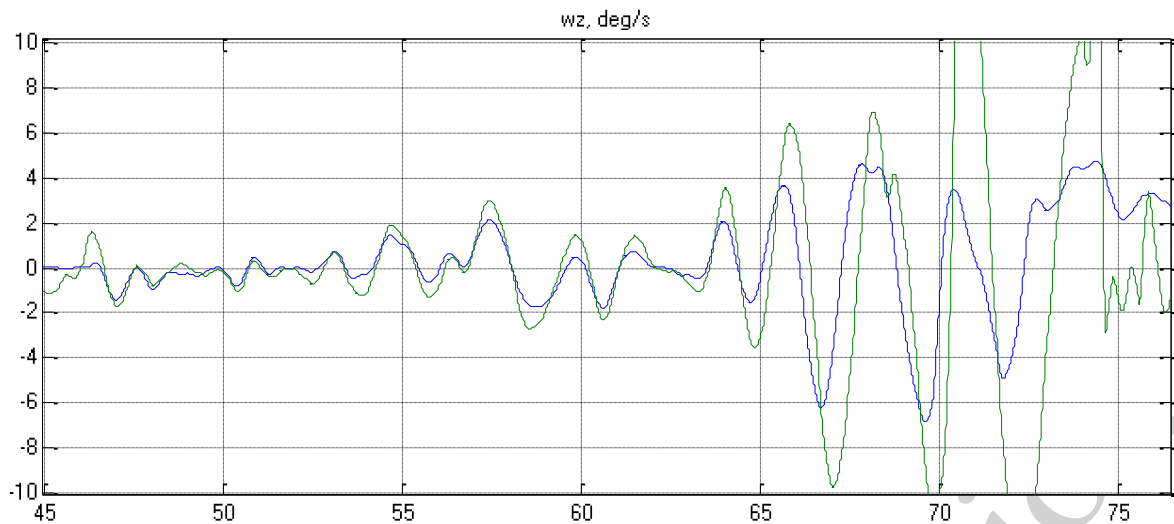
Fig. 106 and Fig. 107 present the results of the simulation (without the automatic deployment of ground spoilers at the landing roll) and Fig. 108 - Fig. 110 do with the automatic spoilers deployment at the landing roll. As for the indicated figures the parameters, obtained as the outcome of the simulation are shown in blue, the FDR record parameters are in green.

Fig. 106. The NORMAL MODE. SPDBRK = 0. The flight path parameters

Fig. 107. The NORMAL MODE. SPDBRK = 0. The control parameters

Fig. 108. The NORMAL MODE. SPDBRK = ARMED. The flight path parameters

Fig. 109. The NORMAL MODE. SPDBRK = ARMED. The flight path parameters

Fig. 110. The comparison of the pitch rates (deg/sec), SPDBRK = ARMED

The analysis of the simulation results is the evidence that without the automatic deployment of ground spoilers the post-touchdown aircraft bounces are preserved. At that the second touchdown occurs with the NLG coming first as well, with the less value of the pitch attitude, which decreases the maximum G at the second touchdown down to 3.6G and allows avoiding another aircraft bounce after the second touchdown due to the post-touchdown lower pitch rate to nose-up.

In the event of the automatic deployment of ground spoilers there is no occurrence of another aircraft separation off the RWY after the first touchdown. The maximum G at touchdown amounts to about 2.6G. At that the NLG lowering on the RWY occurs with the significant angular rate, which causes the second G spike (2.0 G).
