INTERSTATE AVIATION COMMITTEE

FINAL REPORT

ON THE RESULTS OF THE AIR ACCIDENT INVESTIGATION

Type of occurrence	Fatal accident
Type of aircraft	RRJ-95 (RRJ-95B model) airplane
Nationality and registration marks	RA-89098
Owner	VEB Leasing, JSC
Operator	Aeroflot, PJSC
Aviation authority	FATA
Place of occurrence	Sheremetyevo aerodrome, Moscow region, Russian Federation; reference position: 55°58'06.20" N, 37°24'07.20" E
Date and time	May 05, 2019, 18:30 local time (15:30 UTC), daytime

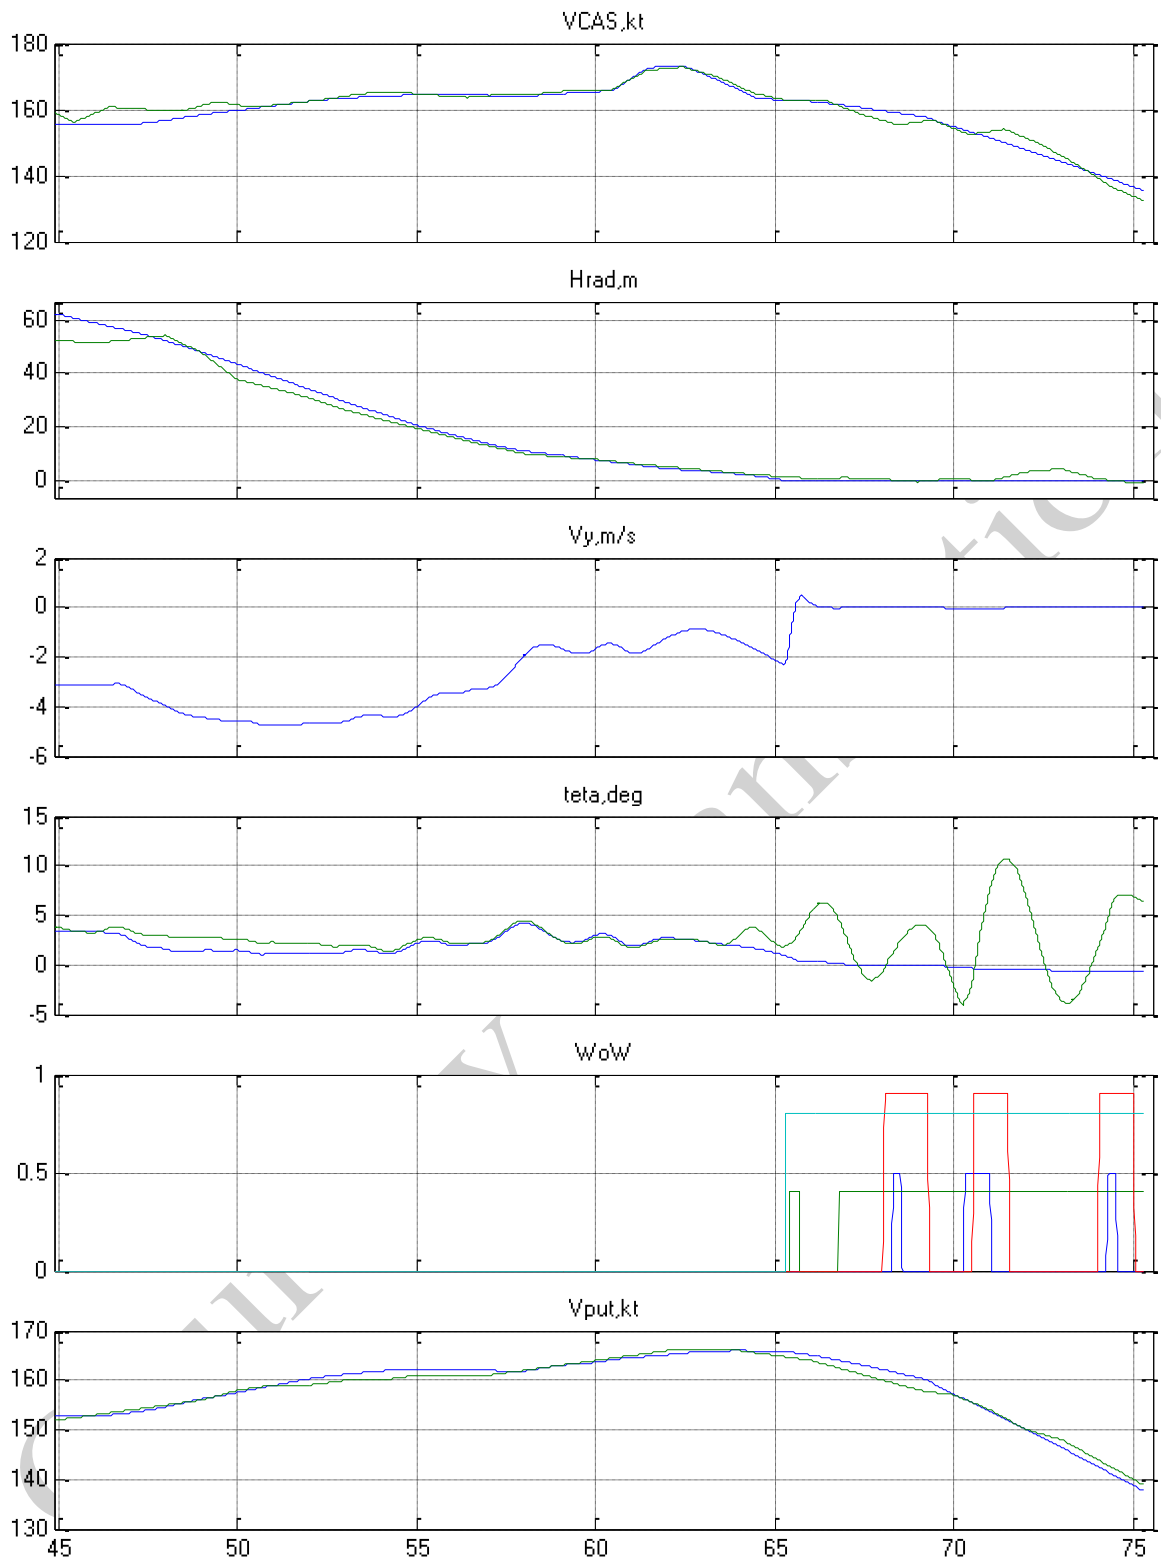
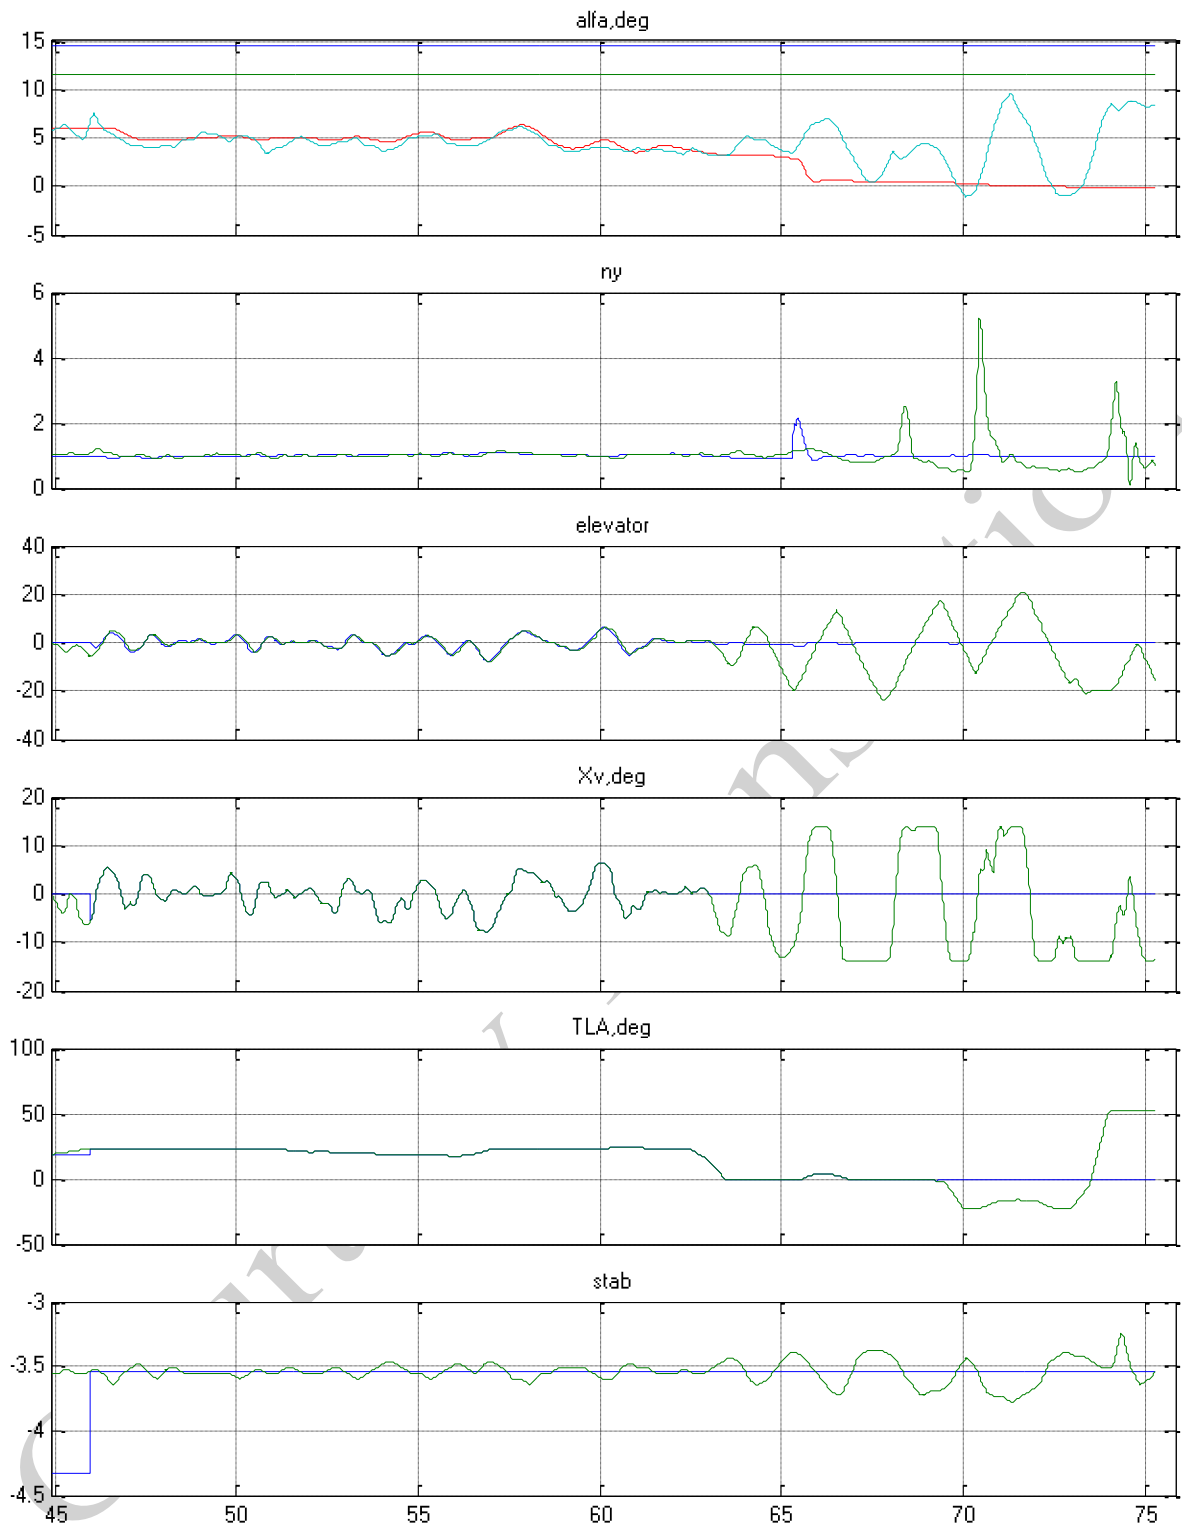
The simulation had been carried out in the conditions of the flight that ended up with the accident, still at the sidestick kept held in neutral at the point of time $T = 63$ sec. (the altitude of 16 ft) instead of its aft input up to 8.8° that had been accomplished by the pilot into the flight that ended up with the accident.

Fig. 111 and Fig. 112 present the outcome of the simulation.

The analysis of the results is the evidence that the piloting technique of the kind at the landing eliminates another aircraft bounce off the RWY after touchdown. The maximum G would have amounted to ≈ 2.0 units.

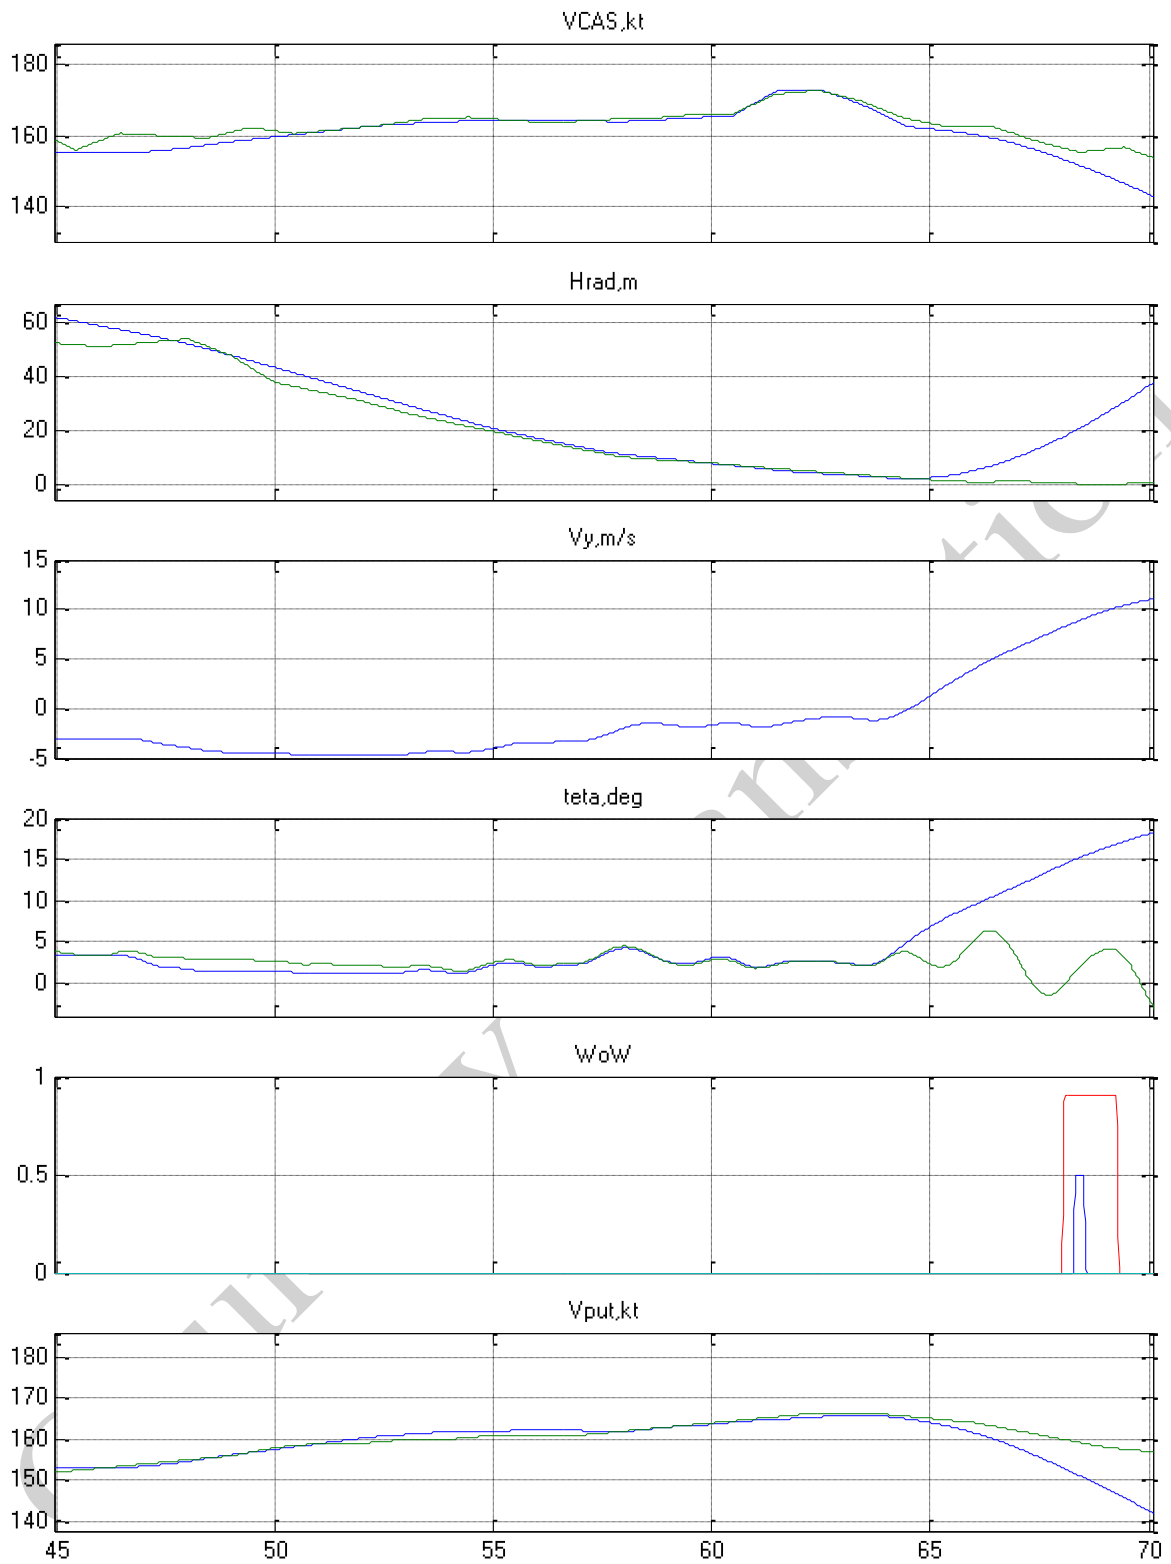
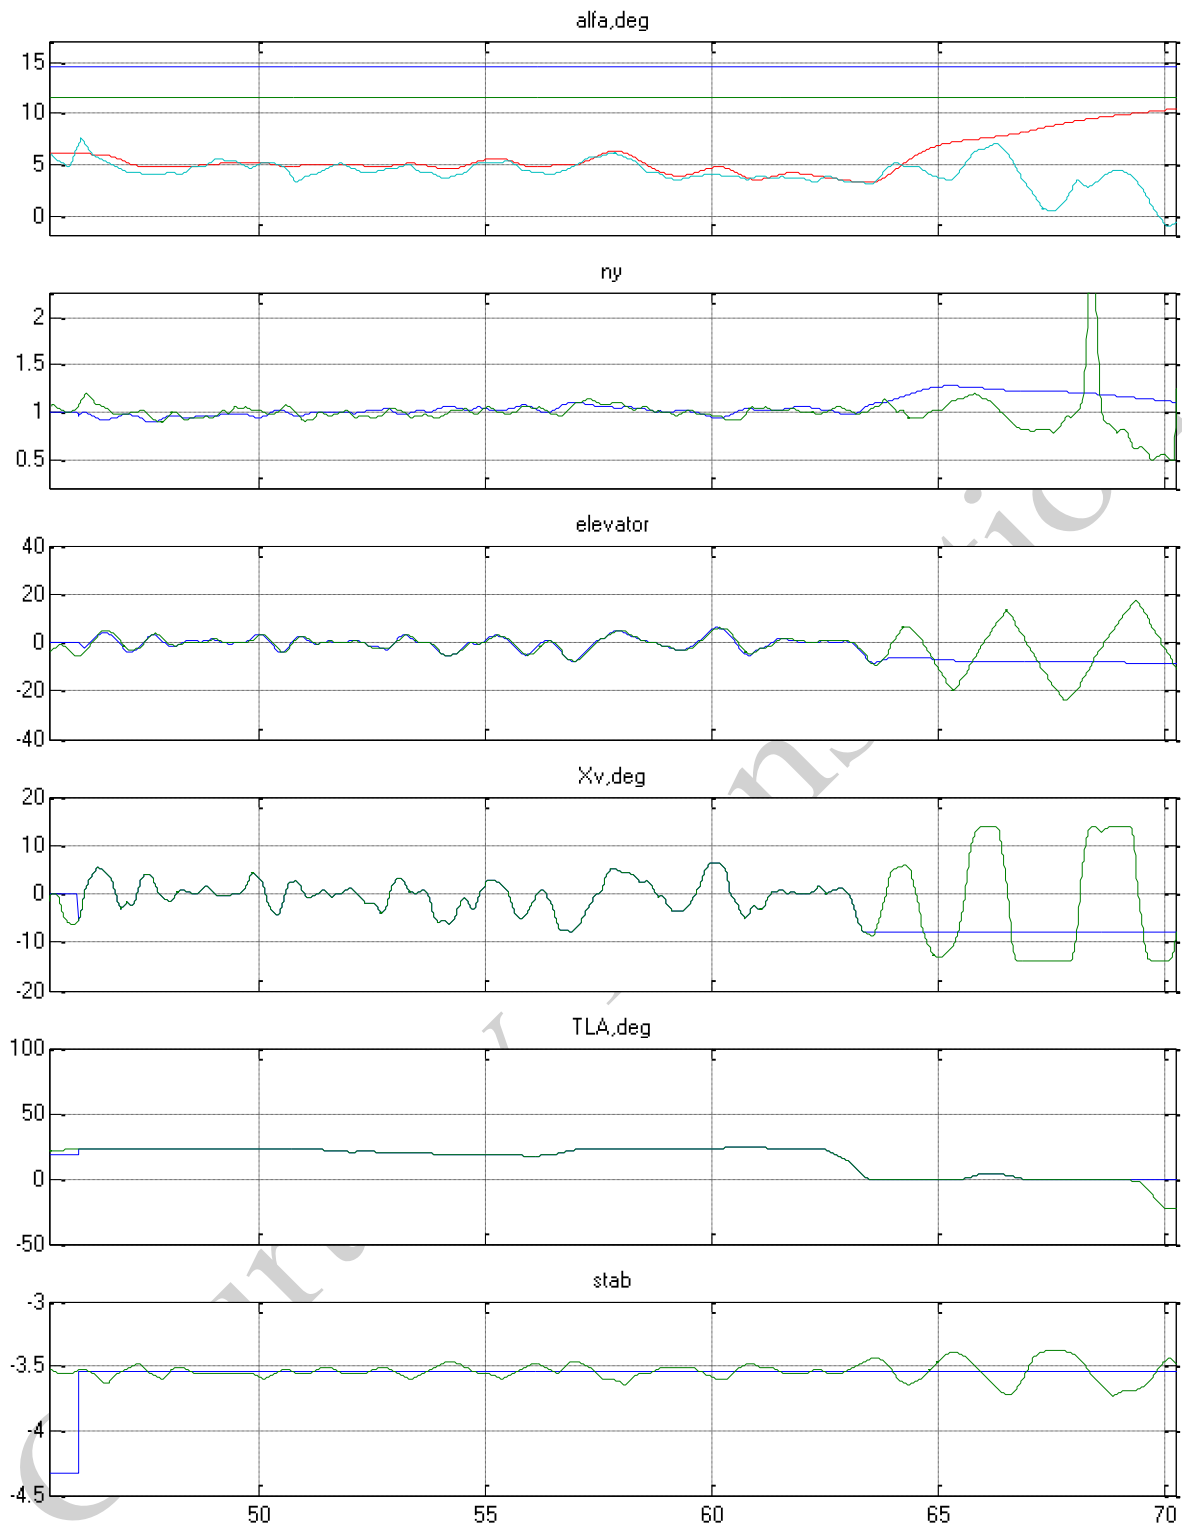
The simulation had been carried out in the conditions of the flight that ended up with the accident, still at the sidestick kept held in the reached position into the flare $X_v = 8.8^0$ to nose-up (T = 63.4 sec.).

Fig. 113 and Fig. 114 show the results of the simulation.

The analysis of the results indicates that as for this case the aircraft does not touch the RWY even on the condition of delayed increase of the engines power rating from IDLE to TOGA. At the altitude of 20 m the aircraft speed stays close to this, recommended by FCOM (155 kt), the aircraft is in positive climb with the rate of climb up to 8 m/sec.

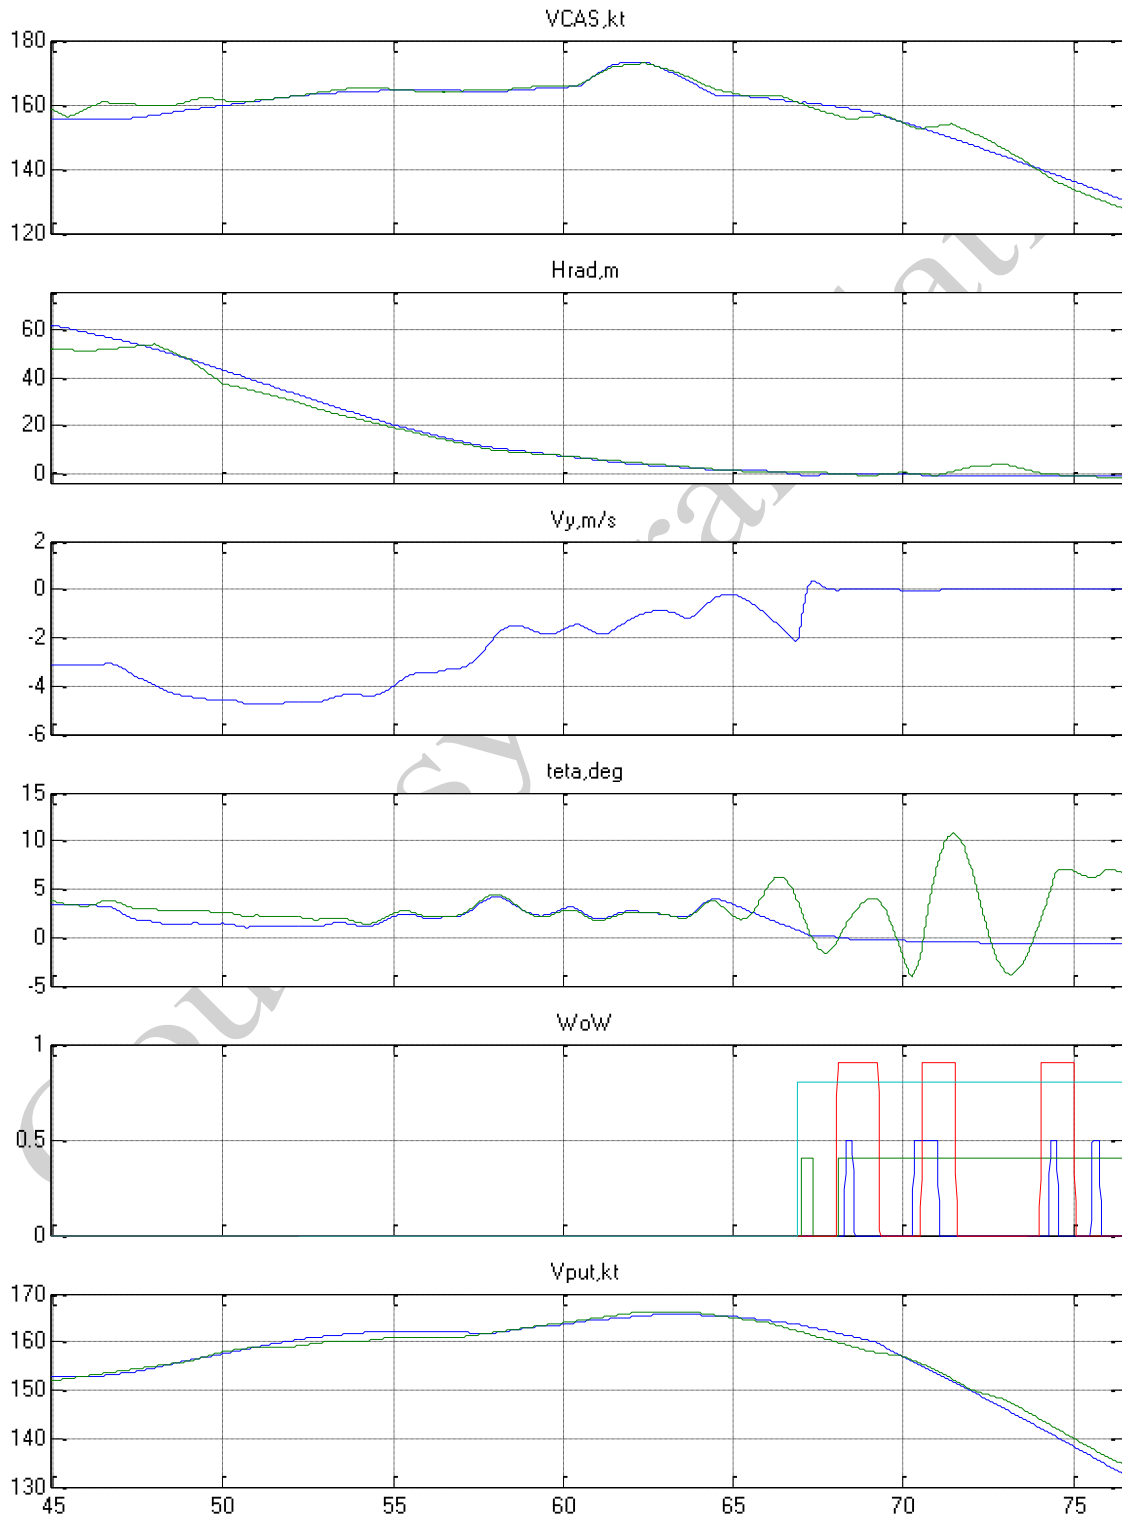
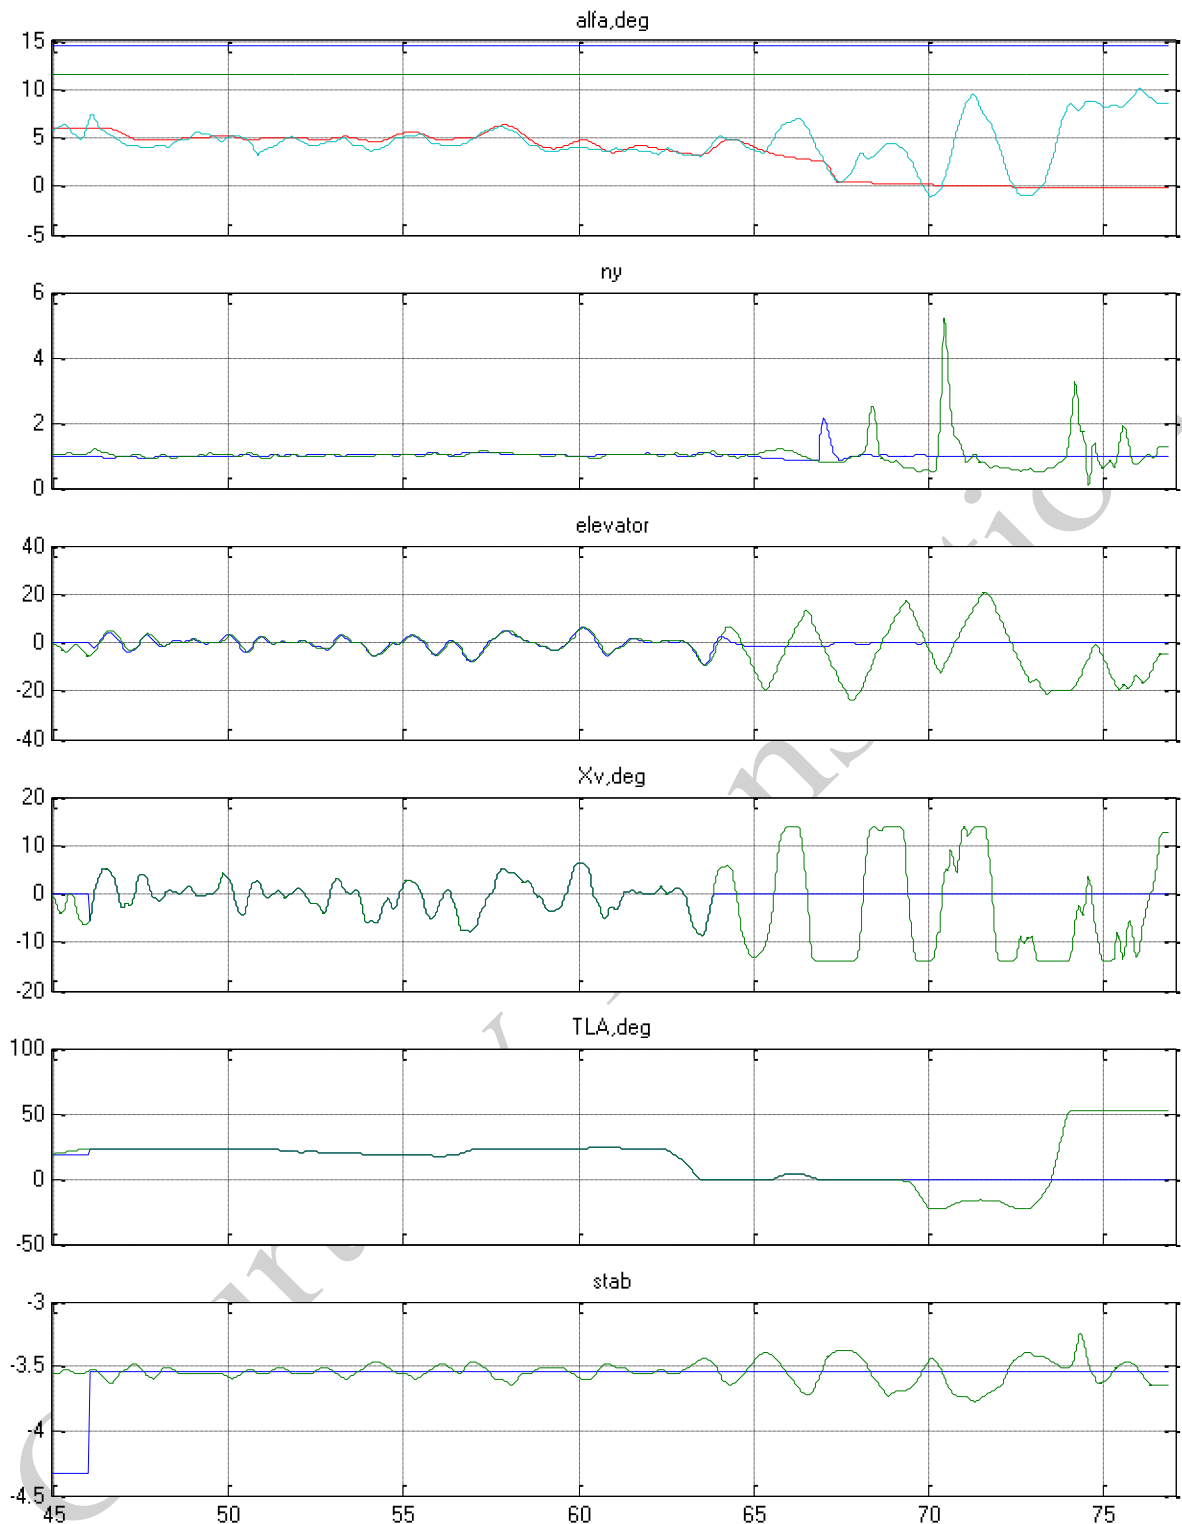
The simulation had been carried out in the conditions of the flight that ended up with the accident, still at the sidestick kept retained neutral after the first input to flare.

Fig. 115 and Fig. 116 demonstrate the results of the simulation.

The review of the results indicates that the elimination of the forward sidestick input at preserving the preceding way of piloting prevents «the three points» touchdown and consecutive bounces after touchdown. The maximum G at touchdown would have amounted to ≈ 2.0 units.

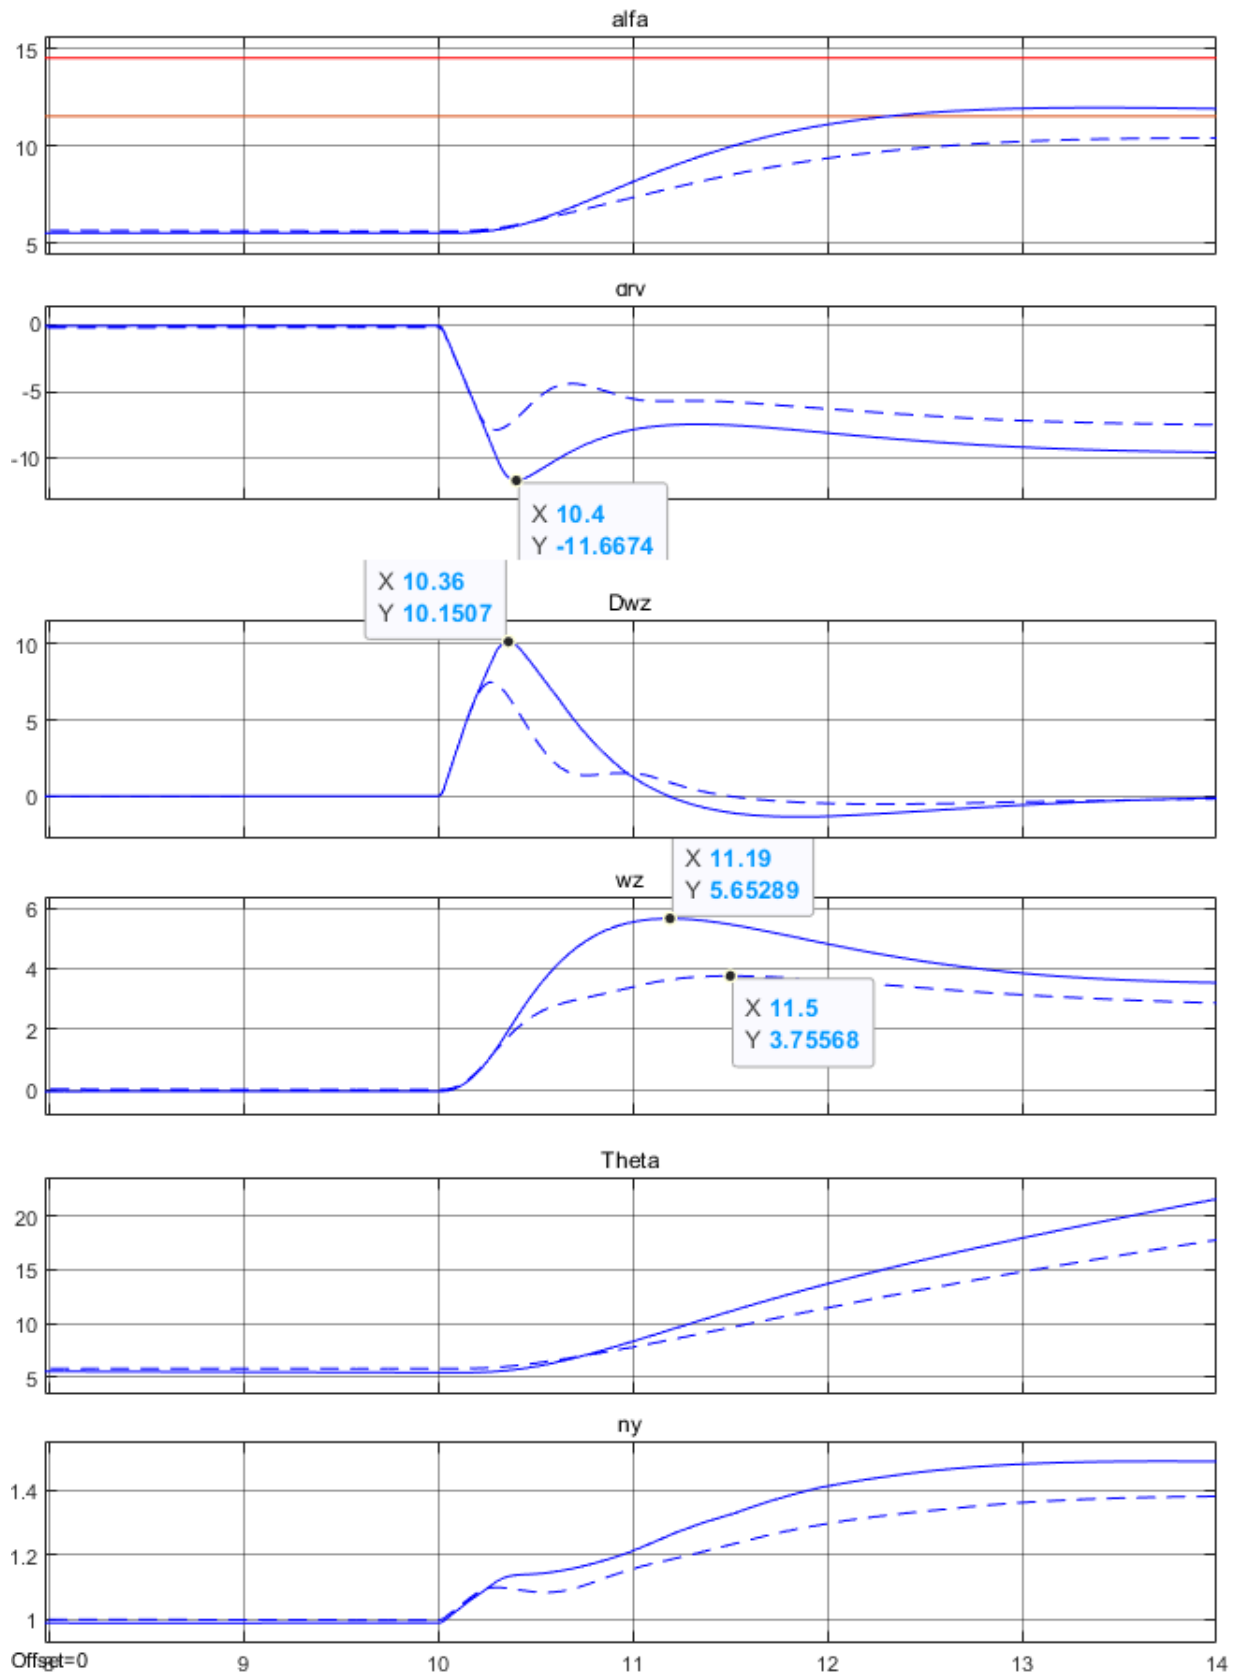
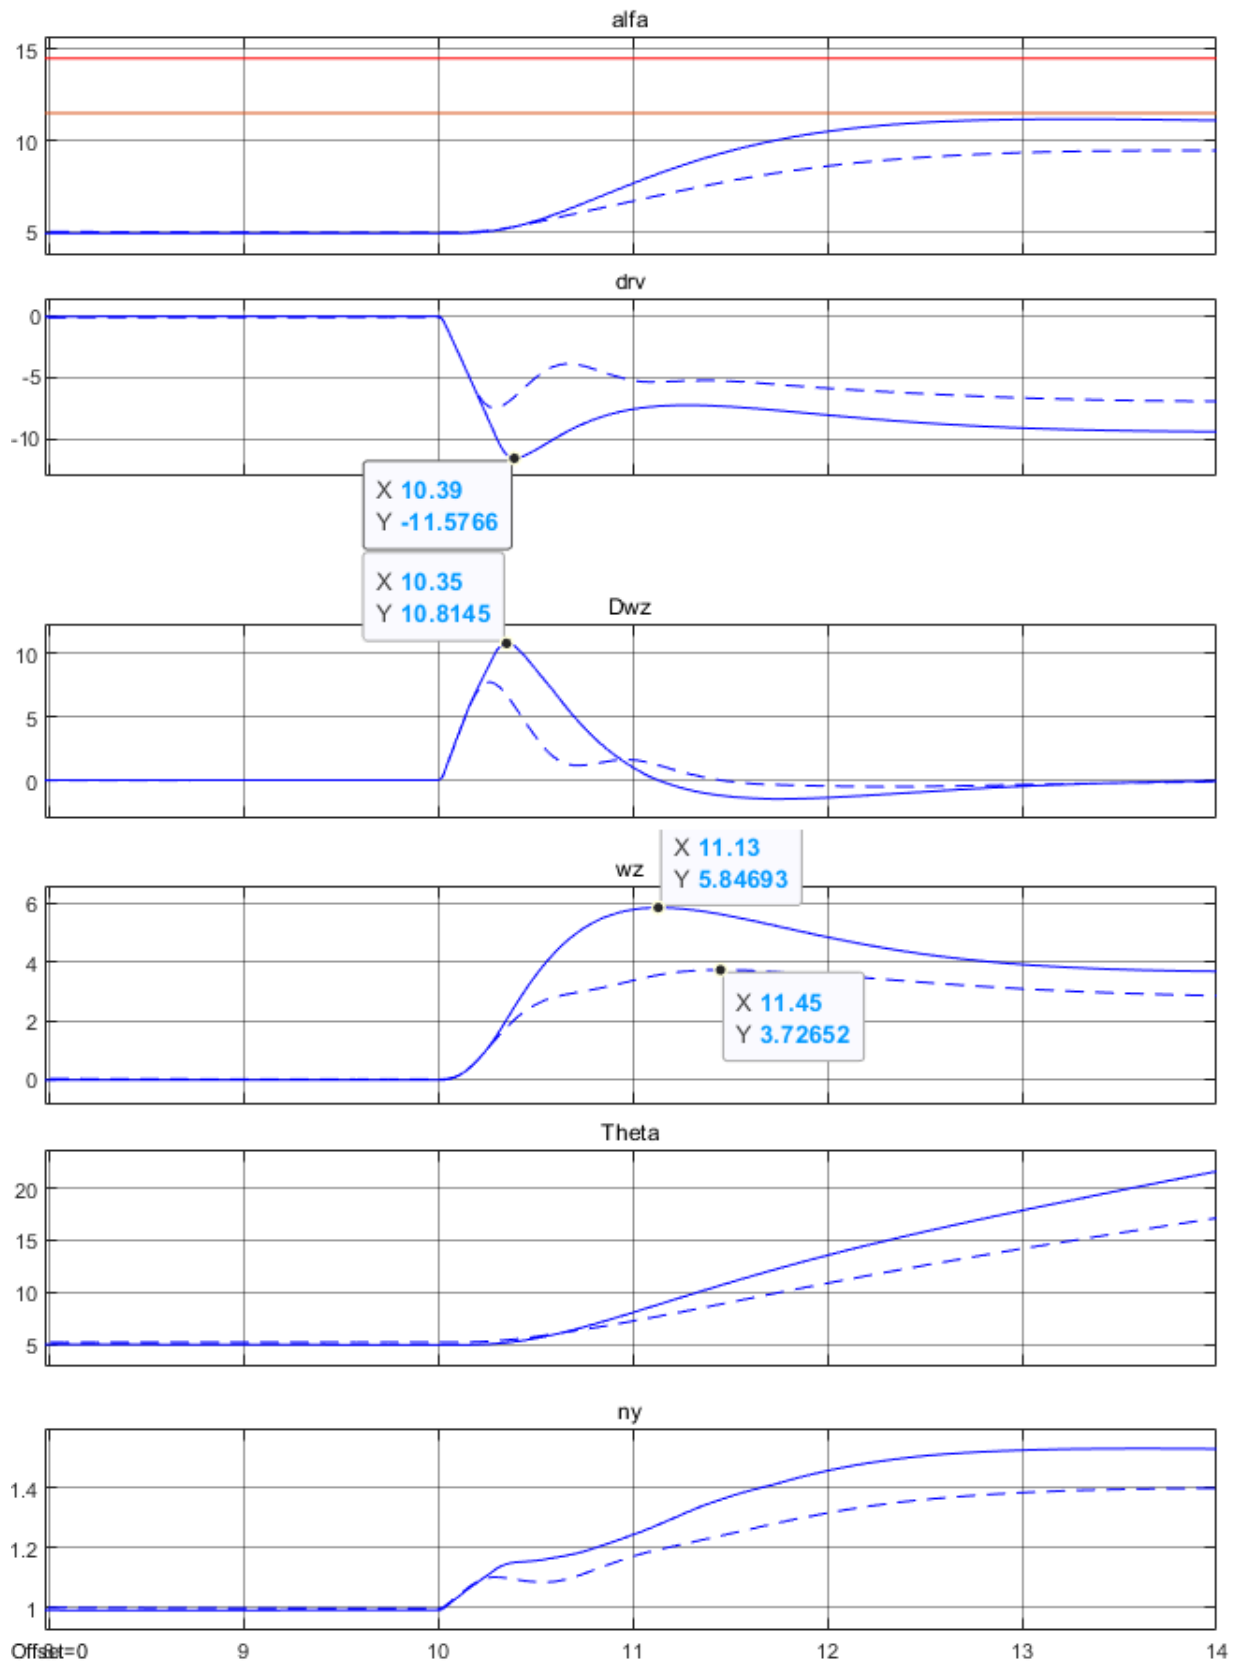
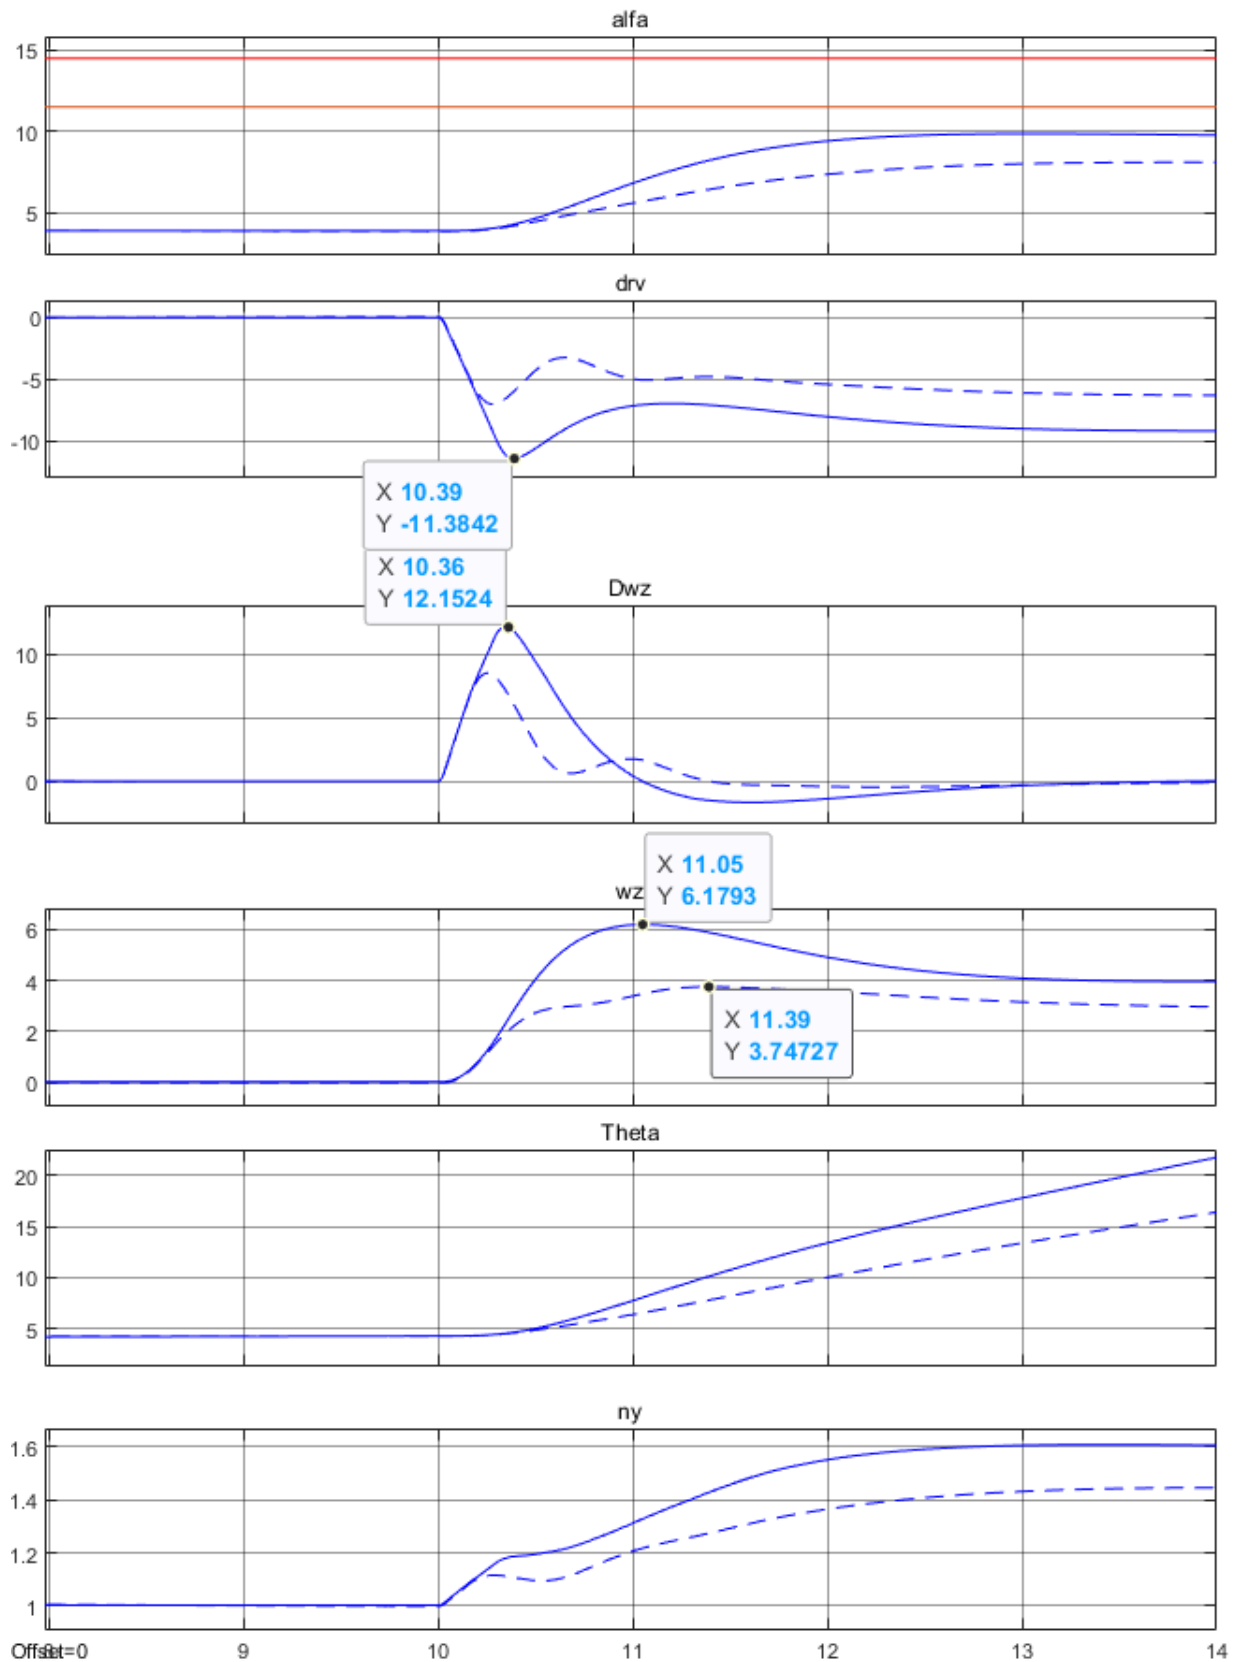
To evaluate the effect of IAS on the sidestick input in pitch the simulation had been carried out as to three IAS values: 155 kt, 160 kt and 170 kt. The simulation is accomplished for the FBWCS DIRECT MODE (solid curve) and NORMAL MODE (dashed curve), FLAPS 3, landing gear down, true altitude less than 50 ft. The magnitude of the sidestick deflection had amounted to 9° that is it had been roughly consistent with the aft input magnitude at the initiation of flare into the flight that ended up with the accident. The outcome of the simulation is given on Fig. 117 - Fig. 119.

Fig. 117. The aft sidestick input, VCAS=155 kt

Fig. 118. The aft sidestick input, VCAS=160 kt

Fig. 119. The aft sidestick input, VCAS=170 kt

The results of the simulation are the evidence that in DIRECT MODE the aircraft response to the same sidestick input is the more dynamic the higher is IAS. As for NORMAL MODE the aircraft response is not affected by IAS.

At an early stage of the transient process the aircraft response to the sidestick inputs in both control modes is virtually the same. Further on the response in DIRECT MODE is more dynamic than in NORMAL MODE. The said difference is as well noted by test pilots at their evaluation of performance by denoting the aircraft response to the control input in pitch channel in DIRECT MODE as «*a bit more dynamic*» than in NORMAL MODE.

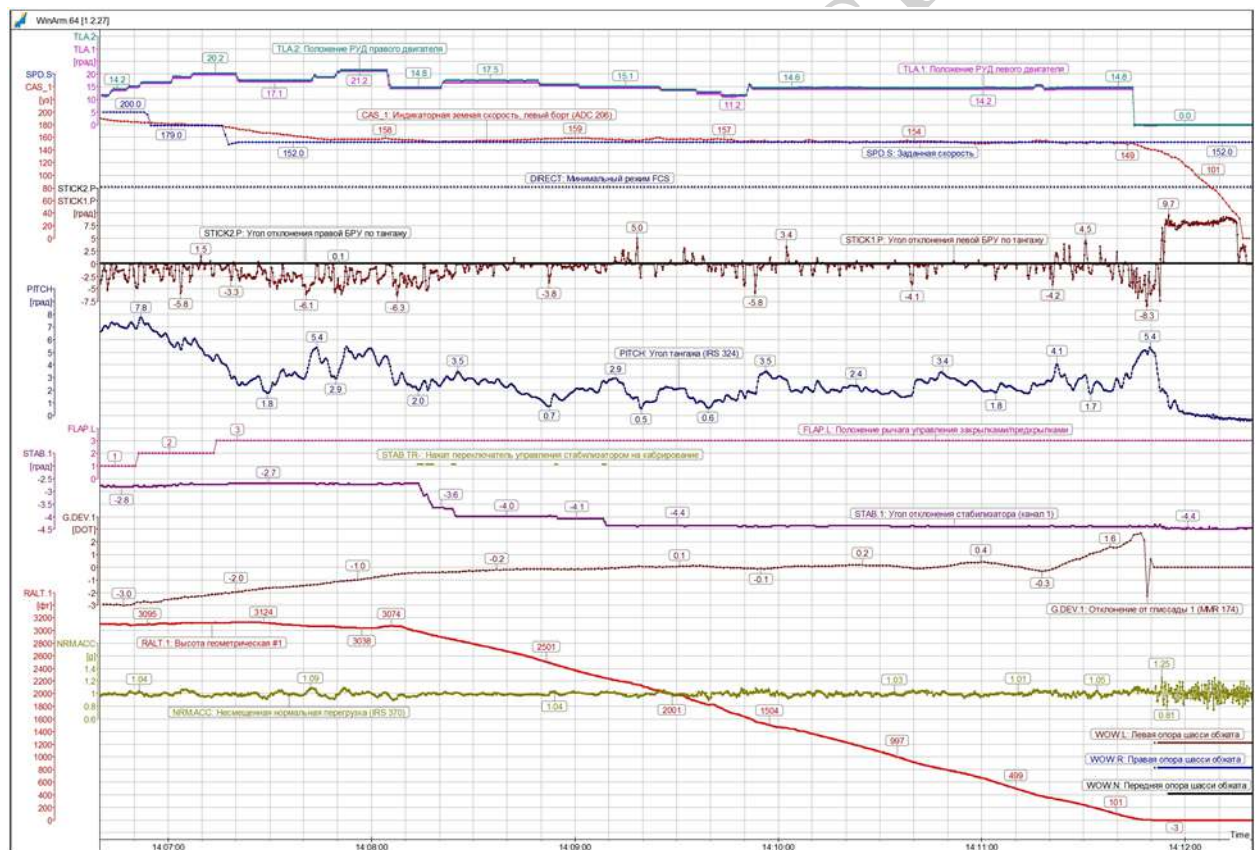
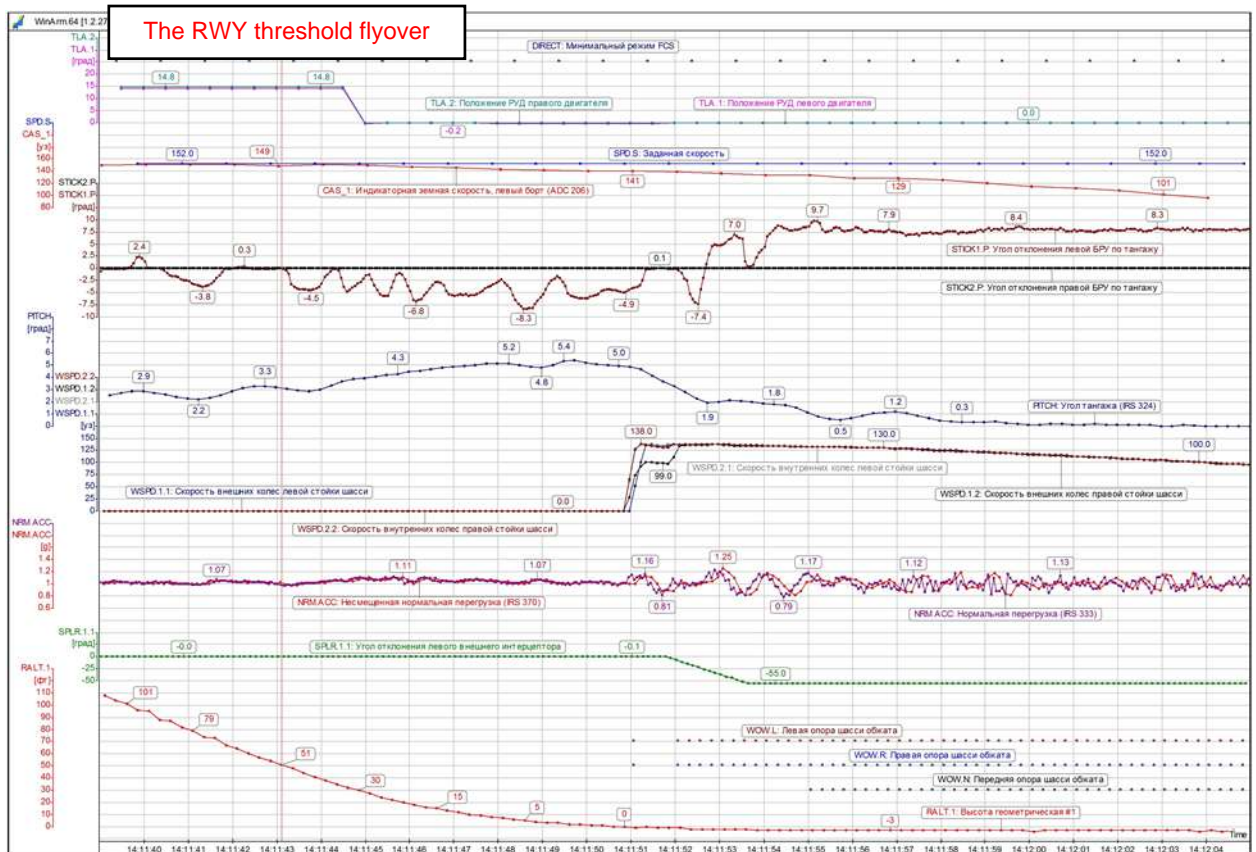
The analysis of the flight data records (Fig. 124 and Fig. 125) to the flight, having been performed in DIRECT MODE, accomplished by the investigation team revealed the following:

- the RWY threshold was flown over at the true altitude of 51 ft and target approach speed;
- after the engines were set on IDLE and the flare was initiated the sidestick had been repositioning to nose-up by not more than 8.2° . The sidestick had never been returning to neutral and deflecting to nose-down;

- the flare had resulted in the established aircraft pitch of 5-6° and the arrest of the vertical speed and IAS;
- the landing occurred with the pitch of 5° approximately to nose-up at the IAS of 142 kt with the concurrent WOW to both MLG legs. The maximum recorded acceleration amounted to 1.16G;
- in under a second after landing the speedbrakes had been manually deployed, thus preventing consecutive bounce off the RWY. The TR had not been applied;
- prior to the onset of the steady WOW to the MLG legs there had been no sidestick input beyond neutral to nose-down;
- the NLG had been lowered smoothly with no consecutive separations;
- into the landing roll the crew had been maintaining the sidestick forward position by a half-travel approximately.

Fig. 124. The flight data at the Venice airport approach on October 2, 2019

Fig. 125. The flight data into flare, landing and landing roll at the Venice airport on October 2, 2019

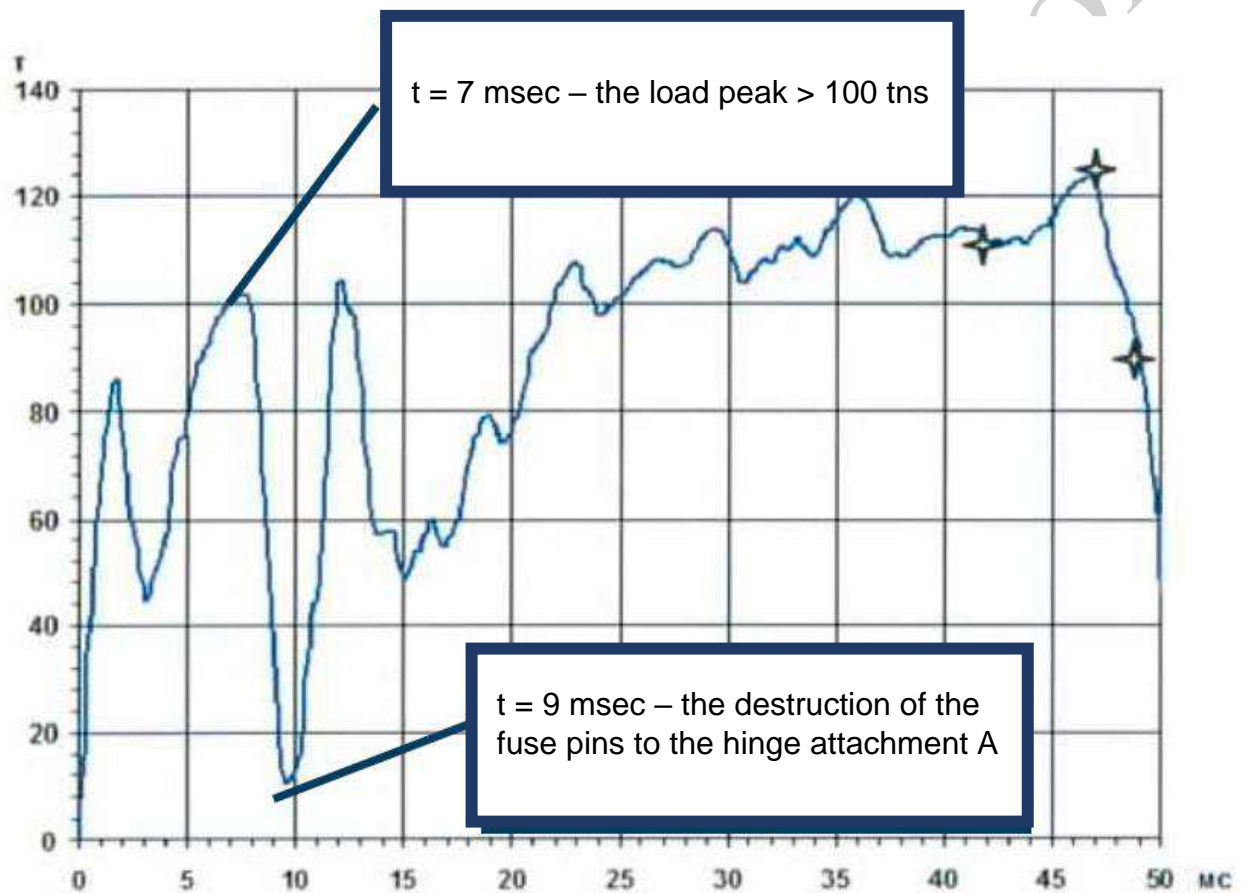
Fig. 130. The force on the leg vs time dependence at the simulation of the leg separation off the airplane under vertical load

gear legs failed to extend to the occurrence of the fuel spillage out of the fuel system enough to constitute a fire hazard», RRJ0000-RP-100-1324, Rev. A., 2010, the fuse pins/«weak links» to the A attachment¹⁷⁶ are destructed when the vertical load of 981 kN (100 tons) is exceeded (Fig. 130). Thus, the actual loads on the MLG Attachments A to the wing rear spar exceeded the destructive ones, which led to the shearing of the fuse pins («weak links») of the A attachments to both MLG legs. With that, the analysis of the destructed «weak links» stated their conditionality (Section 1.16.13 of the Report).

Along with that the complete separation of the landing gear legs structure had not occurred at the second touchdown. As seen on Fig. 130, the leg with the disintegrated Attachment A continues to bear the load. The next element to disintegrate at the application of the vertical load is the LG crossbeam attachment to the wing, the required destructive load is 124 tons. There had been no loads of this magnitude, applied on the LG structure at the second touchdown. In this way the destruction of the LG structure had been proceeded compliant to the simulation scenario until

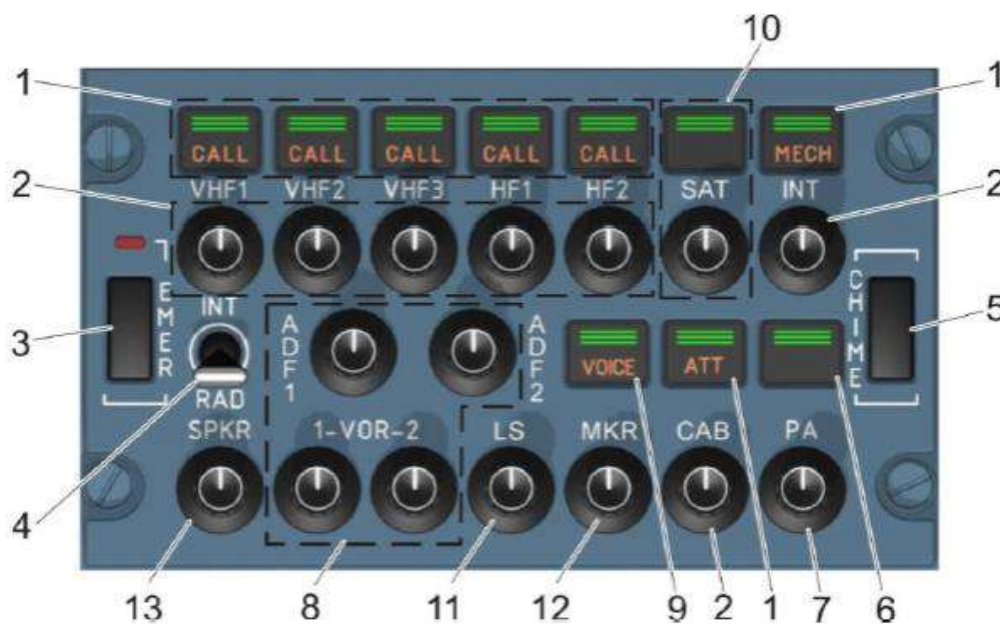
Fig. 134. The exterior of the ACP control panel

Compliant to the OM the command in question is issued via the PACIS. At the interview the F/O confirmed that according to him he had applied the PA button (Fig. 134). However this sentence is not audible on the sound channels to the passengers' cell phones. At that the FDR record is the evidence that over the same time interval the discrete signal is recorded of the external radio contact initiation via VDR2, in other words the F/O instead of the PA button mistakenly applied the INT/RAD switch (Fig. 134), which he had earlier used to conduct the radio communication with ATC.
