INTERSTATE AVIATION COMMITTEE

FINAL REPORT

ON THE RESULTS OF THE AIR ACCIDENT INVESTIGATION

Type of occurrence	Fatal accident
Type of aircraft	RRJ-95 (RRJ-95B model) airplane
Nationality and registration marks	RA-89098
Owner	VEB Leasing, JSC
Operator	Aeroflot, PJSC
Aviation authority	FATA
Place of occurrence	Sheremetyevo aerodrome, Moscow region, Russian Federation; reference position: 55°58'06.20" N, 37°24'07.20" E
Date and time	May 05, 2019, 18:30 local time (15:30 UTC), daytime

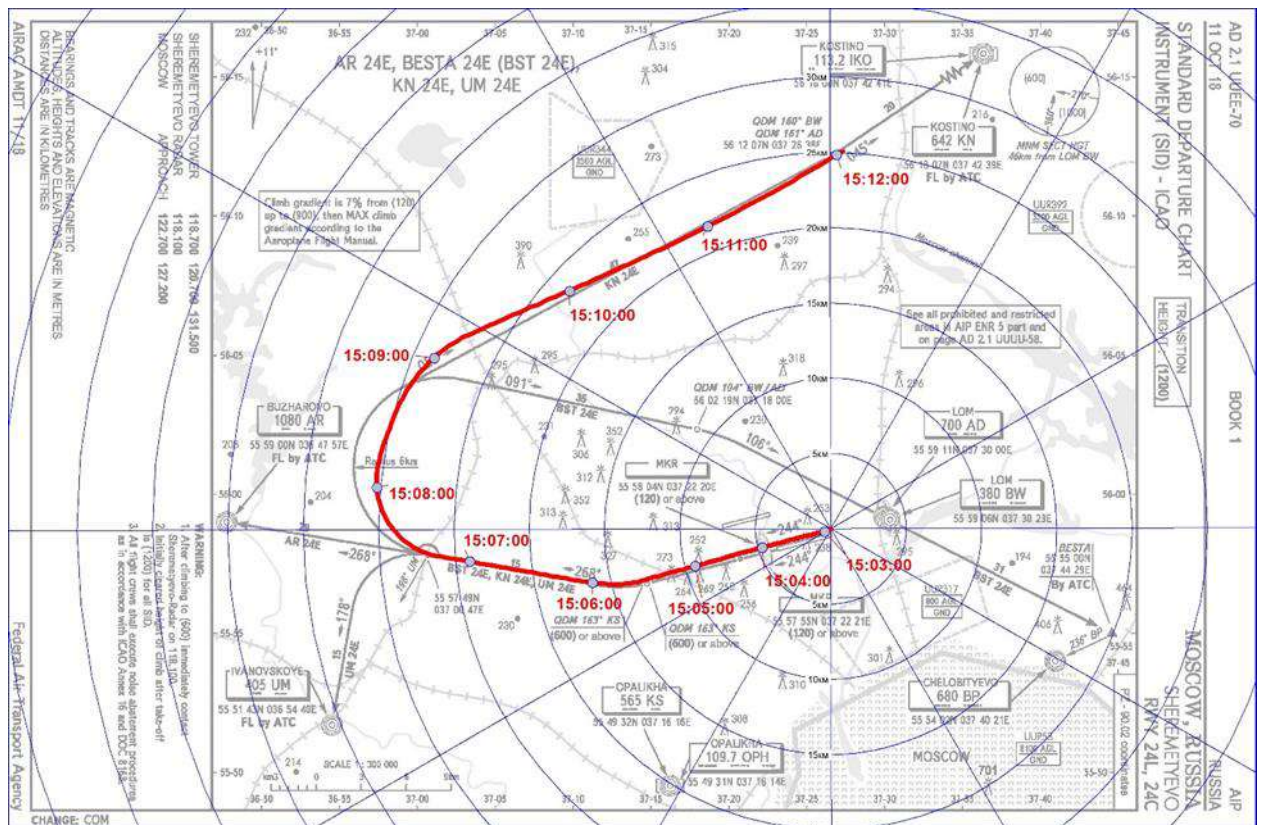
Fig. 145. The flight path, combined with the KN 24E SID

At 15:05:42 the crew engaged the VERTICAL SPEED / VS mode and set the target vertical speed of 938 ft./min (4.8 m/s). Concurrently in the LATERAL NAVIGATION / LNAV mode the aircraft started the right turn to the heading of 268° as per the KN 24E SID (Fig. 145).

Up to the time of 15:07:10 the aircraft had been flown in the automatic mode strictly by the KN 24E SID, at that the AP functioned in the lateral channel LATERAL NAVIGATION/LNAV mode. Still at the point of time in question the AP operational mode in lateral channel had been changed to HEADING/HDG, which resulted in the earlier initiation of the right turn (Fig. 145) that

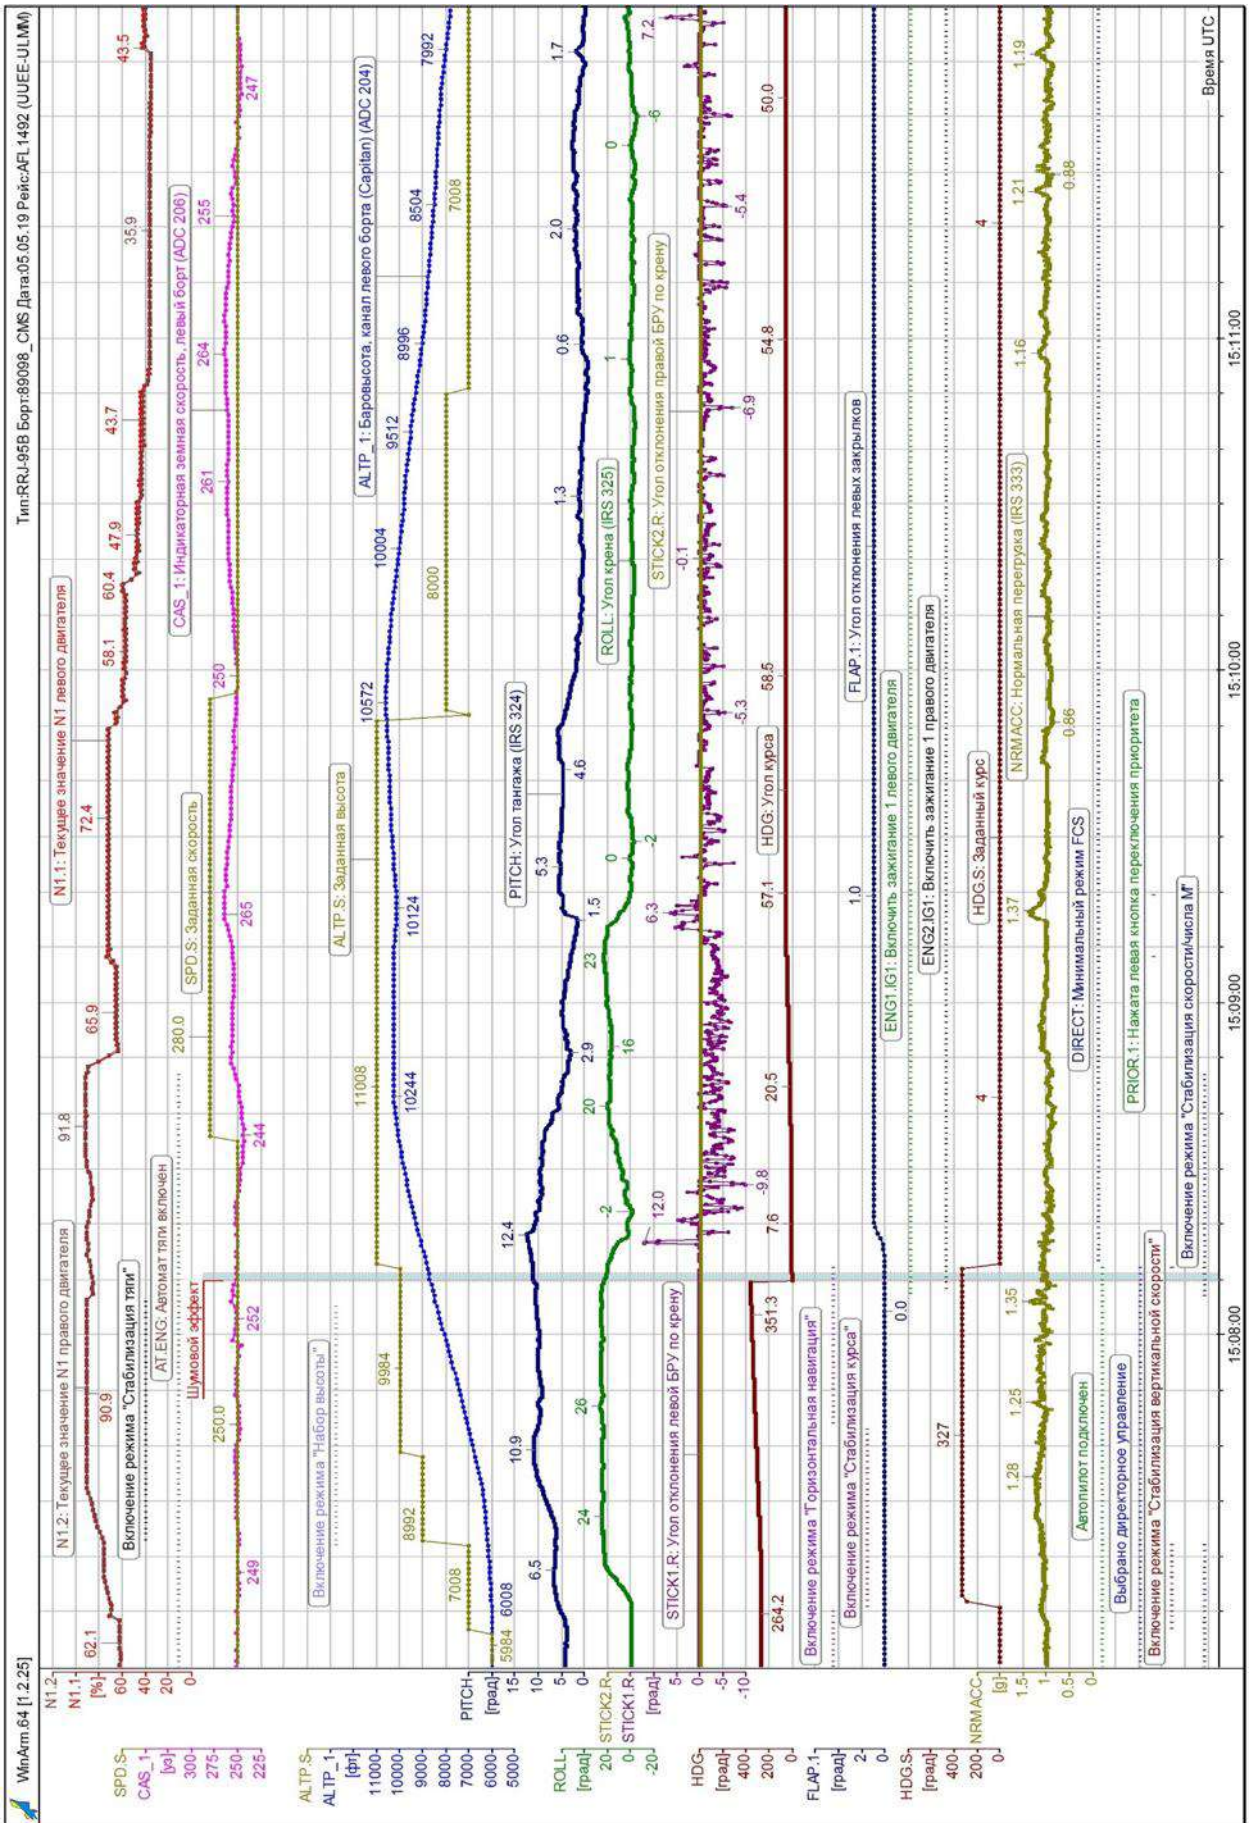
Fig. 146. The data of the RRJ-95B RA-89098 aircraft flight that ended up with the accident (the vertical grey line highlights the point of the exposure to atmospheric electricity)

At 15:07:10 in the A/P lateral channel the HEADING / HDG was engaged, at that the target value was set to 327° (Fig. 146). The autopilot mode was changed by one of the flight crew (by the PIC's, most probably) without calling it out to the other flight crewmember. Up to that point the corresponding changes of the modes were called out by the PIC and acknowledged by the F/O.

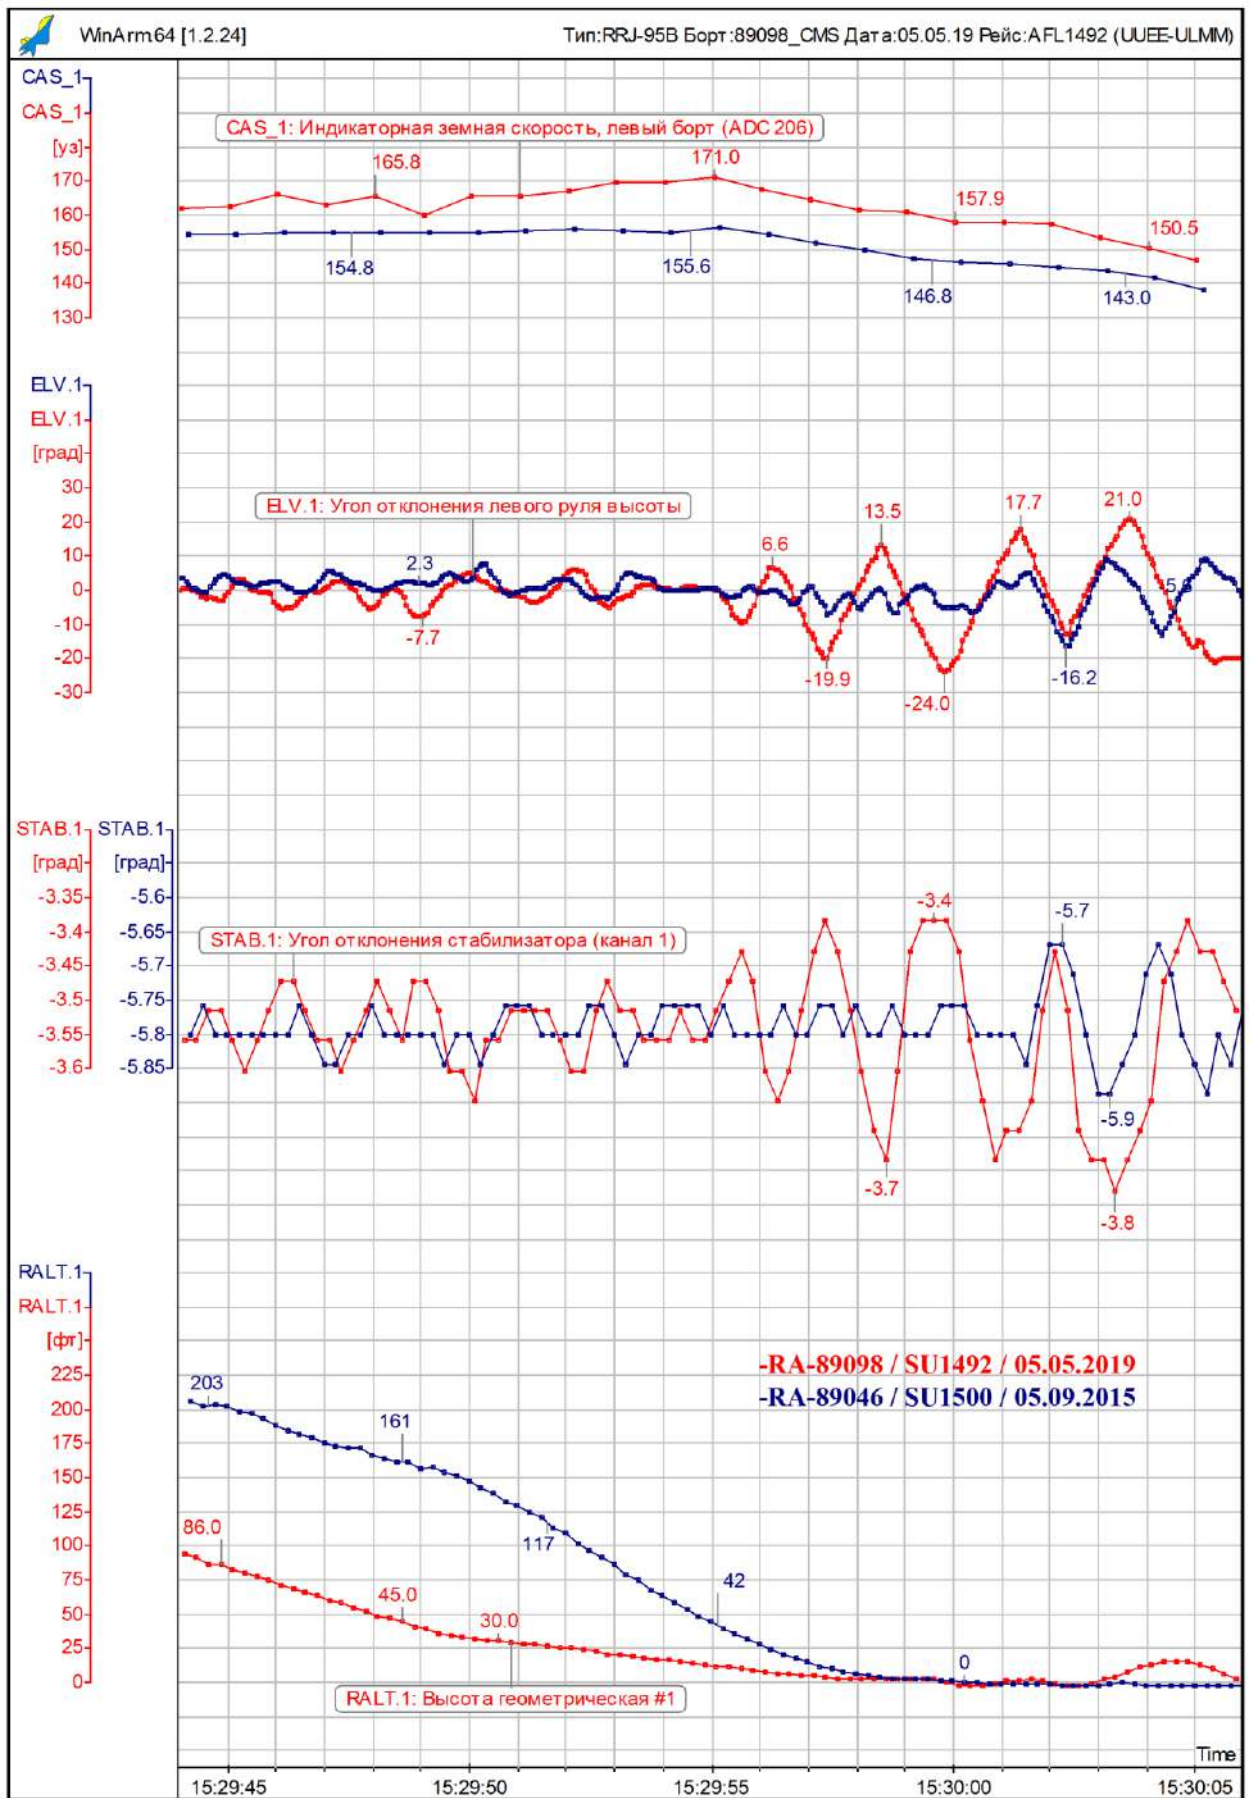
Fig. 154. The comparison of the stabilizer position records at the significant deflection of the elevator

Note: *Similarly for RA-89098 and the other RRJ-95 aircraft, the recorded horizontal stabilizer position is slightly altered at the elevator deflection. At that, the recorded changes of the stabilizer position are always in antiphase to the deflection of the elevator, and the more is the elevator deflection (so is the hinge moment), the more is the change in the recorded value of the stabilizer deflection. This is due to the features of the stabilizer position sensors installation location and their linkage flexibility. This is not the case of the actual further deflection of the stabilizer. For instance Fig. 154 presents the comparison of the data at the landing into the flight that ended up with the accident and into the flight of the RA-89046 aircraft of September 5, 2015, into which the landing was carried out in DIRECT MODE as well, and the pilot exercised significant alternating inputs of the sidestick at flare. The Figure is the evidence that the behavior (nature) of the stabilizer deflection record is absolutely identical. It is also worth noting that the elevator setting rate when the actuators reach the limit (that is, the maximum possible elevator deflection rate) are almost the same into both flights.*

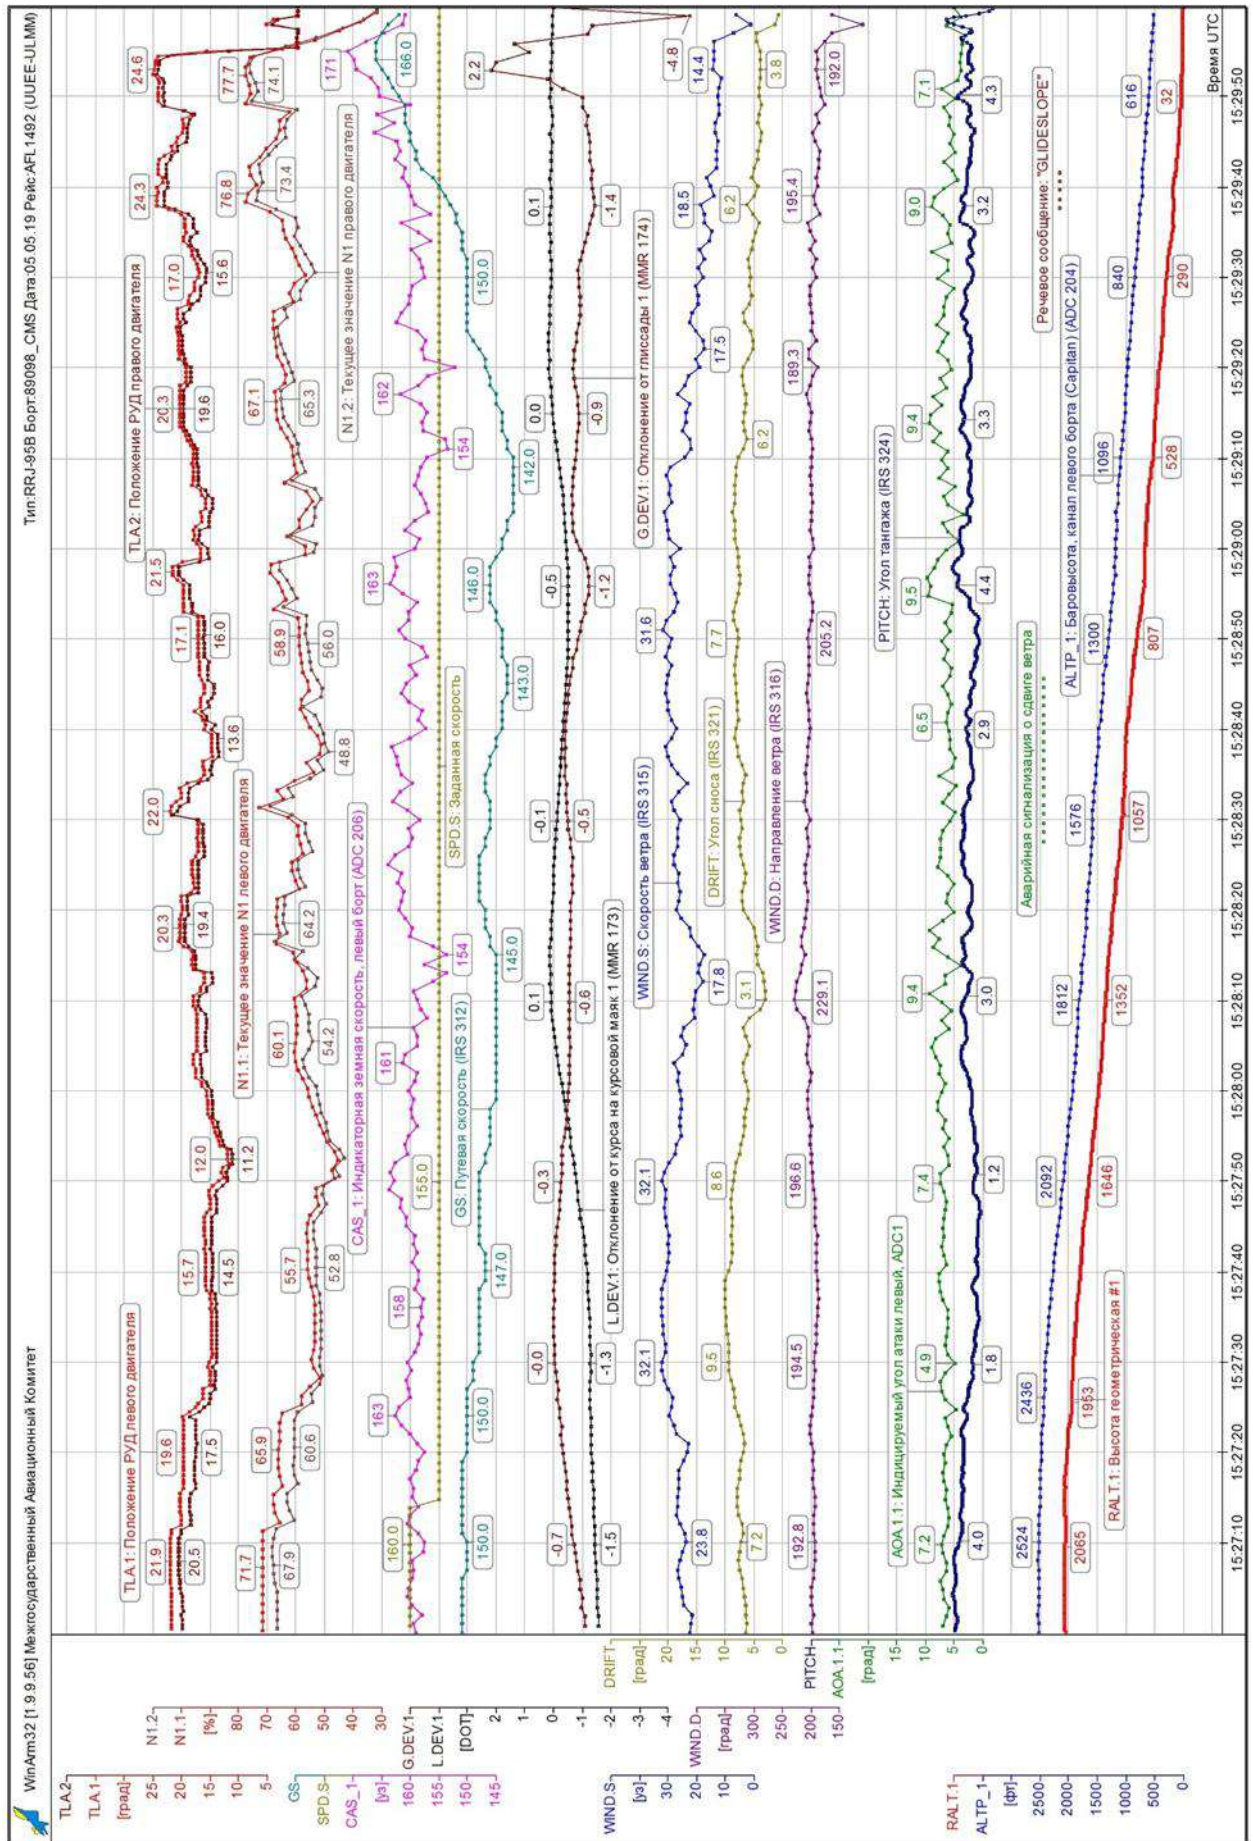
Fig. 155. The flight data at the glideslope descent

The flight data at the glideslope descent are shown on Fig. 155, so is the descent profile on Fig. 156.

The glideslope descent was proceeded at the IAS of 155 – 160 kt (287 – 296 km/h) below (parallel to) the established glideslope track by about 0.5 – 0.6 dot, the deviation off the localizer equisignal zone did not exceed 0.5 dot.

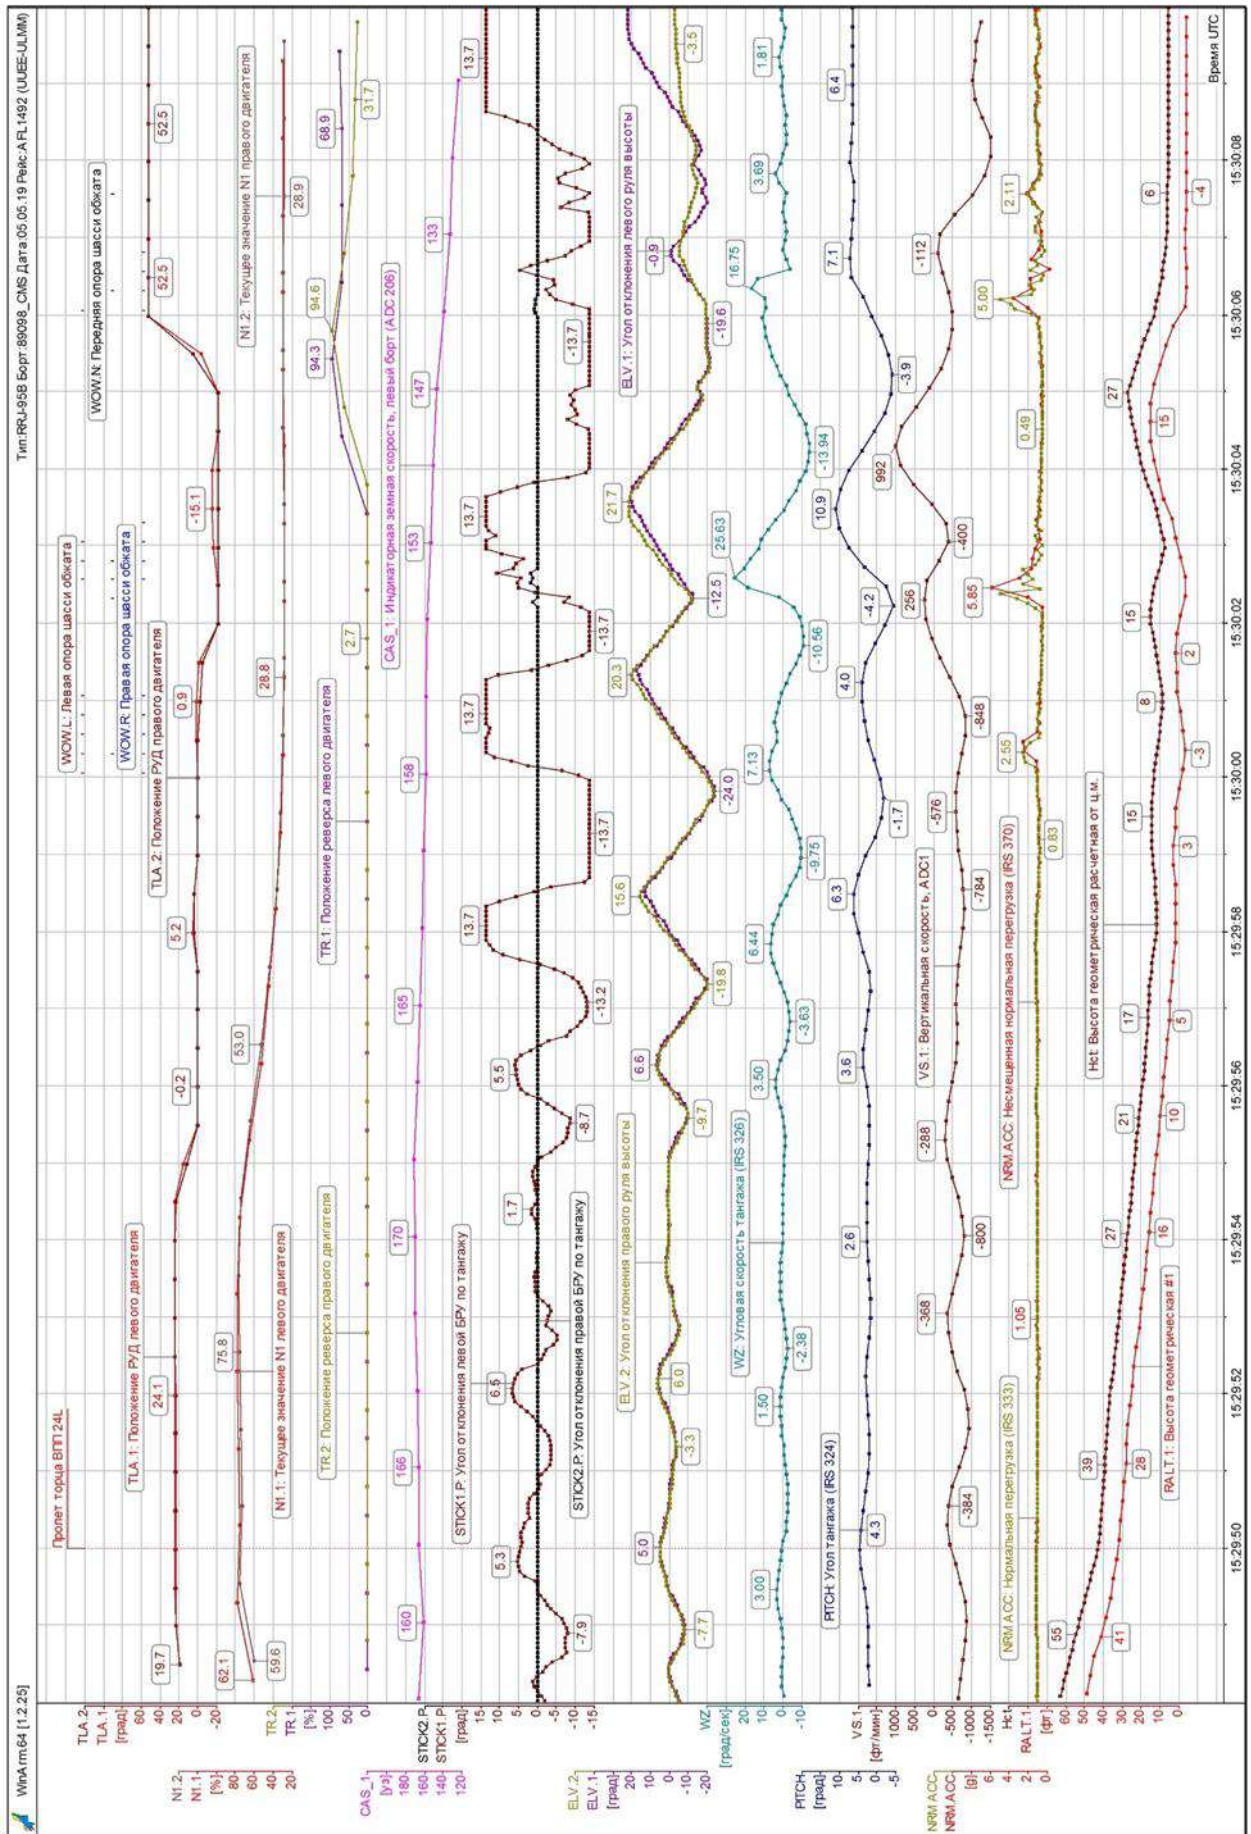
Fig. 157. The flight data through the final stage of descent and at the landing

At the point of being flown over the RWY threshold the true altitude was about 10 m, that is the aircraft was flown below the glideslope (when positioned «on the glideslope» RWY threshold shall be flown over the altitude of 15 m). After flown the RWY threshold there was a decrease of the sink rate. The flight data at the final stage of descent and at the landing are given on Fig. 157.

At 15:29:54 at the true altitude¹³¹ of 17 ft. (5.2 m) the RETARD. RETARD auto callout was activated, which indicates the reaching of the altitude to retard the TL to IDLE at flare. Concurrently with the callout activation the PIC initiated the retard of the TL.

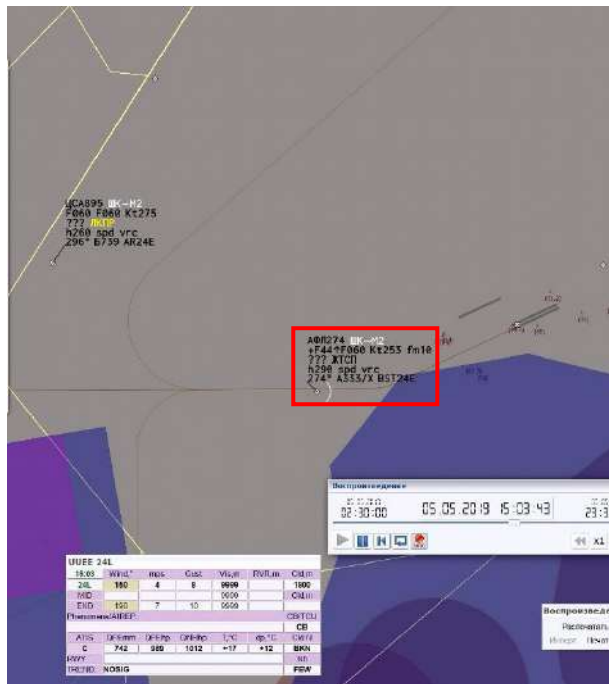
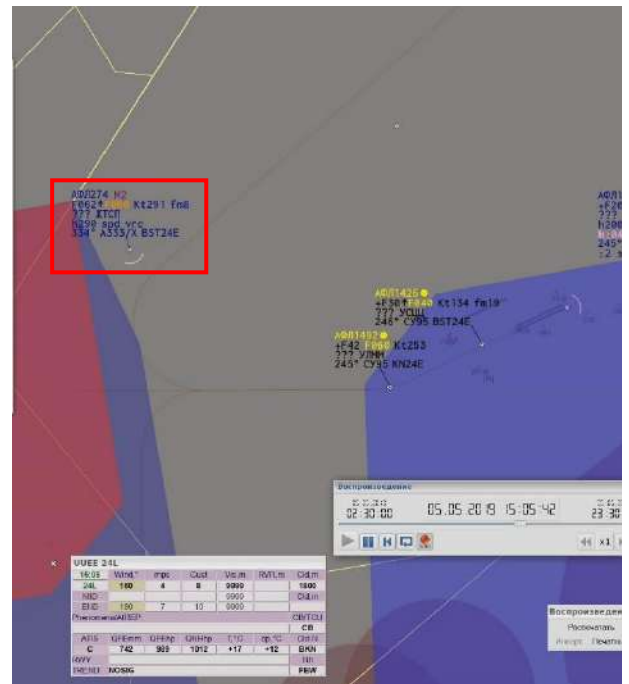
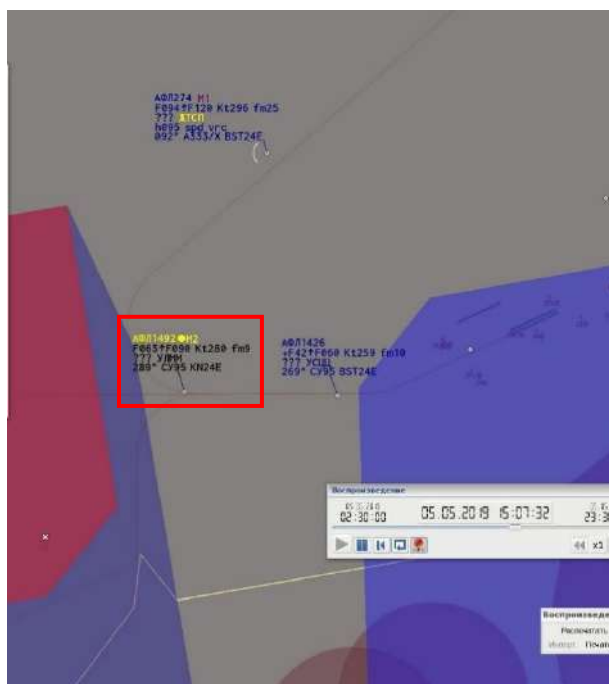
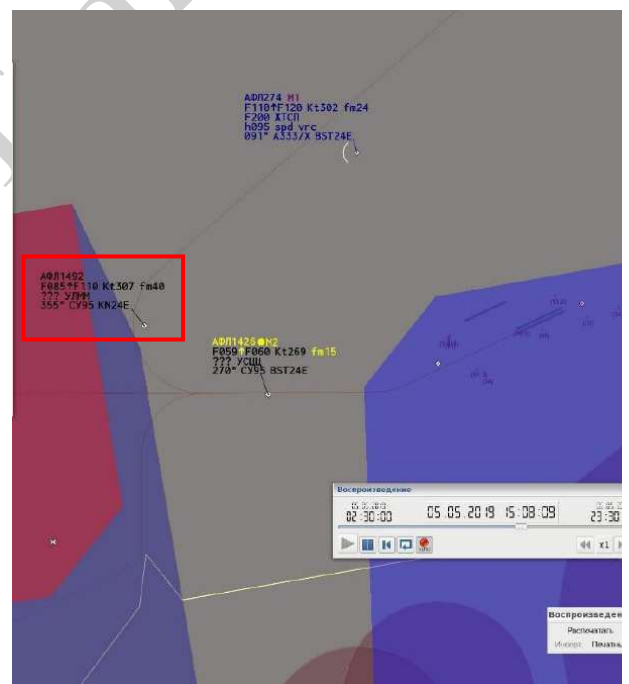
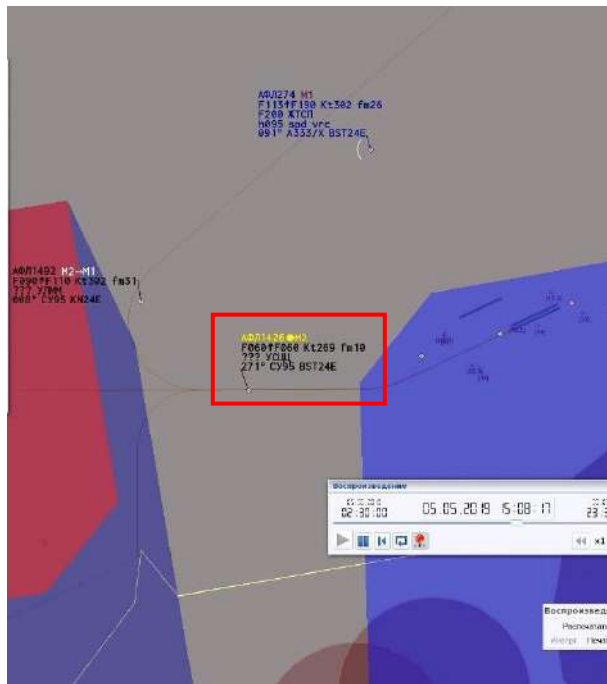
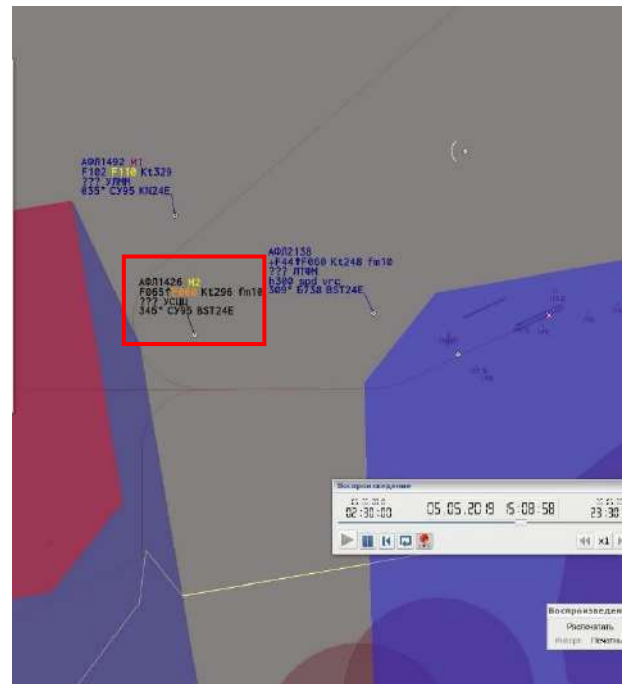
The aircraft, having departed right before and after of the RA-89098 and flown by the same route within the time interval in question (the AFL274 and AFL1426 flights), had both requested¹⁴² the right turn to avoid the thunderstorm activity at the ATC (see Section 1.18.1 of the Report as well). Fig. 158 - Fig. 163 present the frames from the ATC radar with overlapping of the Vnukovo TDWR data, showing the relative positions of the aircraft at the specific points of time. The analysis of the images in question is the evidence that the other flight crews had requested the avoidance and entered the turns earlier. At that the AFL1426 flight had been performed aboard the sister airplane at the interval of a minute approximately, that is to say the weather data images should have been roughly the same to both aircraft.

Note: *At the analysis of the images data it should be taken into account that the TDWR data are updated once every 10 minutes on the display. The thunderstorm cloud had been shifted to north-east with the velocity of 15 m/s, in other words within the time interval between the closest approach to the clutters by the AFL274 and AFL1426 flights the shift had amounted to about 2.2 km.*

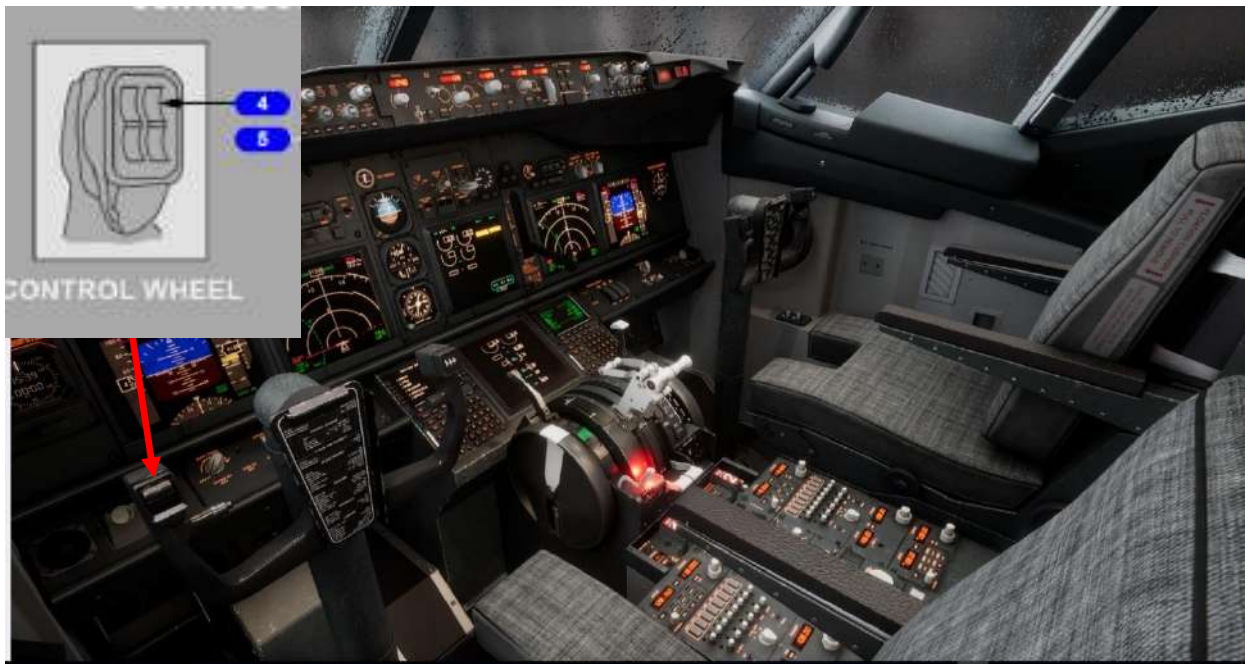
Fig. 164. The view of the B737 stab trim switches

As far as the mentioned types are concerned the aircraft control in pitch and roll is enabled with the control wheel. The stabilizer manual control is done with the use of two stab trim switches on the left (to the PIC) control wheel horn (Fig. 164). The switches are controlled with the left thumb.

This way, the stabilizer control to the previous types, operated by the PIC, and to the RRJ-95 is fundamentally different. As for the previous types, taking into account the «convenient» installation of the stabilizer controls «under the finger» and the fact that the stabilizer may be manually trimmed several times in the progress of every flight, the skill is established at the pilot of the instinctive (reflex) control by the concept: *I feel pressure on the control column (discomfort) – I release it by pressing the switches.*

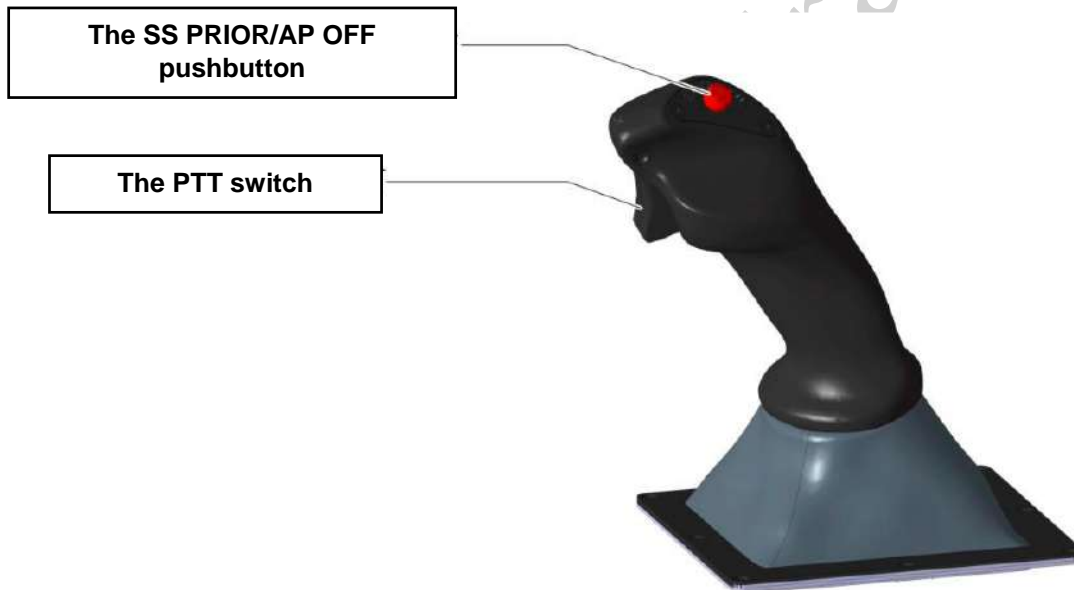
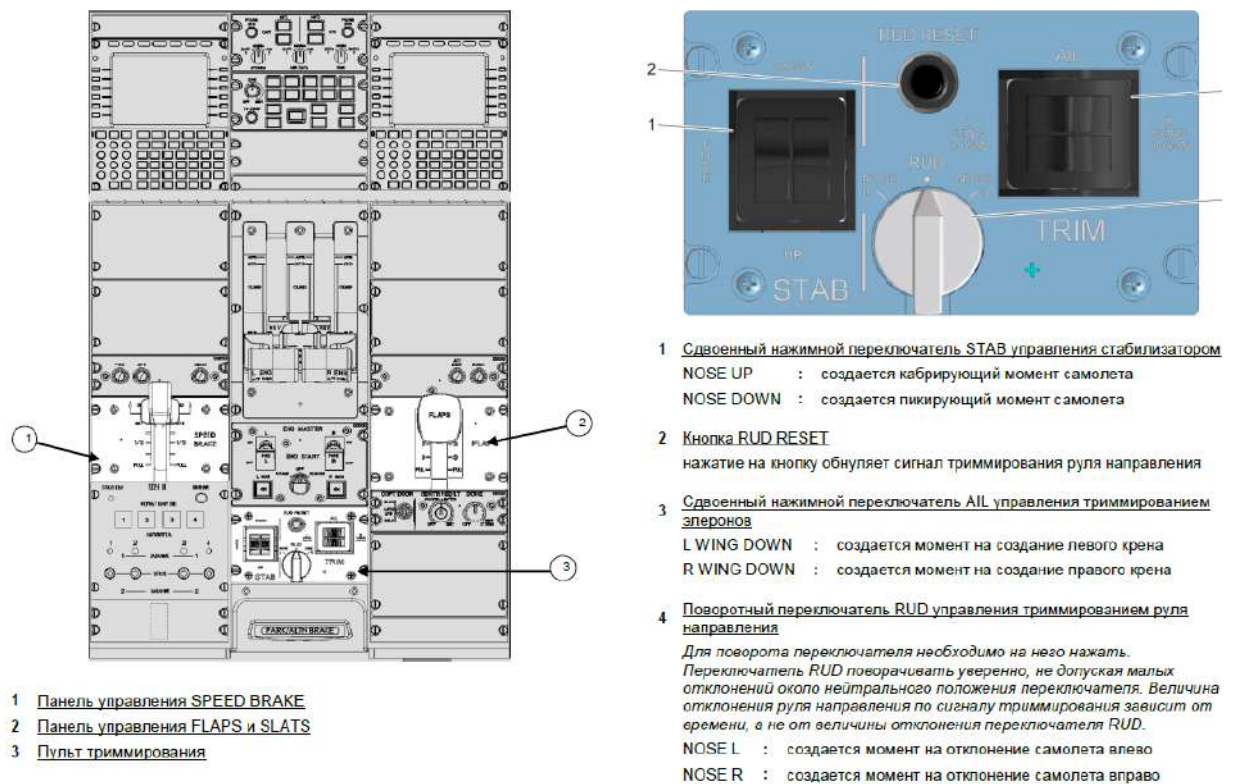
As to the RRJ-95 aircraft it is the priority pushbutton on the sidestick is under the PIC's left thumb (Fig. 165), and the manual trim in pitch is done with the switches on the cockpit central pedestal trim control panel (Fig. 166), which the PIC controls with the right hand.

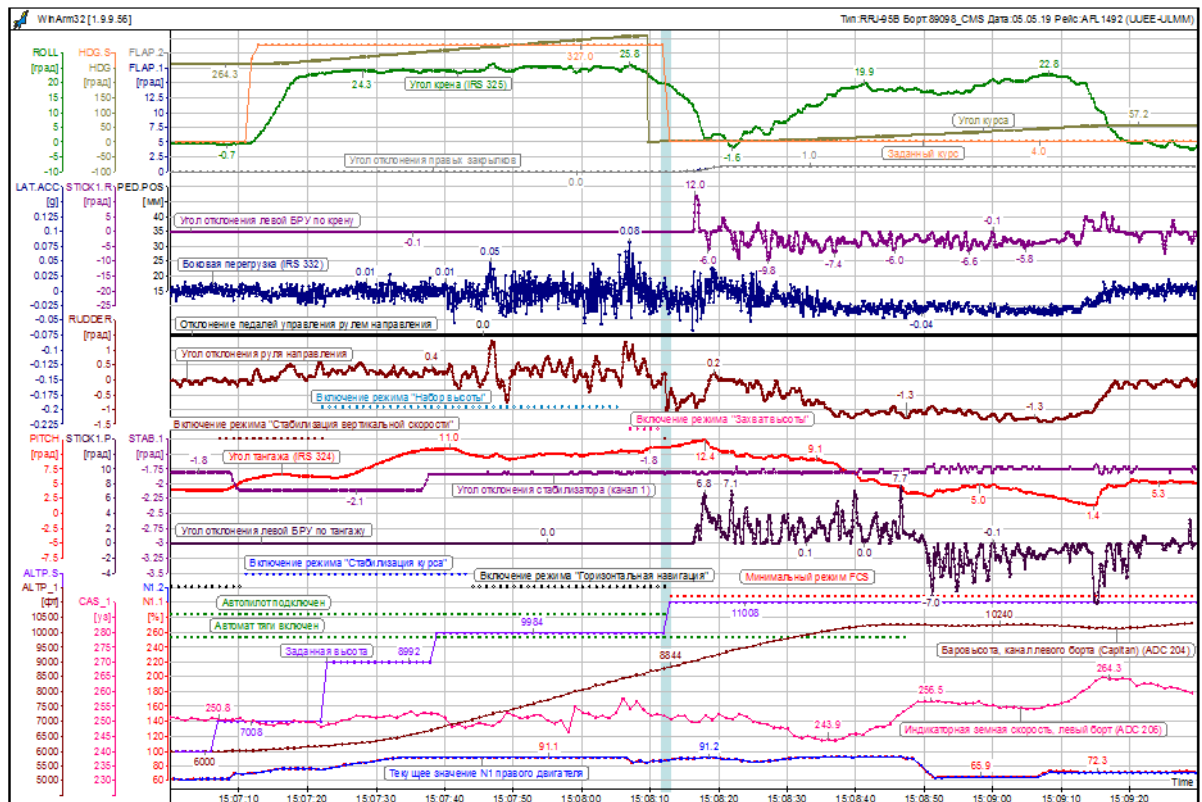
Fig. 167. The flight data into the time interval of 15:07:00 – 15:09:30 (the vertical line highlights the point of the aircraft encounter the atmospheric electricity)

The time interval of 15:07:00 – 15:09:30 (Fig. 167)

Into this early interval (before the airplane had encountered the atmospheric electricity) the flight had been all through proceeded in the automatic mode. Into the climb it had been the right turn performed. At that:

- the stabilizer had been resetting, ensuring the auto pitch trim;
- the rudder had been automatically deflected to the right (at the neutral position of the pedals), enabling the coordinated turn (the sideslip and lateral acceleration close to zero);
- the A/T maintained the target airspeed of about 250 kt.

In reviewing the sidestick inputs in pitch at the subject stage it can be noticed that the PIC's control inputs had been attributable to the «sustainable» skill of the manual operation in NORMAL MODE, when the sidestick pressure after its deflection and the establishment of the required pitch attitude was released and the sidestick returned to neutral. The maximum sidestick inputs in pitch amounted to the slightly over half of travel. As after the transition to DIRECT MODE the flaps had been automatically – as per the design integrated logic – repositioned to 1°, and the PIC did not trim the stabilizer manually, then due to the aircraft out-of-trim condition at the return of the sidestick to neutral, as in the case of the roll, the pitch attitude started to decrease (see the time interval of 15:09:00 – 15:09:15 on Fig. 167, for instance).

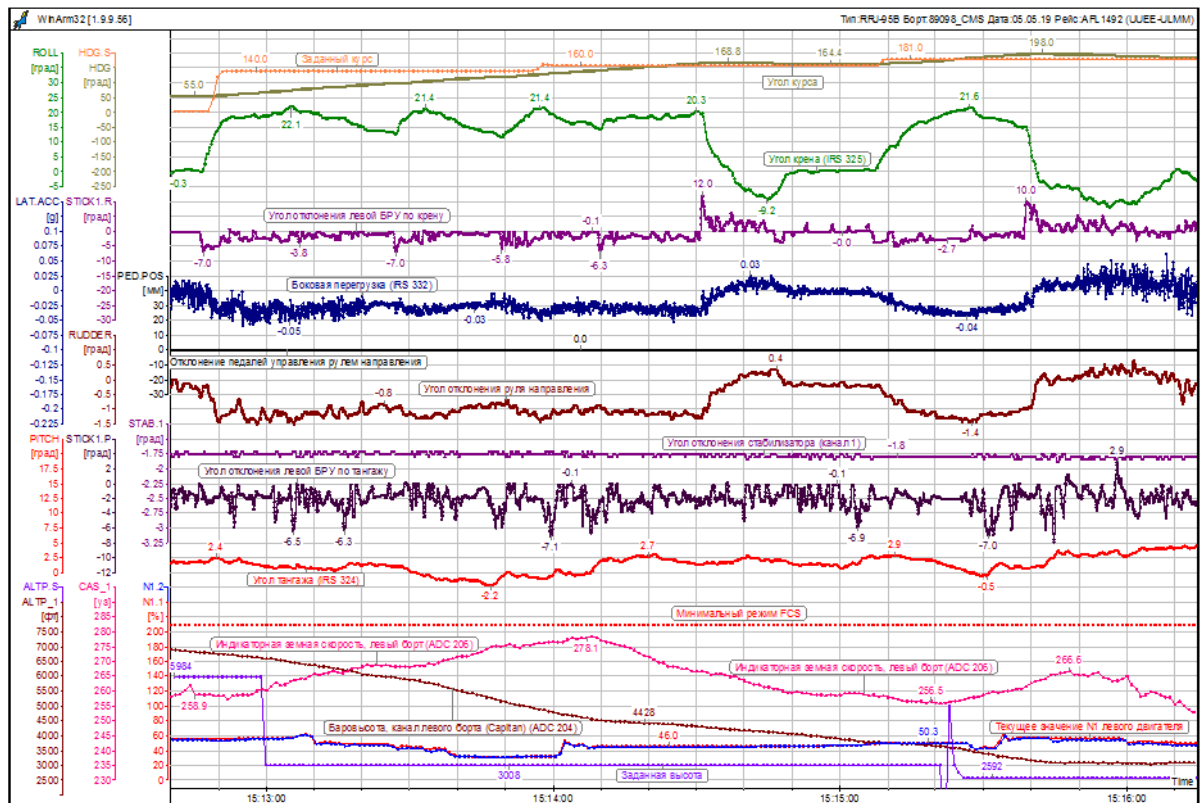
Fig. 168. The flight data into the time interval of 15:12:40 – 15:16:15

The time interval of 15:12:40 – 15:16:15 (Fig. 168)

At this very stage the PIC was solving the task of the airplane track out from the heading of 55° to this of 180° (the controller successively instructed to establish on heading of 140° (at 15:12:43), 160° (at 15:13:51) and 180° (at 15:15:05) and to descend first to the QFE altitude of 900 m (the controller's instruction at 15:12:43), and then – to 600 m (the controller's instruction at 15:15:05).

Note: *The airline performs flights by QNH. Subject to the aerodrome elevation, the respective QNH altitudes were equal to: ≈ 3600 ft. and ≈ 2600 ft. At that at the setting of the altitude of 900 m QFE the crew made an error by setting the value of 3008 ft. (Fig. 168) with no account for aerodrome elevation. This fact, most probably, is indicative of the non-optimal psychoemotional condition of the crew. Further on it had been the correct setting of the QNH altitude, corresponding to 600 m QFE, by the crew.*

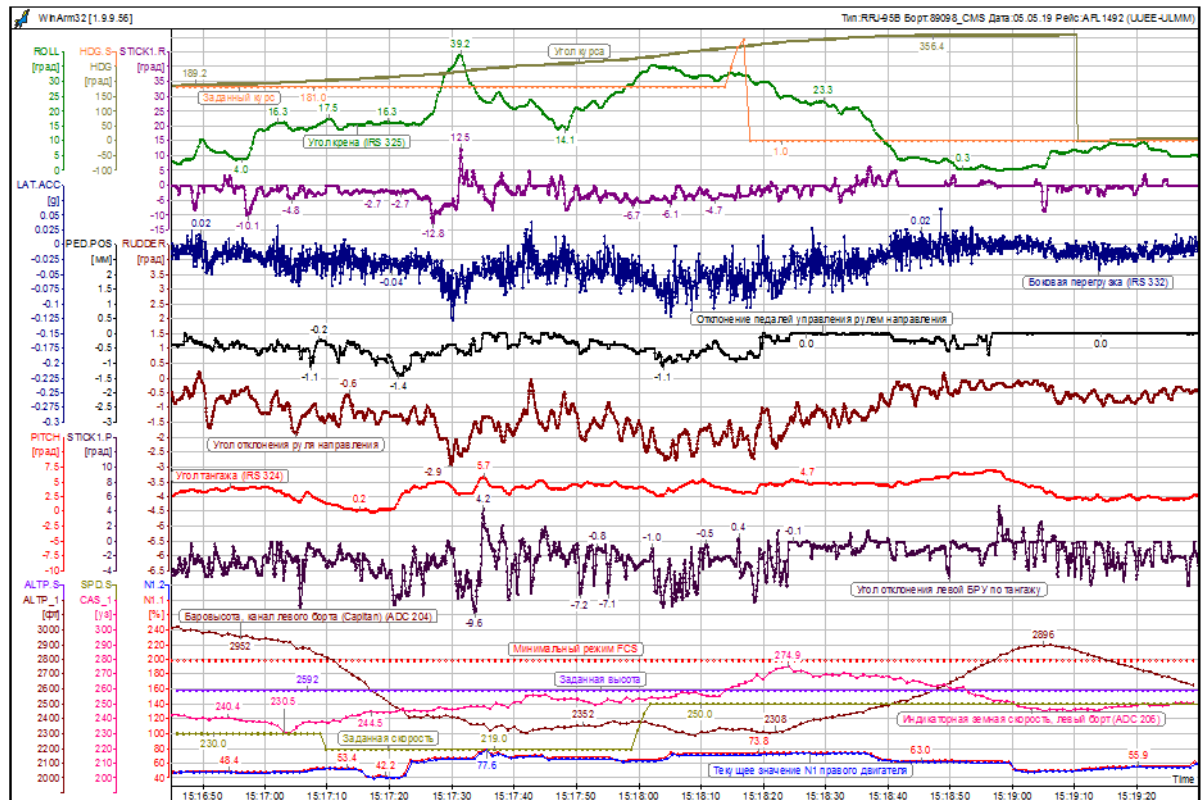
Fig. 169. The flight data into the time interval of 15:16:45 – 15:19:30

The time interval of 15:16:45 – 15:19:30 (Fig. 169)

At this early interval the airplane was completing the descent down to the altitude of 600 m QFE, earlier ordered by the ATC officer at the IAS of 245 kt (454 km/h). At 15:16:55 the crew was instructed by the ATC to turn right to the heading of 210°. The current flight heading was about 190°. After being relayed of this ATC officer's instruction the crew did not reset the target heading value, although this action had not been skipped before¹⁵¹. Presumably, the PIC was totally focused on operating the aircraft, and the F/O was concentrated on the reading on the F/CTL DIRECT MODE QRH Section, that's what he was doing at the time.

It is also noteworthy that the crew reset the values of the target speed several times (Fig. 169). It had not been possible to identify who and for what purpose did this, since no commands or acknowledgment of changing the set values were recorded by the CVR.

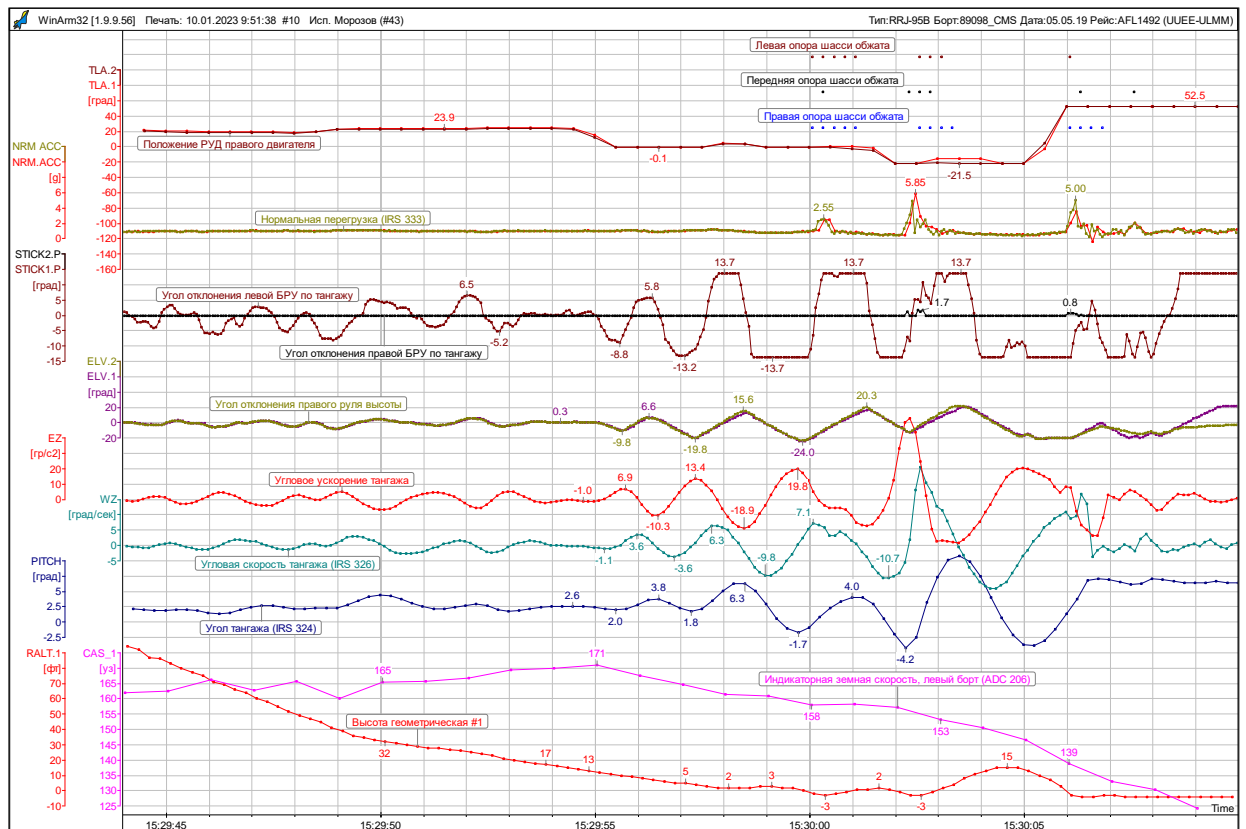
Fig. 170. The flight parameters from the altitude of 100 ft. (30 m)

Fig. 170 presents the flight parameters starting from the altitude of 100 ft. (30 m).

At the GLIDESLOPE warning activation the PIC increased the engines power rating, but did not take effective actions to recover the descent path (to establish on the target glideslope). This resulted in the aircraft IAS increase: by the point of being flown over the RWY threshold – up to 165 kt (306 km/h), and by the altitude of 16 ft. (5 m) – it did up to 173 kt (320 km/h). The target approach speed (V_{app}) was equal to 155 kt (287 km/h). The airline OM sets out the maximum value + 20 kt (37 km/h), being the stabilized approach criterion (see Section 1.18.7 of the Report). This value is inconsistent with the aircraft FCOM, which determines the value + 10 kt (18.5 km/h).

After the activation of the RETARD auto callout at the altitude of 17 ft. (5.2 m) the PIC proceeded to the aircraft flare: it was a dynamic aft sidestick input up to 8.8° (beyond a half travel) (Fig. 170). The TL were concurrently retarded to IDLE.

expectations and the sidestick after its retainment in the forward position was the fastest possible deflected back to the stop with the retainment as well. As appears from Fig. 170, as before, the sidestick input to nose-up was a distinctly reflex one and was induced at the development of the significant angular acceleration to nose-down, at that the pitch angular rate was still positive and the pitch attitude continued to increase, reaching the value of about 4° to nose-up, which was somewhat less of the normal landing value (5° - 6°). That is to say the further pitch control input to nose-up was not required, one should have just captured the current value of the parameters. Presumably, the PIC did not realize all this, having become psychologically incapacitated, as the current environment was beyond his psychoemotional potential, although did not cause the psychological stupor at him.

Further on the alternating sidestick inputs «from stop to stop» with keeping the sidestick retained were continued (Fig. 170), which resulted in the aircraft pitch oscillations in close proximity to ground (the runway). The oscillations in question are the occurrence that may be described as the unfavorable aircraft-pilot coupling/APC. These occurrences are quite rare, unexpected to the pilots, and bring about the hazardous alterations of the aircraft attitude and flight path. If these alterations are oscillatory by nature, then they speak of the PIO (pilot-induced/involved oscillations), i.e. of the oscillatory nature of the aircraft motion, associated with the pilot's actions. It should be understood that the involvement of the pilot in these oscillations is a mandatory condition, it is the active pilot's control inputs that make up an airplane-pilot closed-loop system, susceptible to the oscillations. With that this is precisely about the unfavorable (inadvertent) oscillations of the airplane-pilot closed-loop system, but not about the pilot's deliberate inputs to establish a certain oscillatory nature of the change in any parameter (the pitch attitude, for instance).

Note: *As Fig. 170 indicates, there had been no sidestick control inputs by the F/O. The minor impulse deflections of the right sidestick, recorded at the points of the accomplishment of the maximum vertical acceleration at the second and third touchdown (1.7° to nose-down and 0.8° to nose-down at the third one at most), can be explained by the F/O, having held on to the sidestick «smoothly». These deflections had no effect on the handling of the aircraft. At the first touchdown no inputs by the right sidestick are recorded. Given the considerable vertical acceleration, accomplished at the first touchdown as well, the F/O had been more likely never held on to the sidestick at that point of time.*
