INTERSTATE AVIATION COMMITTEE

FINAL REPORT

ON THE RESULTS OF THE AIR ACCIDENT INVESTIGATION

Type of occurrence	Fatal accident
Type of aircraft	RRJ-95 (RRJ-95B model) airplane
Nationality and registration marks	RA-89098
Owner	VEB Leasing, JSC
Operator	Aeroflot, PJSC
Aviation authority	FATA
Place of occurrence	Sheremetyevo aerodrome, Moscow region, Russian Federation; reference position: 55°58'06.20" N, 37°24'07.20" E
Date and time	May 05, 2019, 18:30 local time (15:30 UTC), daytime

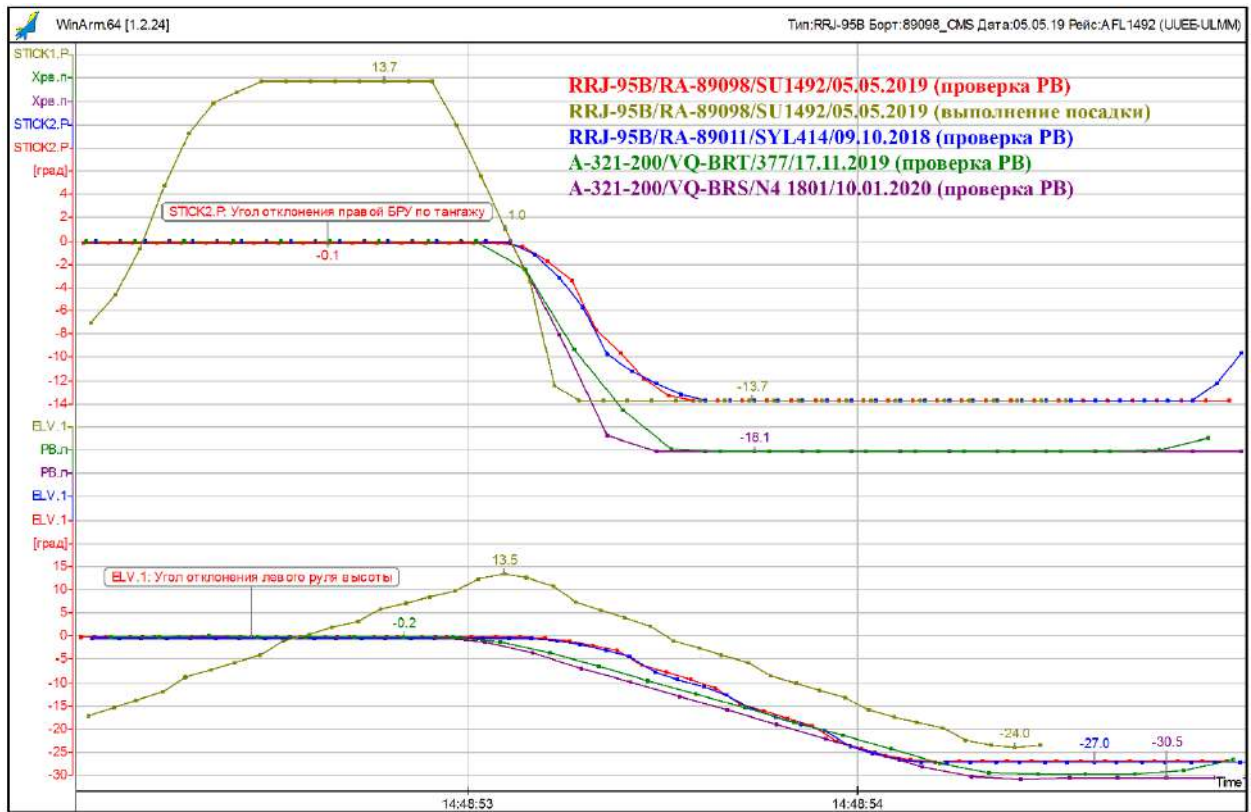
Fig. 171. The comparison of the elevator travel rates at the dynamic sidestick inputs (the time is relative on the Figure)

⁸⁰ As explained by the aircraft designer, these requirements correlate well with the statistical data on the other modern commercial airplanes actuators (see Fig. 171 of the Report as well).

At the actual speeds and the amplitudes of the sidestick inputs into the flight that ended up with the accident the aircraft feedback was fully determined by the available rate of the elevator actuators travel. Fig. 171 presents the comparison of the elevator surfaces deflection rates at the full travel sidestick inputs at the check of the elevators to the RRJ-95 and A320 aircraft and into the emergency process in flight that ended up with the accident. By the comparison it is clear that:

- the sidestick input rate at RA-89098 into the emergency had been higher against this at the preflight checks.

This way, the sensation of lag in the aircraft response to the sidestick input had been only attributable to the PIC's psychological condition and is of the same nature as the reflex control by the perceived accelerations.

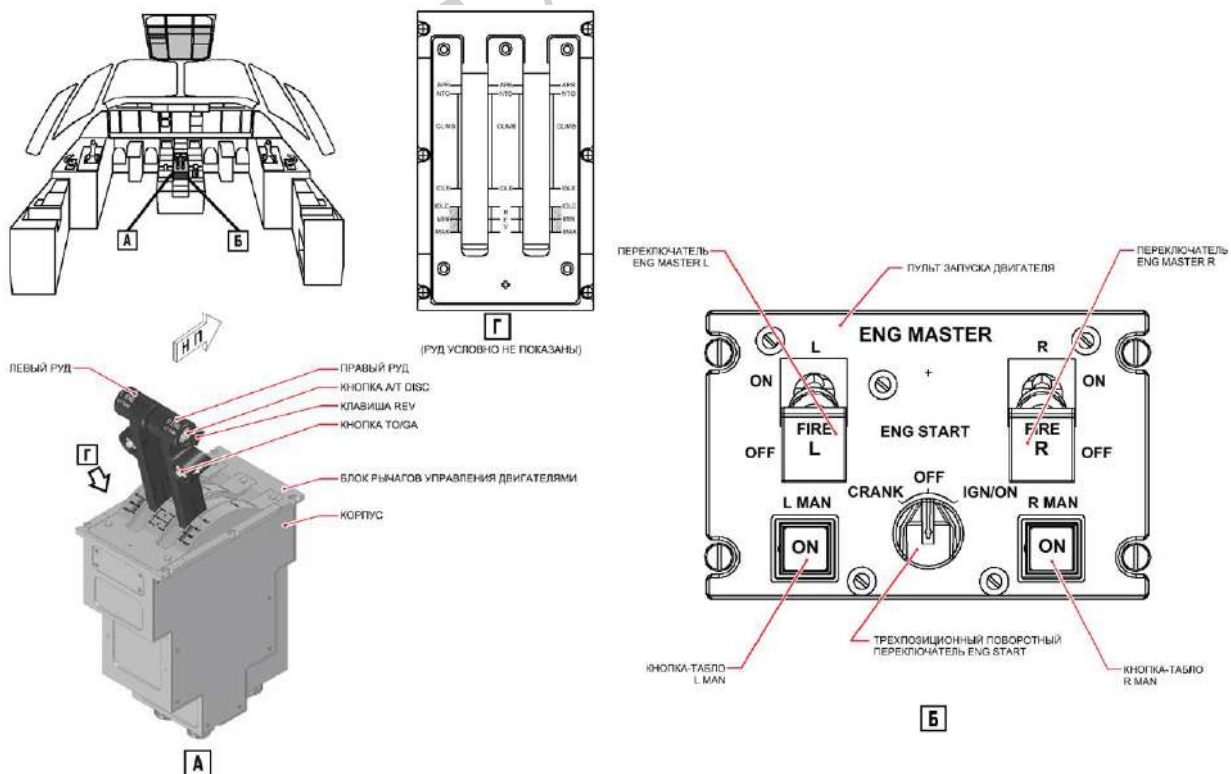
Fig. 172. The layout of the engine control components

Fig. 172 presents the engine control (startup and shutdown) panel and the TL quadrant. The engine control panel (engine startup/shutdown) is designed, inter alia, to stop the running engines.

To shut the engine down the high pressure shutoff valve/HPSOV interrupts the fuel supply to the fuel nozzles. The HPSOV is an integral part of the FMU, installed on the engine. The switching of the running engine ENG MASTER (Fig. 172) to the OFF position by the pilot commands the closing of the respective HPSOV.

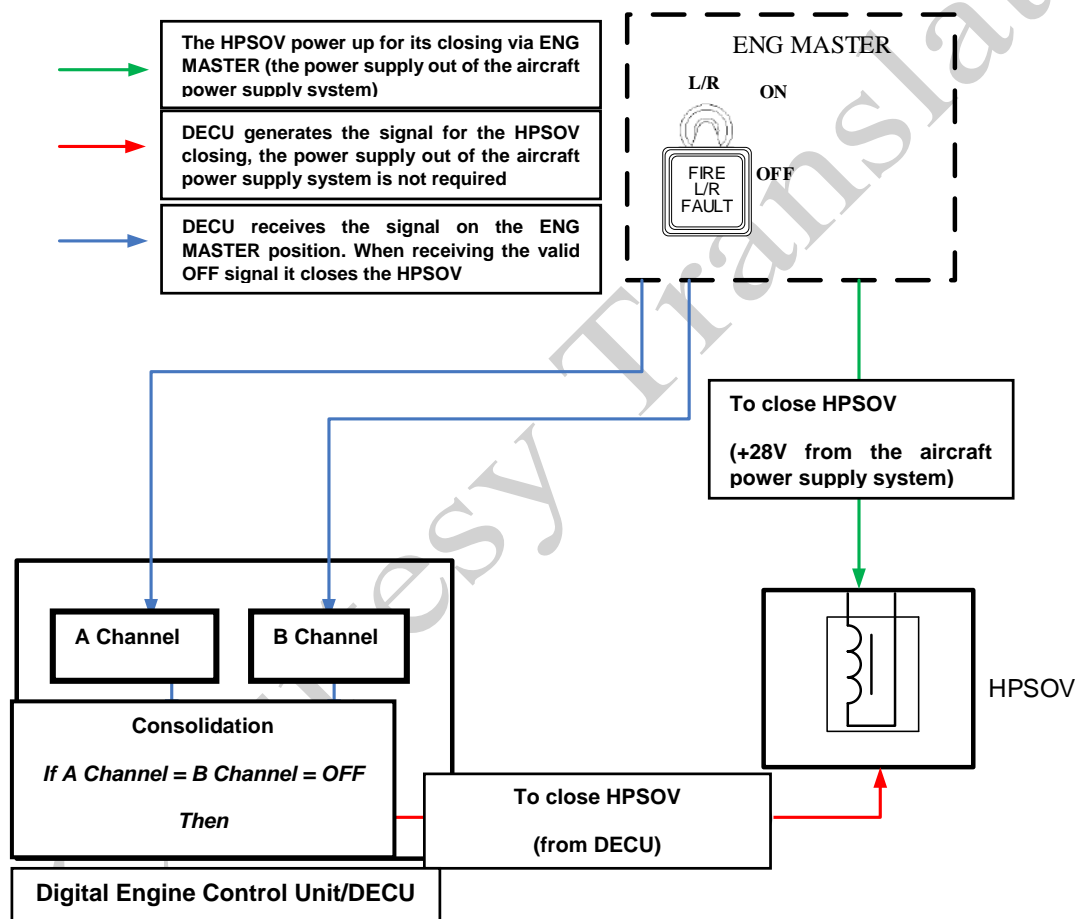
**Fig. 173. The schematic of the generation of the command to have HPSOV closed, when switching ENG MASTER to the OFF position**

When the crew switches ENG MASTER to the OFF position, the signal to close HPSOV is delivered both from the ENG MASTER switch itself and from DECU, i.e. through two independent interfaces (Fig. 173). The delivery of any signal is enough to have it closed.

The engine control system design ensures that the HPSOV control loop from the ENG MASTER switches via DECU (Fig. 173) remain efficient even at the airplane total power off, as with the running engine it is powered by the DECU self-sustained power supply, which in turn is powered by the PMA. This shutdown loop is to function every time, irrespective of the presence/absence of the airplane on ground signal. In the course of the investigation the efficiency of this method in the accident flight environment had been confirmed by the direct experiment on a real airplane.

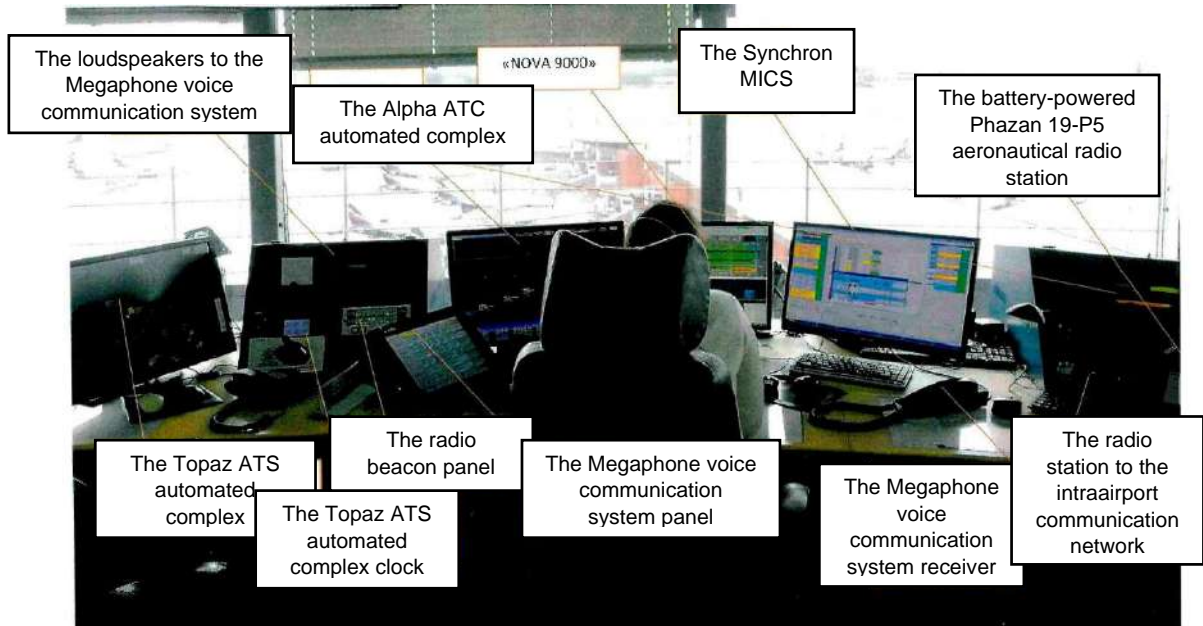
Fig. 174. The exterior of the Tower C1 sector controller’s duty station

Fig. 174 presents the exterior of the Tower Sector C1 controller duty station. The Tower controller may choose the meteorological conditions information be displayed either on the Topaz ATC automated complex screen (Fig. 175), or be obtained right from the KRAMS Integrated Aerodrome Radiotechnical Weather Station display (Fig. 176), which is installed above the controller's duty station. The meteorological information is updated every minute.

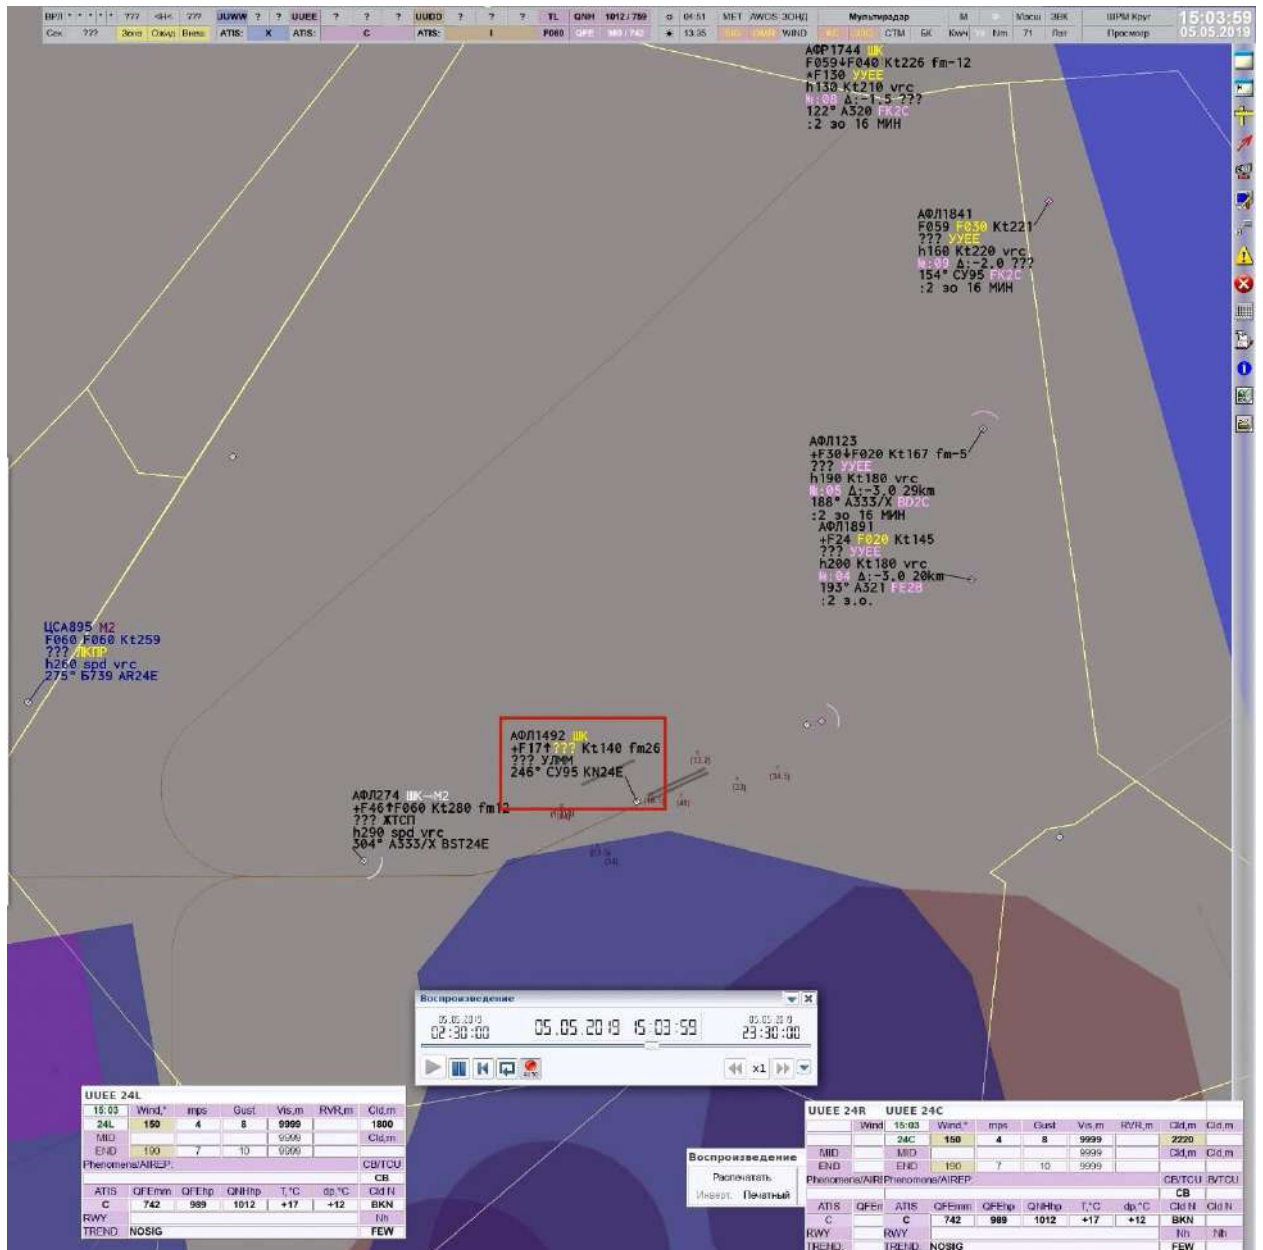
The radar environment, combined with the TDWR indication, at the points of receiving the aircraft for control and the control transfer is presented on Fig. 178 and Fig. 179. Over preceding 10 minutes before receiving the aircraft for control the controller had been relayed six requests by three different aircraft for the avoidance of the thunderstorm cells¹⁹². The TDWR «image» changed at 15:05.

Fig. 178. The SYNTEZ-AR4 ATC automated complex indication at the Radar controller's duty station at 15:03:59 when receiving the AFL1492 flight for control (the aircraft data block is outlined with the red rectangle)

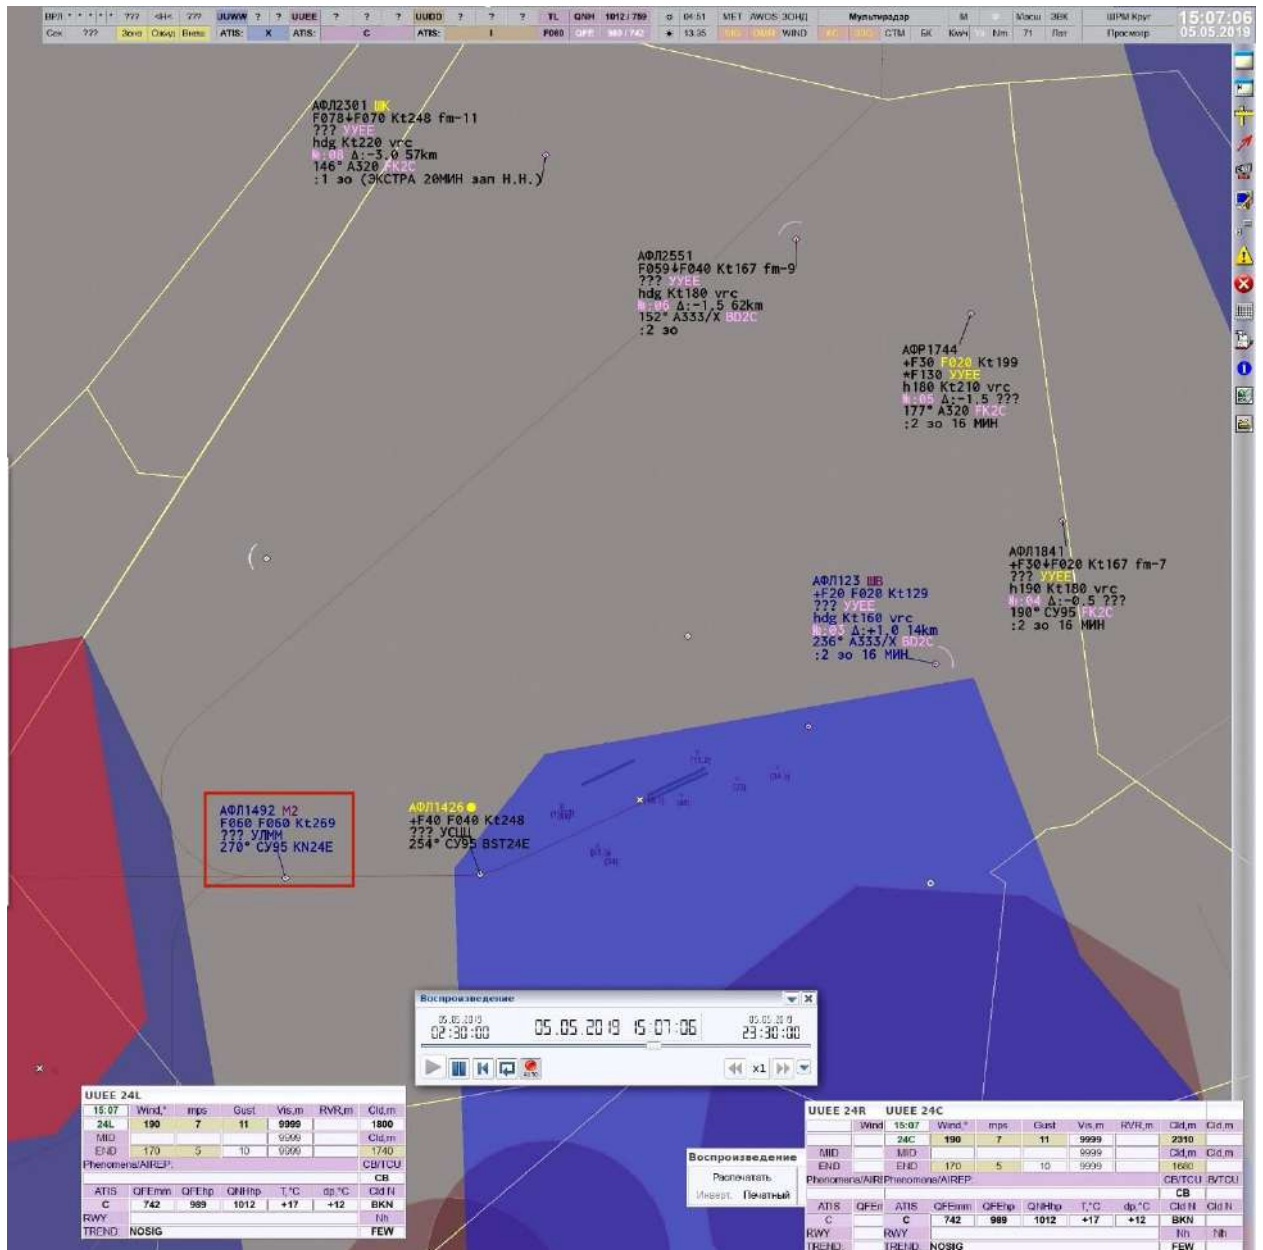
Fig. 179. The SYNTEZ AR-4 ATC automated complex indication at the Radar controller’s duty station at 15:07:06 at the transfer of the AFL1492 flight for control (the aircraft data block is outlined with the red rectangle)

The said item 6.2.3 to the SOP sets out as well that the radar control officer «*shall analyze the actual weather environment to determine the potential to perform air operations or the necessity to impose restrictions (prohibitions) on their performance*». On Fig. 179 one can see that, while proceeding by the KN 24E SID, the aircraft was dangerously approaching the thunderstorm activity zone. The RA-89098 aircraft crew, unlike the other aircraft, had not requested the avoidance of the zone. The investigation team is of the opinion that the Sheremetyevo Radar sector radar control officer, guided by the indicated item, could have briefed the crew appropriately and suggested the options of avoidance. In fact the radar control officer had shown passivity.

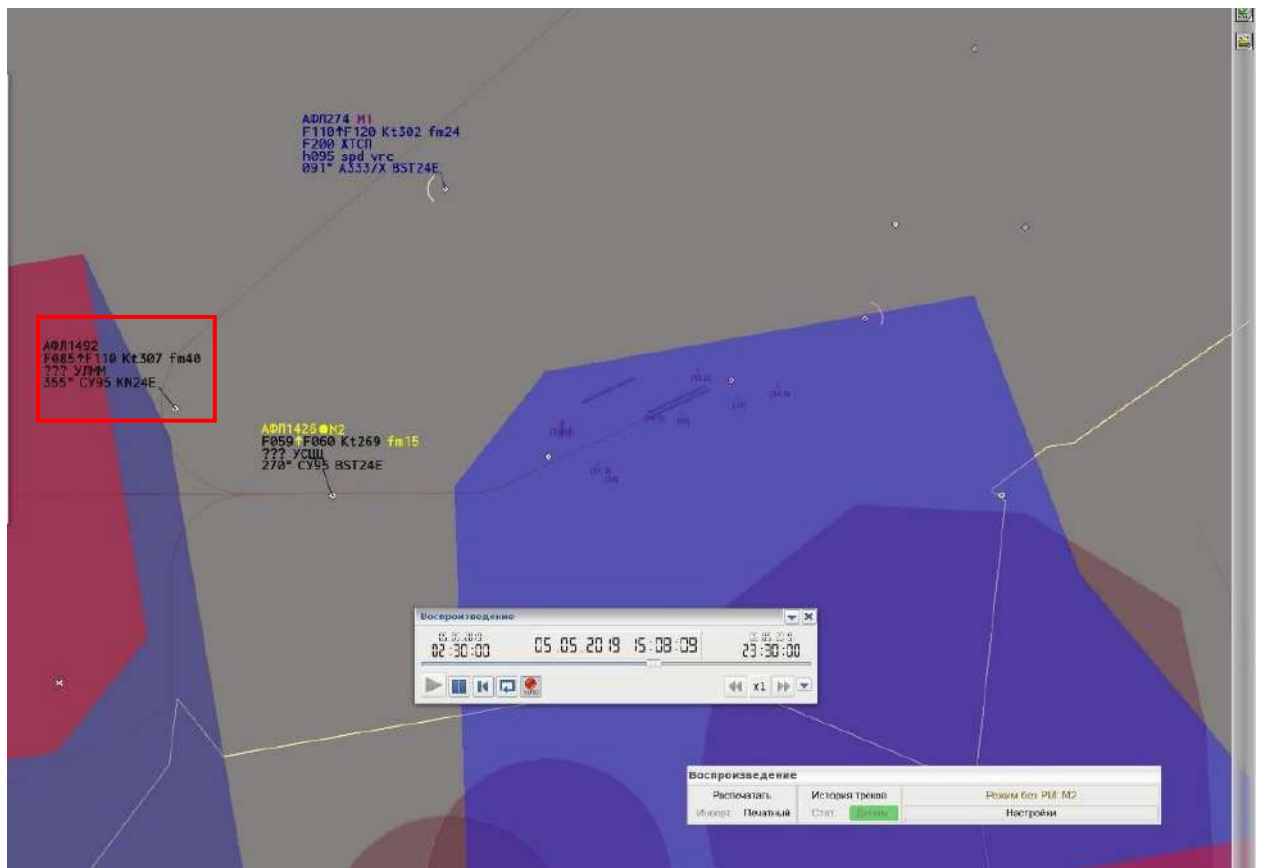
Reportedly, at the ATM of the AFL1492 flight the TDWR data had been displayed to the Approach controllers. The aircraft position at the encounter the atmospheric electricity is shown on Fig. 181. Compliant to SOP (items 5.2.4 and 6.2.3), the required actions by the radar control officer at the M2 sector in terms of briefing the aircraft crews on the hazardous weather phenomena zones are the same as these by the Radar controller. Equally, the said provisions of the SOP had not been fulfilled by the Approach controller. The controller had been unengaged.

Fig. 181. The SYNTEZ AR-4 ATC automated complex indication at the Approach controller's duty station at 15:08:09 at the AFL1492 flight encounter the atmospheric electricity (the aircraft data block is outlined with the red rectangle)

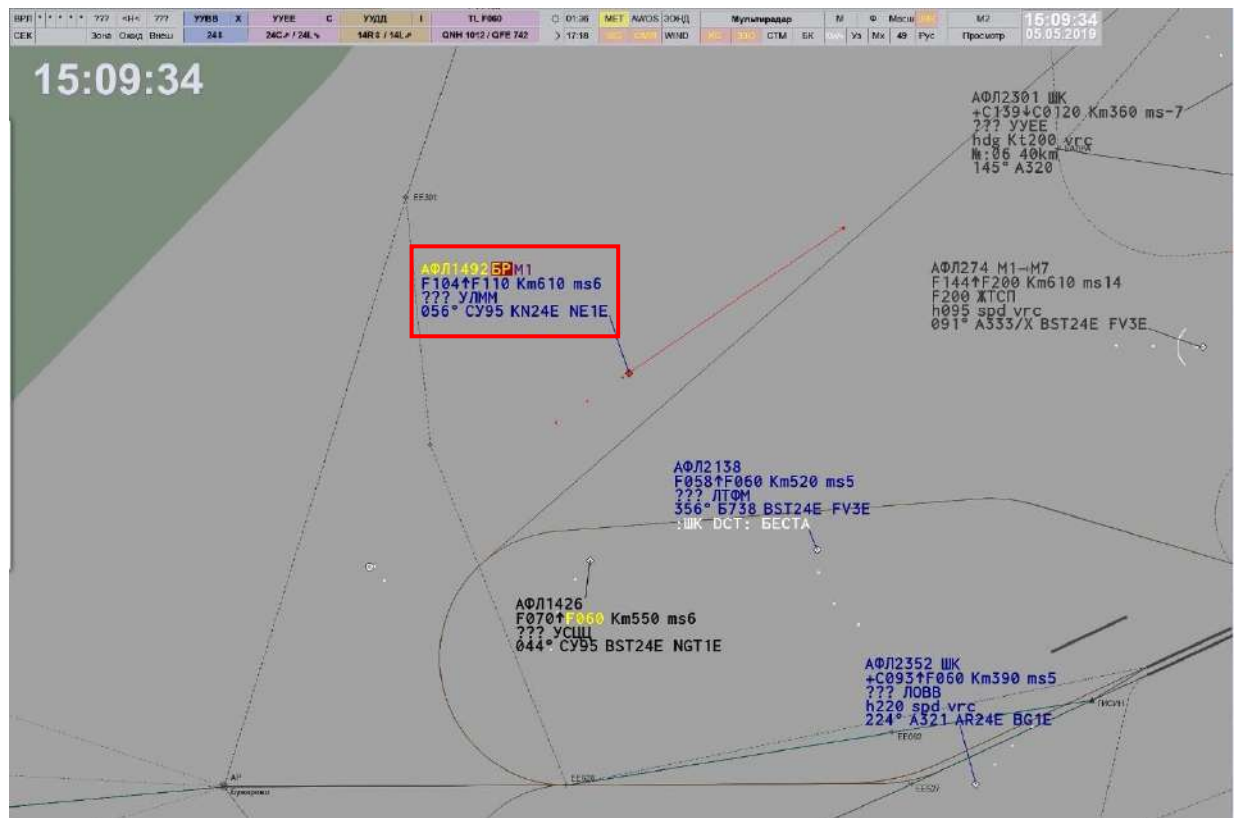
At 15:09:29 the aircraft crew on the 121.5 MHz emergency frequency relayed the PAN-PAN urgency signal «*PAN-PAN, PAN-PAN, PAN-PAN, Aeroflot 14-92*». At 15:09:34, after the crew set the 7600 squawk code, at PPI the PC (radio loss) mode is activated in the AFL1492 data block, whereas at the screen to the SYNTEZ AR-4 ATC automated complex in the AFL1492 flight data block there appeared the BP (Radio Loss) status (Fig. 182).

Fig. 182. The SYNTEZ AR-4 ATC automated complex indication, the point of the change in the data block status (it is outlined with the red rectangle) to the AFL1492 flight, the activation of the BP/Radio Loss mode¹⁹³

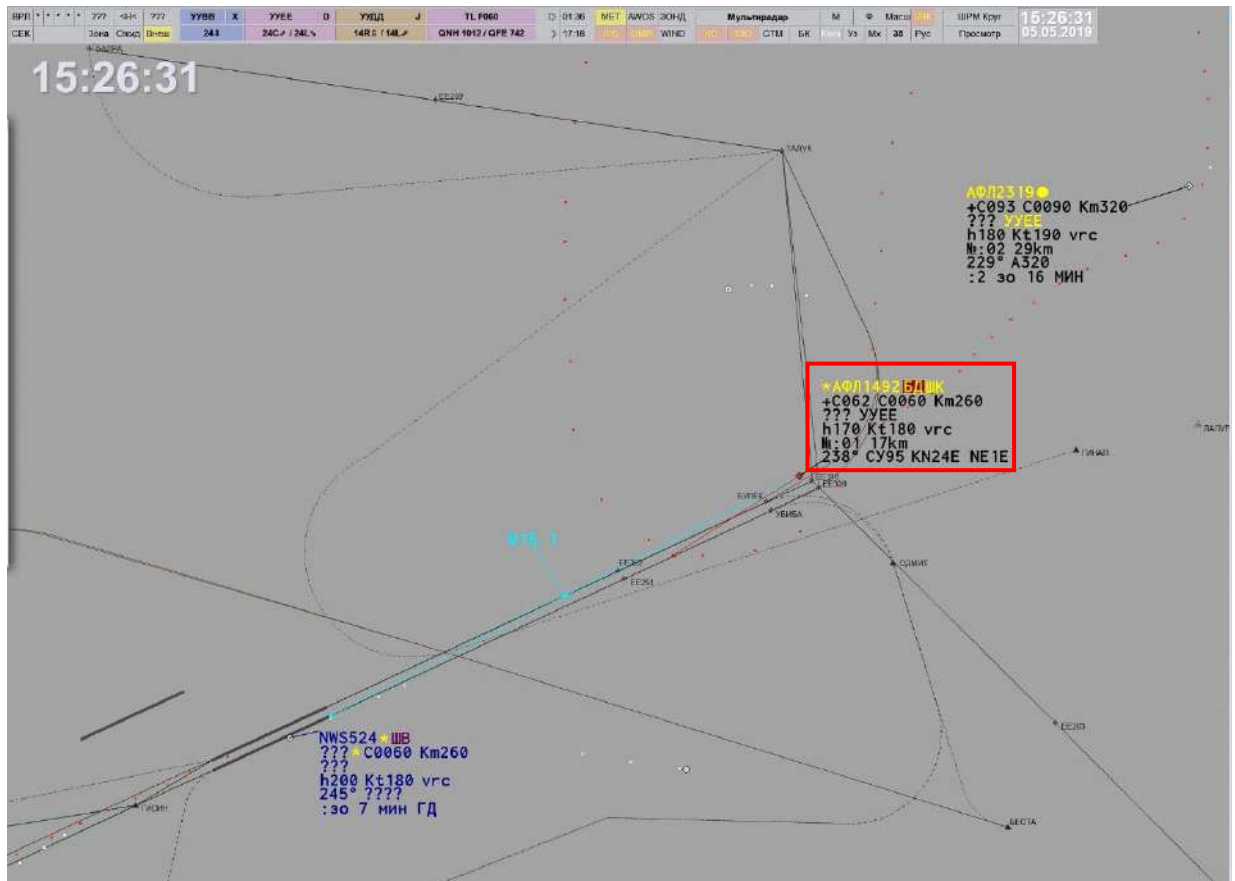
After the setting of the 7700 code the indication in the AFL1492 data block on the Radar controller's SYNTEZ AR-4 ATC automated complex screen changed from БР/Radio Loss to БД/Distress (Fig. 183). After the crew was transferred to the Tower controller, the Radar controller had to make sure by monitoring the radio communication that the radio contact between the crew and the Tower controller had been established. At the reviewed stage of flight the two-way radio communication had not been established, in other words, the control transfer had not actually occurred. The Radar controller might not have noticed the change of indication (status). With that the investigation team points out that it were only two letters to change in the data block, whereas the display on the red background remained unchanged. The indication of the kind does not have an attracting effect (keeping in mind it had been for a long time by then that the controller had observed this «red background»), and as of the day of the air accident the SYNTEZ AR-4 ATC automated complex had not been equipped with the sound alert to draw the controller's attention to the change of the flight status.

Fig. 183. The SYNTEZ AR-4 ATC automated complex indication, the point of the data block status change (it is outlined with the red rectangle) to the AFL1492 flight, the activation of the БД/Distress mode

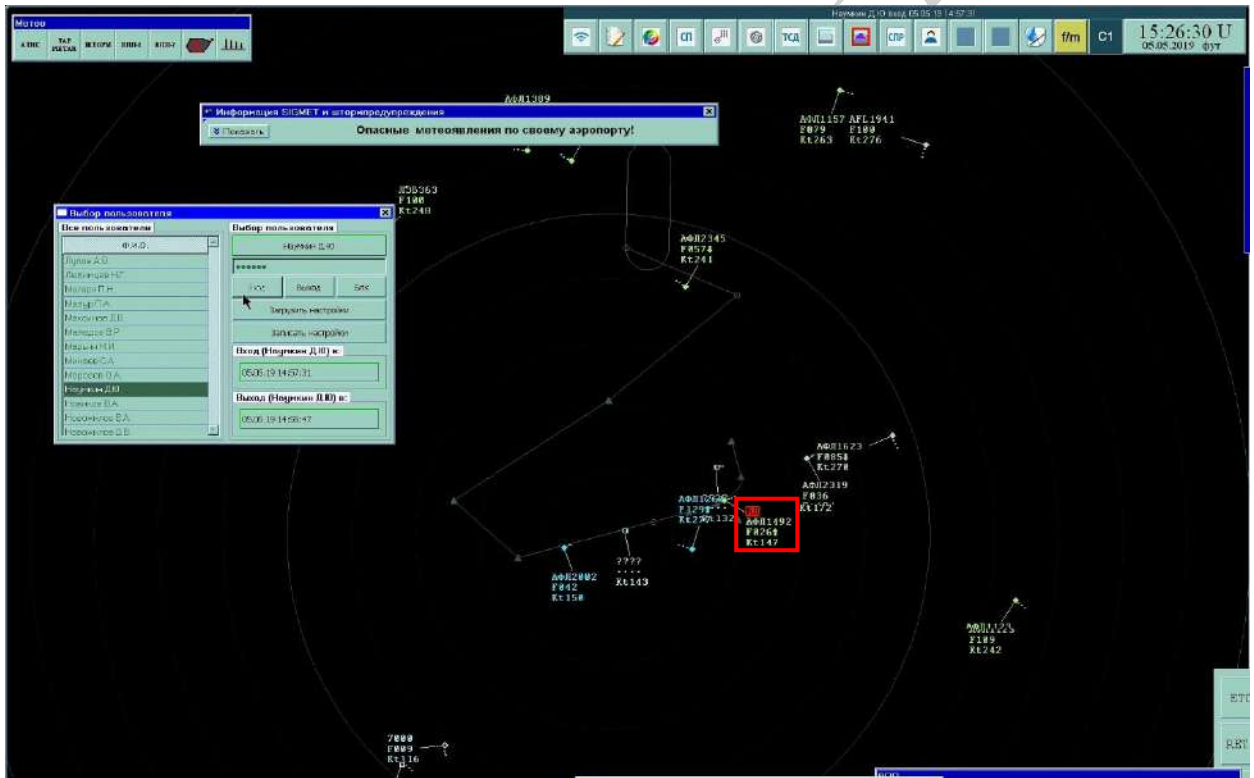
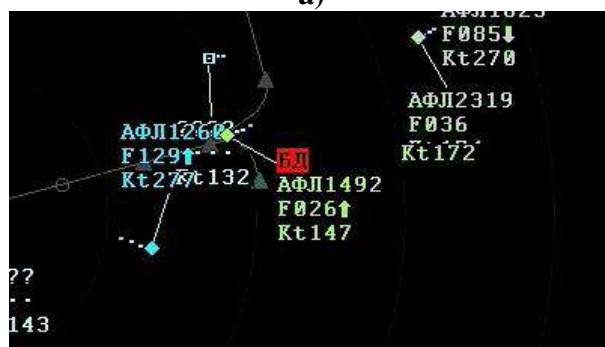
After the 7700 squawk code was set at the PPI to the Topaz ATC automated complex the status of the data block to the AFL1492 flight changed from the BP/Radio Loss mode to the БД/Distress (Fig. 185). In the data block on the NOVA 9000 A-SMGCS airfield surveillance radar indicator the status should have been changed from the RCF mode (Radio Communication Failure) to the EMG (Emergency) mode. Indeed, in fact, initially there were two statuses displayed concurrently - «EMG, RCF» (at the entrance in the radar coverage zone, when the 7600 squawk code was set) (Fig. 186), and later, after the setting of the 7700 squawk code, there were three statuses, simultaneously displayed - «EMG, RCF, HIJ» (Emergency, Radio Communication Failure and Hijacking) (Fig. 187), consistent with three different squawk codes («7700», «7600» and «7500»). This presentation is a non-normal one, it had not been possible to determine the reason for such operation of the NOVA 9000 A-SMGCS airfield surveillance radar. Three statuses remained simultaneously displayed till the aircraft landing and after the landing changed to the «EMG» symbol.

Fig. 185. The Topaz ATC automated complex indication, the point of the data block status change (it is outlined with the red rectangle) to the AFL1492 flight, the activation of the 7700 БД/Distress mode; a) the shot of the entire radar display b) the data block

Similar to the Radar controller, the Tower ATC officer neither responded to the change of the status in the data block, nor requested the crew on the reasons of the 7700 squawk code setting, nor reported the conflicting information in the NOVA 9000 A-SMGCS airfield surveillance radar data block to the senior controller or the air operations supervisor. In this way the Tower controller may not have noticed the change of the status.

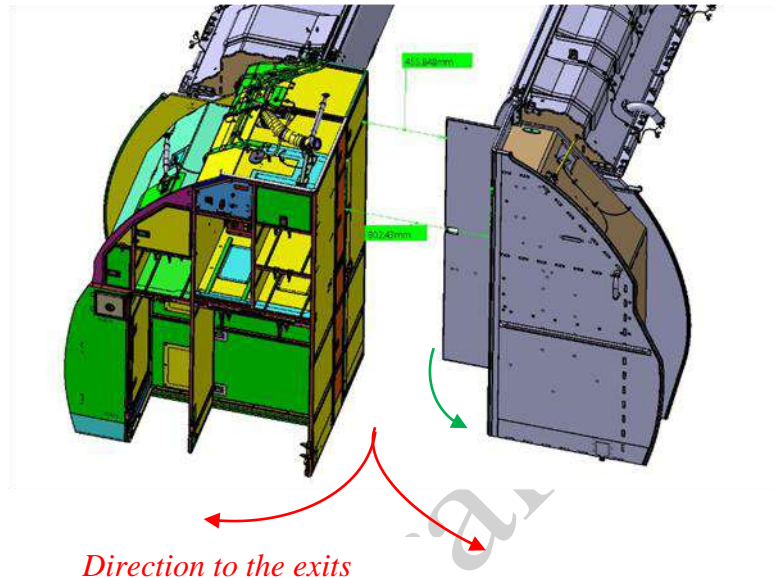
did not communicate that they had attempted to take the megaphone out. The CFA mentioned that the effort to open the closet door (where, among other things, the megaphone is located) could have obstructed the way to evacuate. Still the investigation team notes that the closet door, when opened, does not completely block the way from the passenger cabin to the front compartment and is designed in such a way that the direction of its closing matches the direction of the passengers' movement to the emergency exits (Fig. 188).

Fig. 188. The closet door in the front compartment

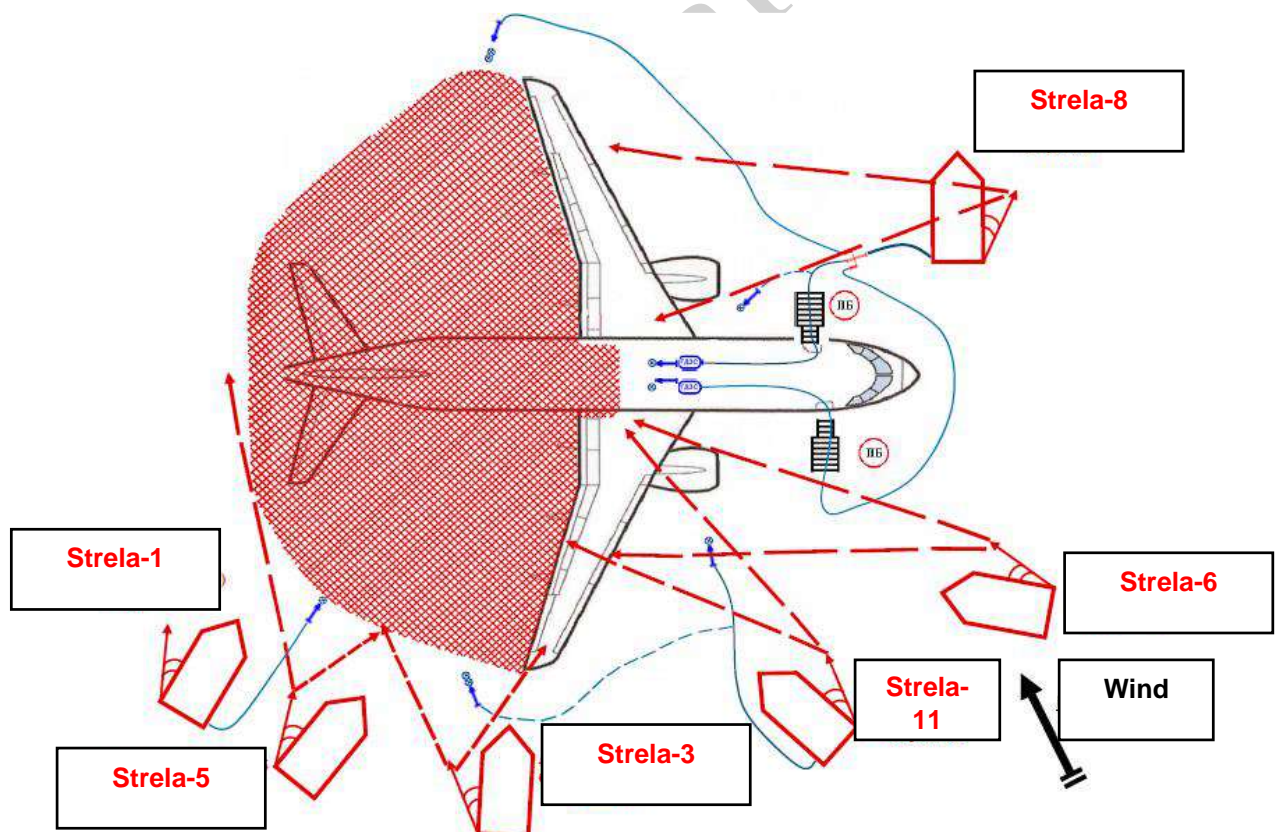
The Strela-1, Strela-3 and Strela-5 firefighting vehicles, the three ones to arrive first, took up the combat position and started to suppress the fire seat, having allocated at the right rear against the aircraft wing (Fig. 191), discharging the fire suppressant to the area, adjacent to the fuselage compartment # 4, and this of the spilled fuel.

Fig. 191. The layout of the workforce and means at the fire extinguishing (the red lines stand for roof monitors, the blue ones do for the hose lines)
